**REPORT ON THE ASSESSMENT OF TRENCHING IN THE
ROAD RESERVE OF THE ROAD BETWEEN BEAUFORT
WEST AND CARNAVON.**

RFP No. 3259/08/02/2019

CSIR
Meraka
SANReN

CSIR Built Environment
Transport Infrastructure, Bldg 2C
Meiring Naude Road
PO Box 395
Pretoria 0001, South Africa
Tel.: +27 12 841 2911
Fax: +27 12 349 1153

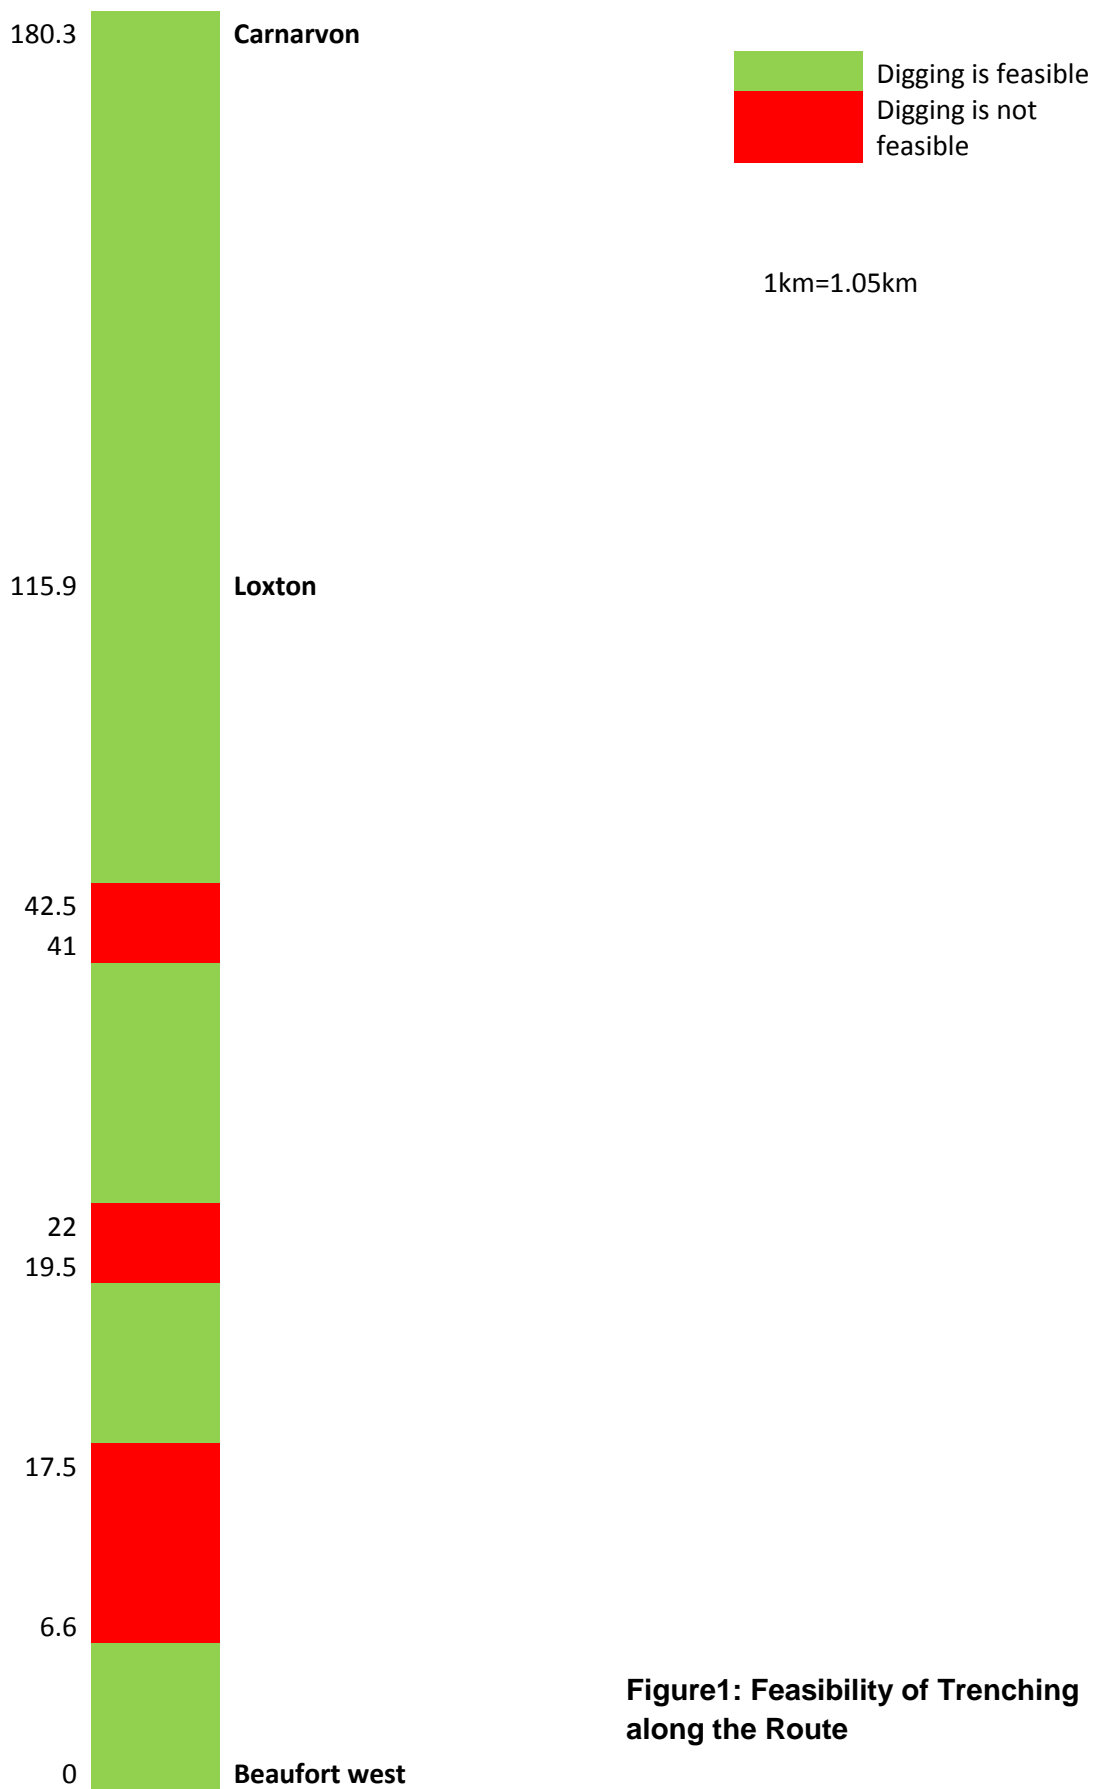
Figure1: Feasibility of Trenching along the Route

Figure 1, gives an estimate of the road reserve that can easily be trenched. However, it must be emphasized that it is a visual survey and as such does not include what may occur below the surface. Figure 2 is a more detailed observation of the obstacles to trenching.

Most of the road reserve is suitable for trenching and backfilling. However, approximately 15 km are deemed to be unsuitable for trenching.

The areas considered unsuitable were where the road goes through the Molteno pass, which is very rocky and other areas that have extensive rocky outcrops (Figure 1). It may be prudent to consider alternatives to trenching in these areas. The possibility of digging in the road itself may be a viable alternative, if allowed by the Roads Authorities of the area. However, it is not known what may be encountered under the road (the depth to which there is soil)

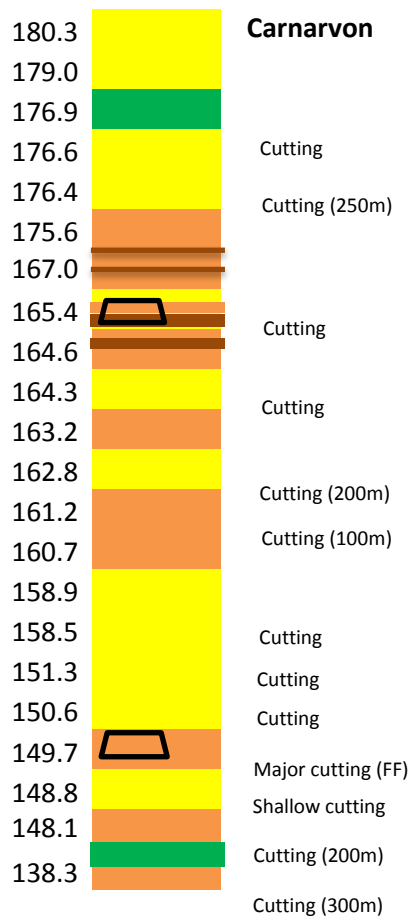
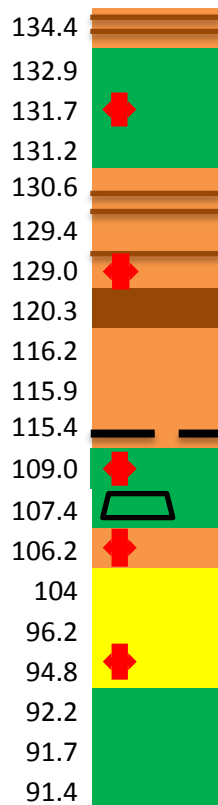
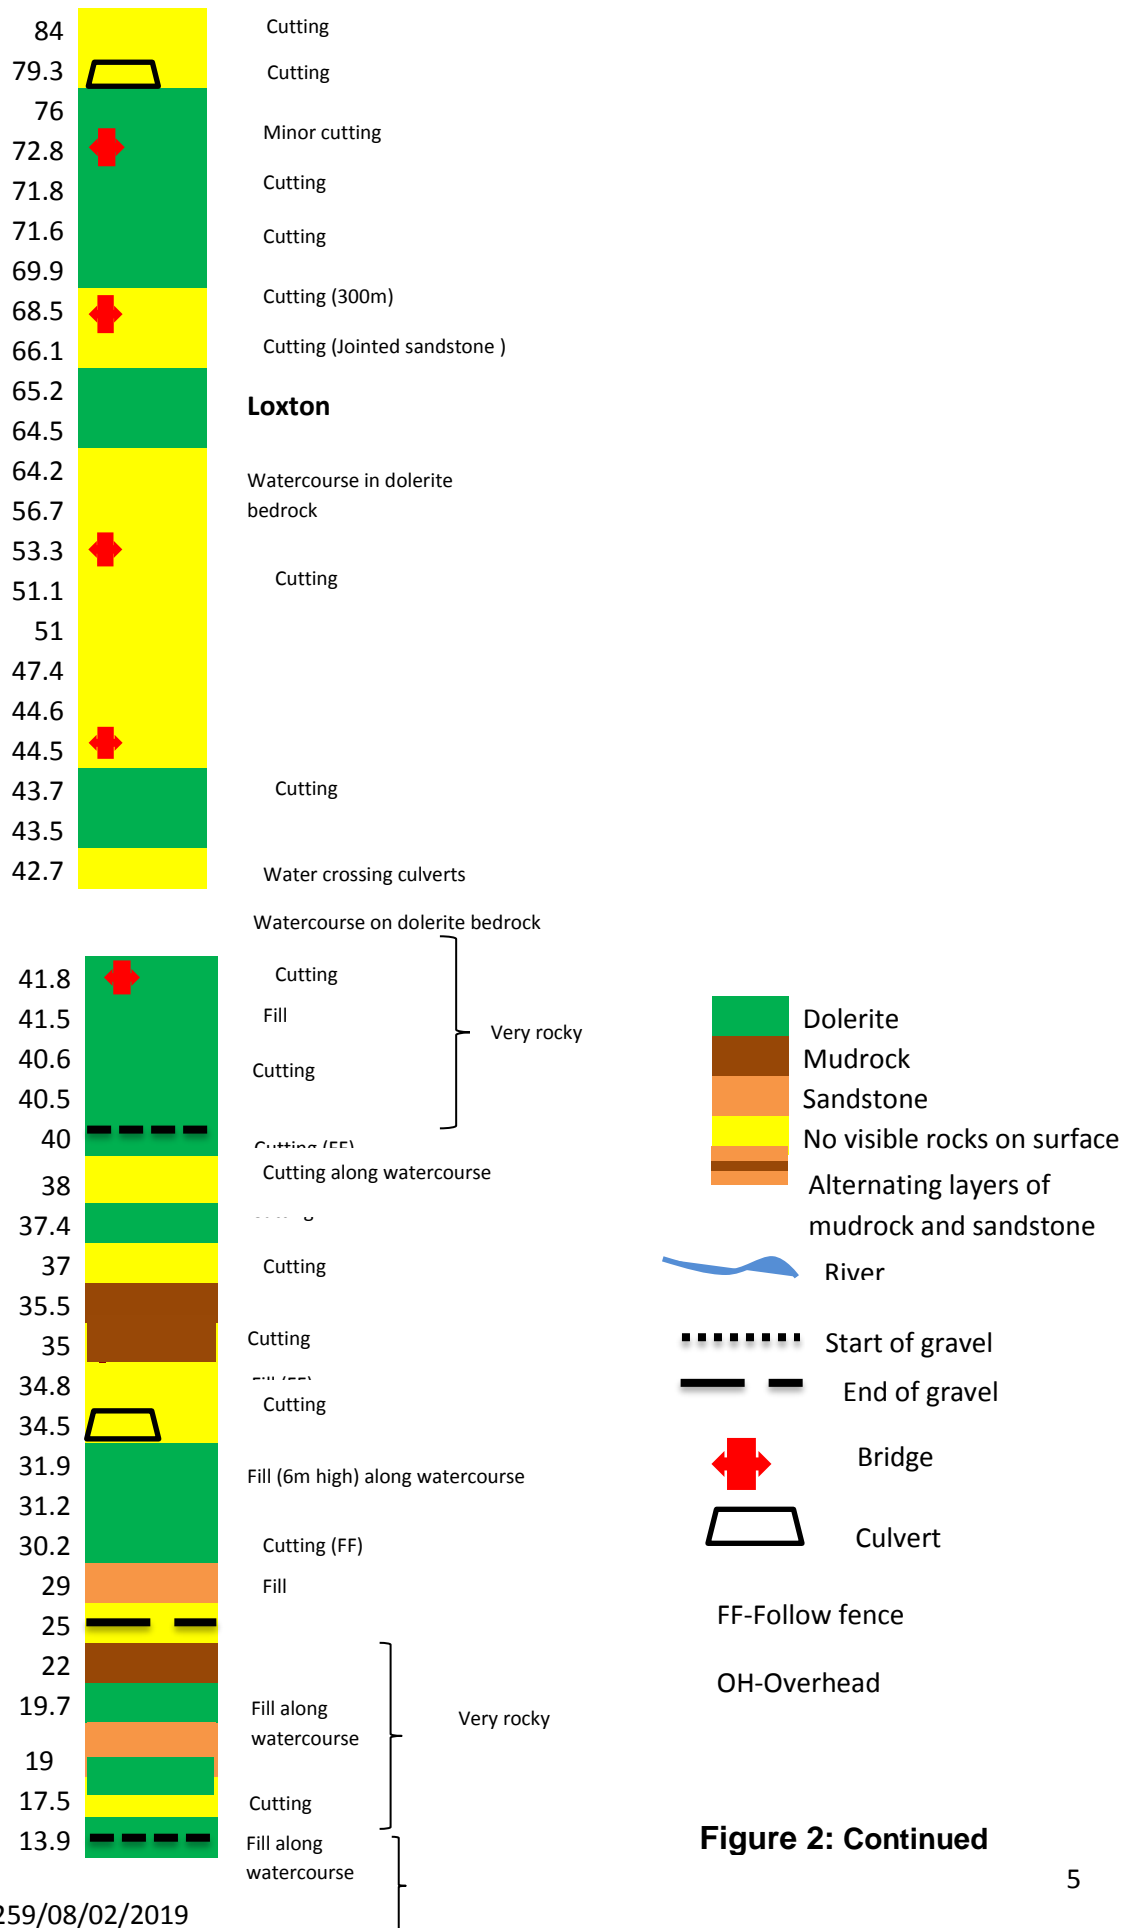
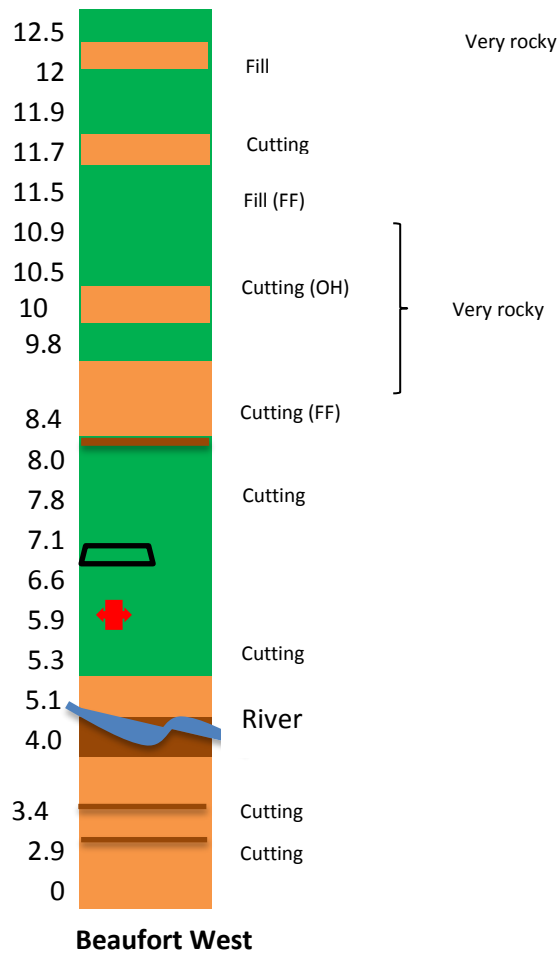
Figure 2: Details of obstacles to trenching

A number of man-made features (bridges and culverts) were observed. Details of these are given in Figure 2 and Table 1.

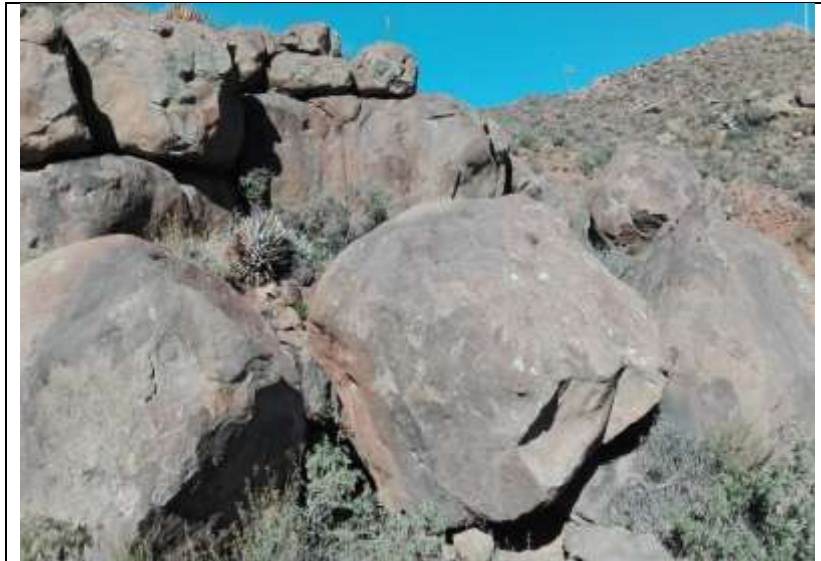
Figure 3: weathered dolerite boulders

The study area is located in the Karoo Supergroup within the Beaufort group and Ecca group. Both groups comprises of sandstone, mudrock (siltstone, shale, clay) and the karoo dolerite. The sandstone is mainly jointed and fractured (Figure 3) and forms alternating layers with mudrock (Figure 4) in some areas. The dolerite is in a form of boulders (core stones) which are a result of spheroidal weathering (Figure 5). In some areas, secondary minerals such as kaolinite, chlorites etc are observed, which, are the end products of dolerite weathering. The compressive strength of these rocks is fundamental when constructing a trench. In general, sandstone has UCS strength of 20-170 MPa while mudrocks ranges between 5-100 MPa (shale) and 100-200 MPa (slate). Dolerite on the other hand has a compressive strength ranging between 200-300 MPa.

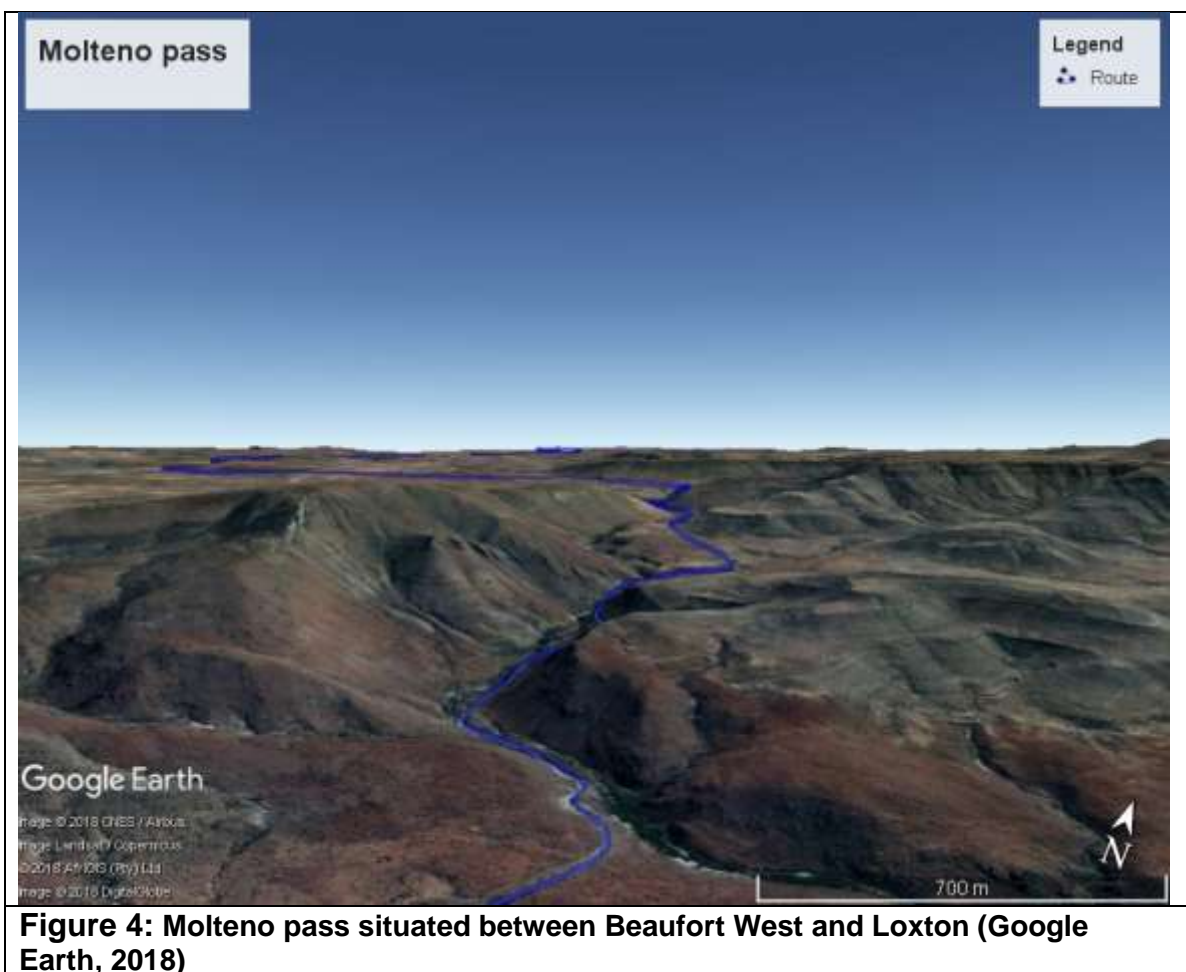
Figure 4: Molteno pass situated between Beaufort West and Loxton (Google Earth, 2018)

The road within the study area is 180.3 km and can be divided into two sections i.e. from Beaufort West to Loxton and Loxton to Carnarvon. The first section of the road (Beaufort West to Loxton) is quite mountainous (Figure 6) and dominated by dolerite. Between 6.6 km and 25km, the area is very rocky and mainly made of dolerite (Figure 7). From 25km to 40km, digging a trench is possible as the area is less rocky but has more trees. Between 40km and 43km, the area gets rocky again. After 43km, digging is again possible.

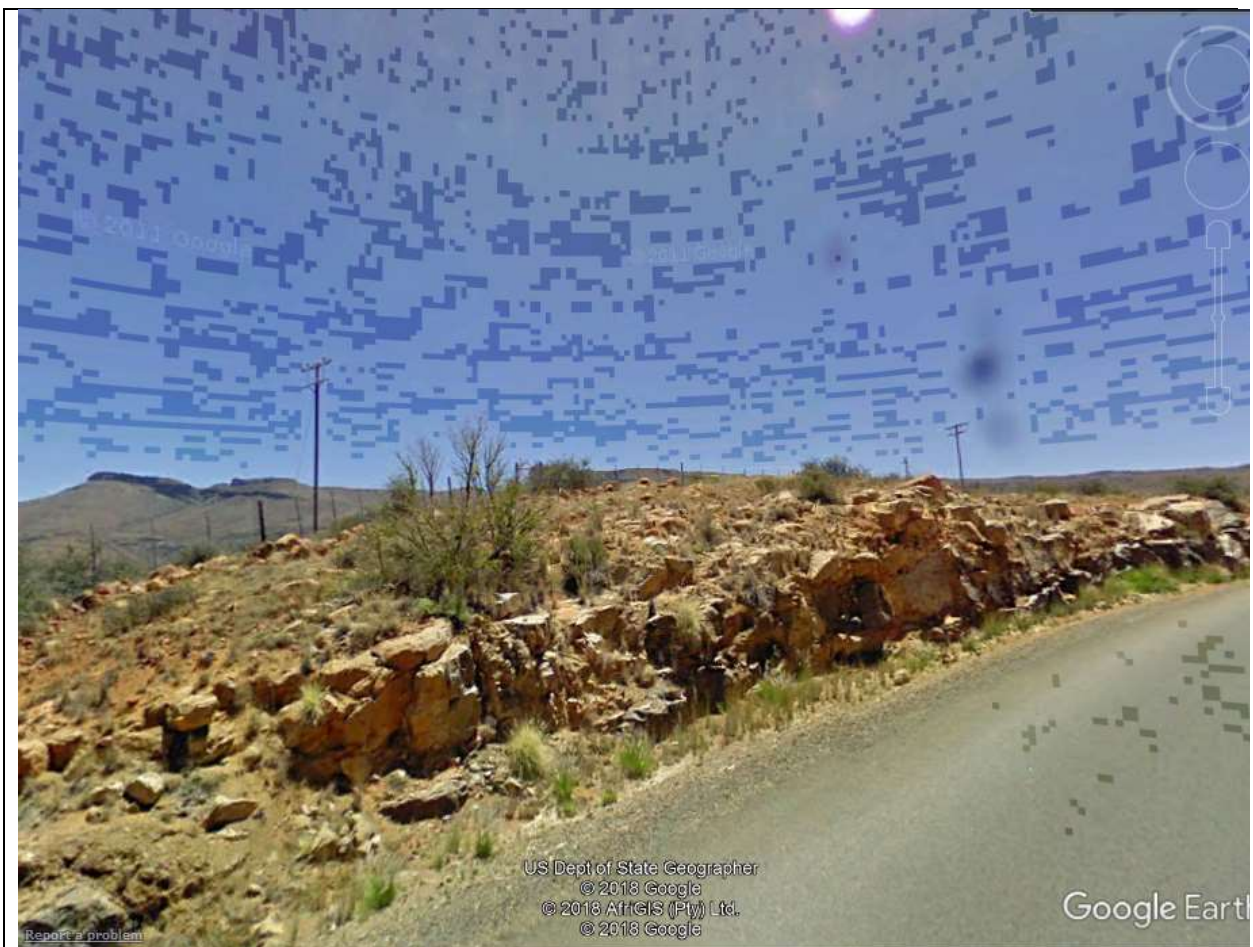
Figure 8: Typical representation of many small cuttings

The path between Loxton and Carnarvon is less rocky but has quite a number of small cuttings (Figure 8 typical small cutting). Some of the cuttings are of dolerite in composition whilst some are of sandstone and mudrock. The sandstone is highly fractured compared to

the dolerite. The jointing and fracturing of the sandstone as well as the weathering of dolerite has an influence on the strength of the rocks, respectively. Generally, jointing and weathering reduces the rock strength thus weakening the rock.

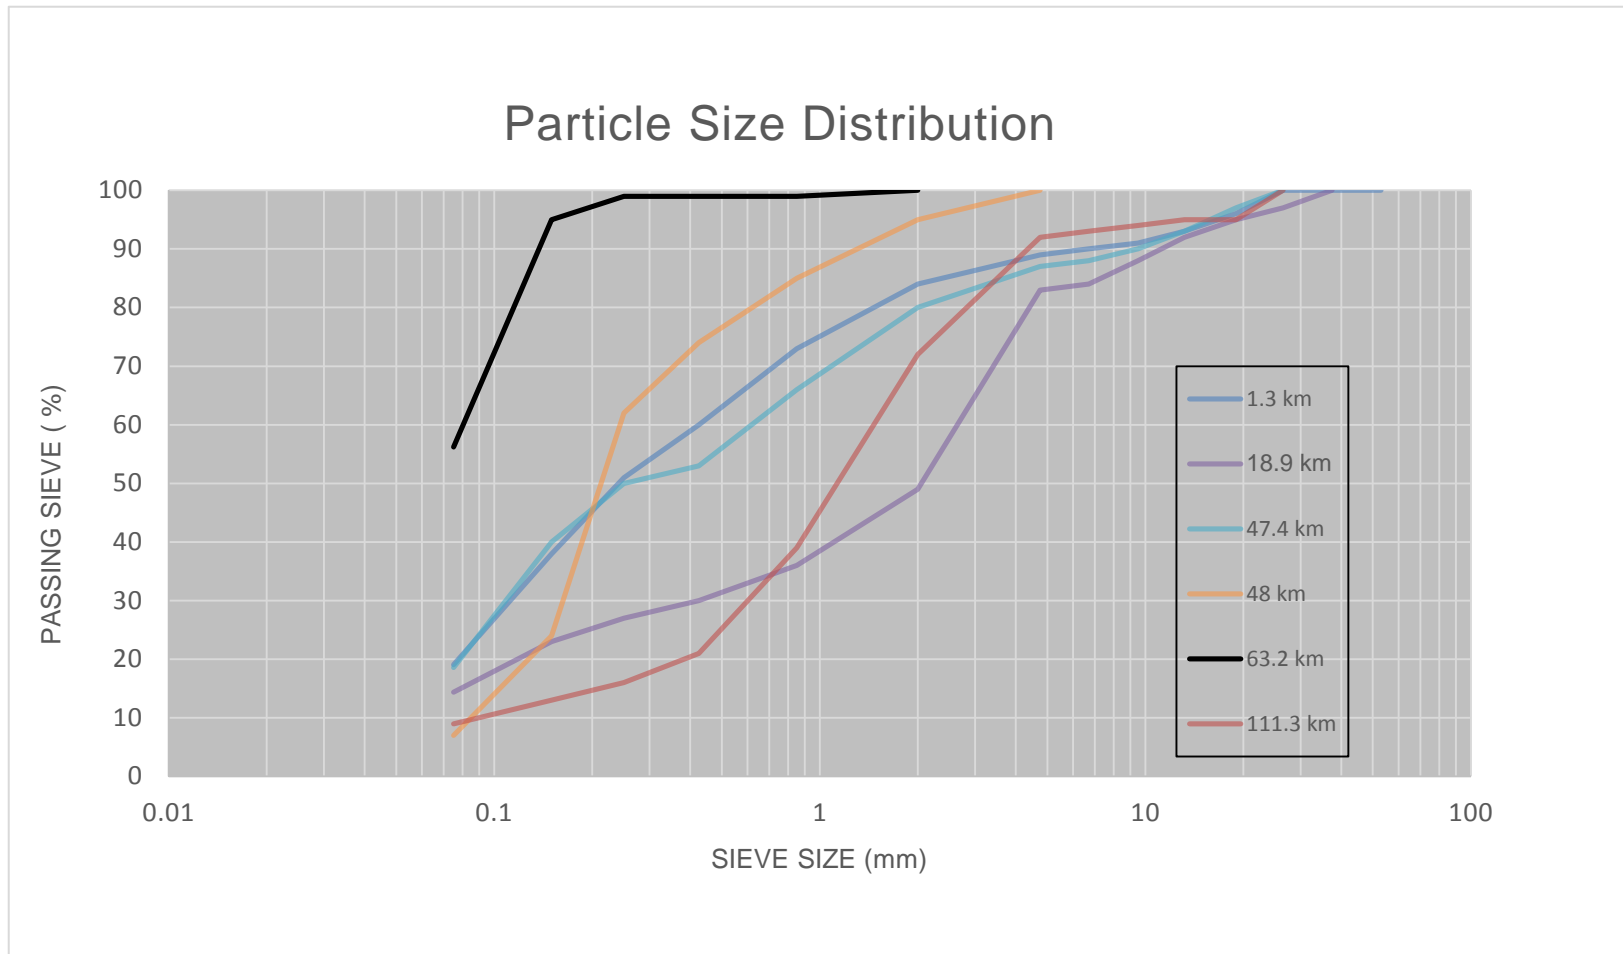
Figure 9: Grading Analysis of Sampled Materials

From the grading results it is evident that the materials from kilometres 1.3, 47.4, and 48 are mostly gap - graded sandy gravels with a fair amount of silt and may be somewhat difficult to compact. The sample from km 113 is a fairly well graded sand and should compact well. The material sampled at km 63.2 is considered a sandy silt and also can be problematic when compacting. However, as this is not a road layer being constructed, where compaction is very important, it should not present difficulties.

- *Particle size distribution*, which gives good indication of the material's compactability and strength, after compaction. Table 2 and Figure 9.
- *Atterberg Limits determinations*, which gives an indication of the clay content of the soil and how active the clay can be on wetting and drying.
- The compactability of the material under a relatively light compaction effort, such as would be applied by a light compacting device (possibly a plate compactor).
- The optimum moisture to be added to the soil in order to achieve maximum compaction for the compaction effort applied.
- The strength of the compacted material was also determined. This was to determine whether the compacted material has sufficient strength to carry vehicles coming off the road surface and traversing over the backfilled trench.

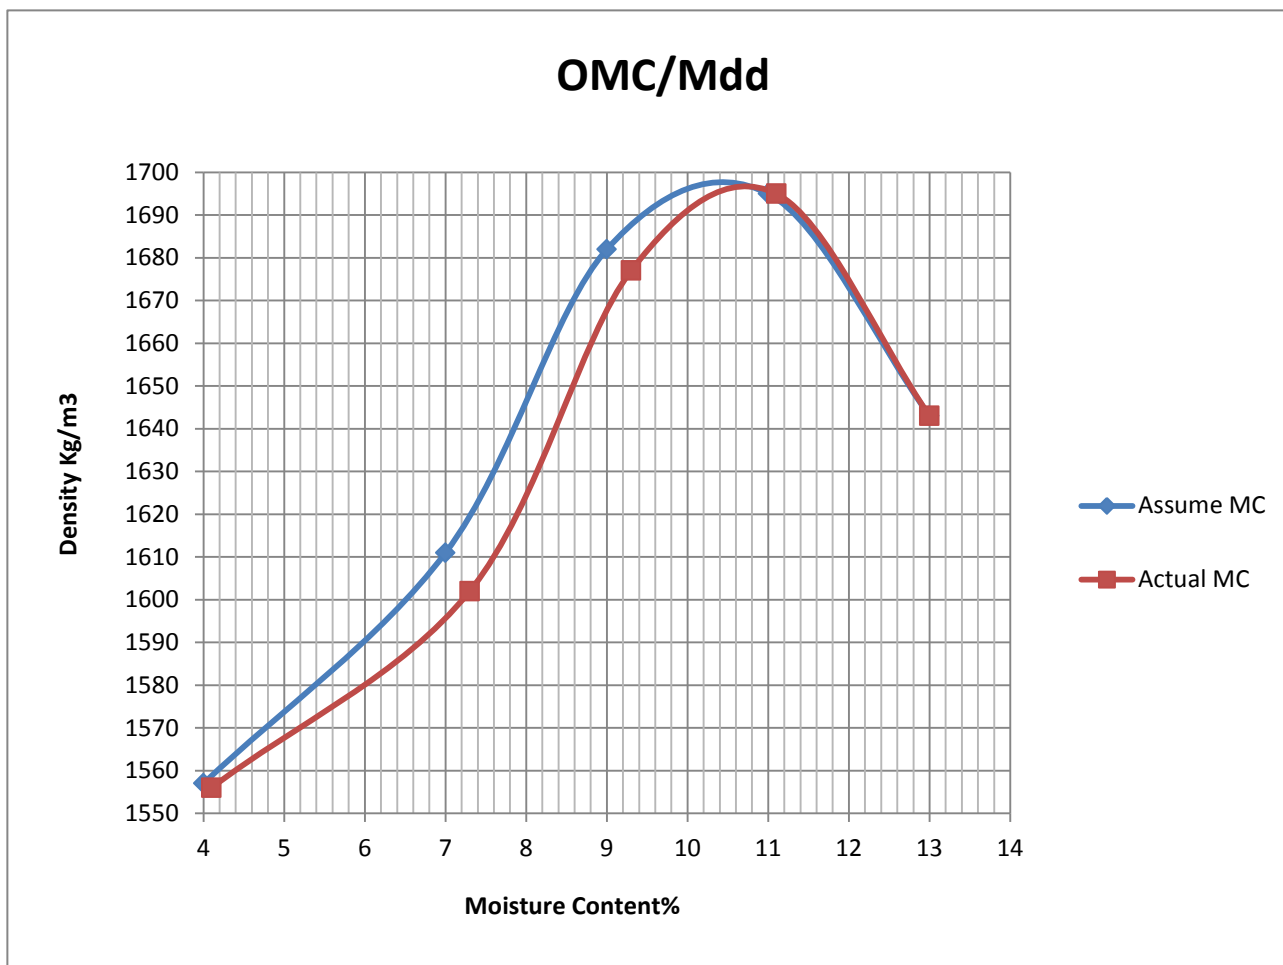
Figure 10: Optimum Moisture Content and Compactability Determination

The optimum moisture content is a determination of the percentage of moisture required in a given soil, which will maximize the compacted density of that soil for a given compaction effort. Too much or too little water will result in a less than optimal compacted density.

It can be seen in Figure 10 that the maximum density obtained was 1696 kg/m³ when the moisture content was 10.7%. When the moisture content was above or below this level the densities obtained were lower.

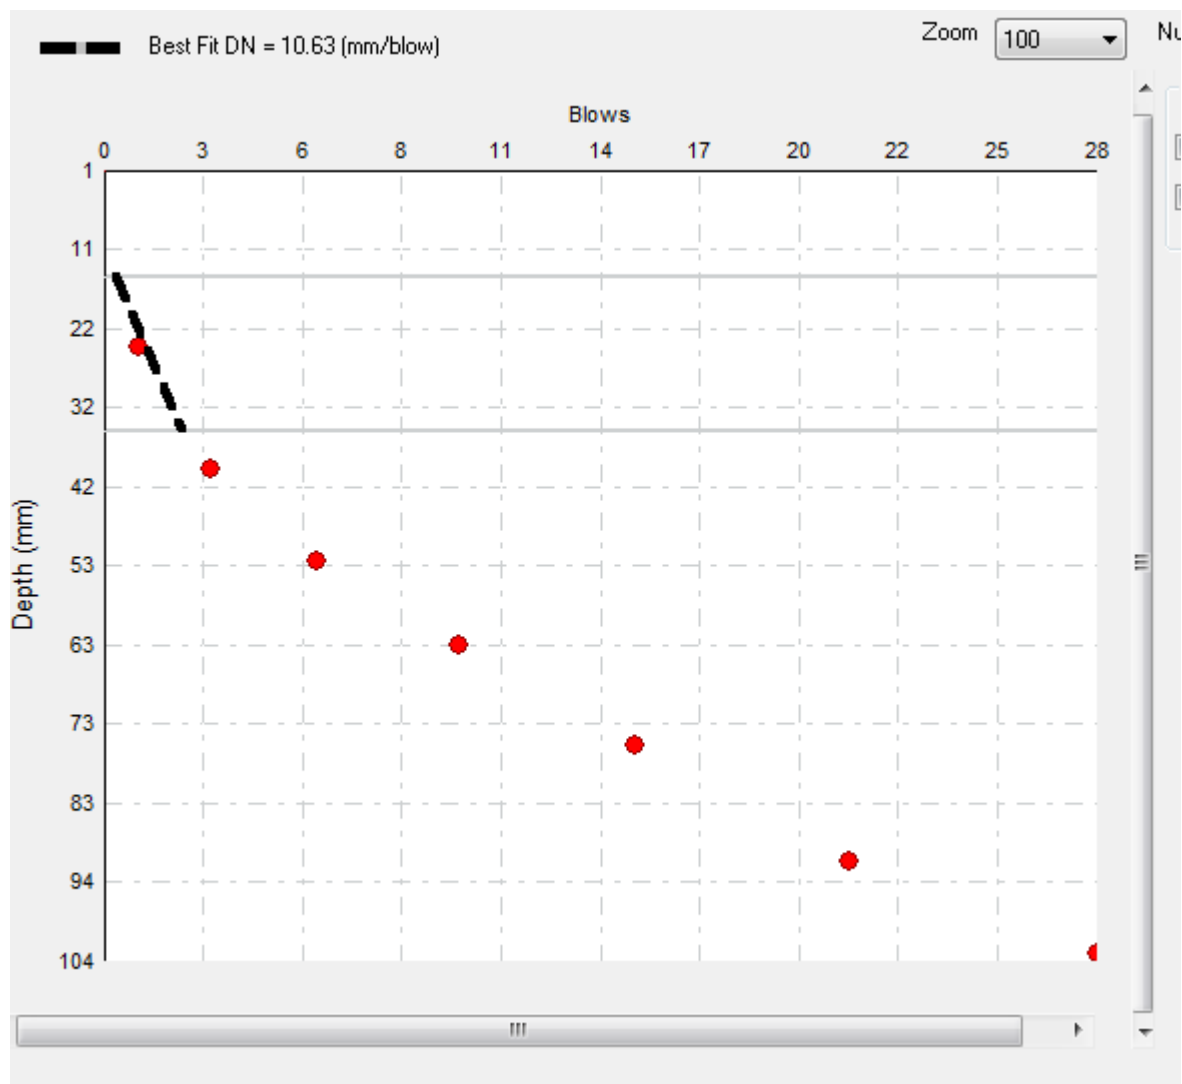
Figure 11: California Bearing Ratio (DCP) Determination

The CBR value gives an indication of the bearing capacity of the gravel after compaction.

The material was compacted in a mould to determine its compacted strength. The compaction effort used was the lowest effort commonly used to compact road building materials.

When a light compaction effort was applied to the material, known as Proctor compaction effort, a strength value of CBR = 20.5 was achieved (see Figure 11). This should be more than sufficient to carry traffic that might ride over the compacted trench.

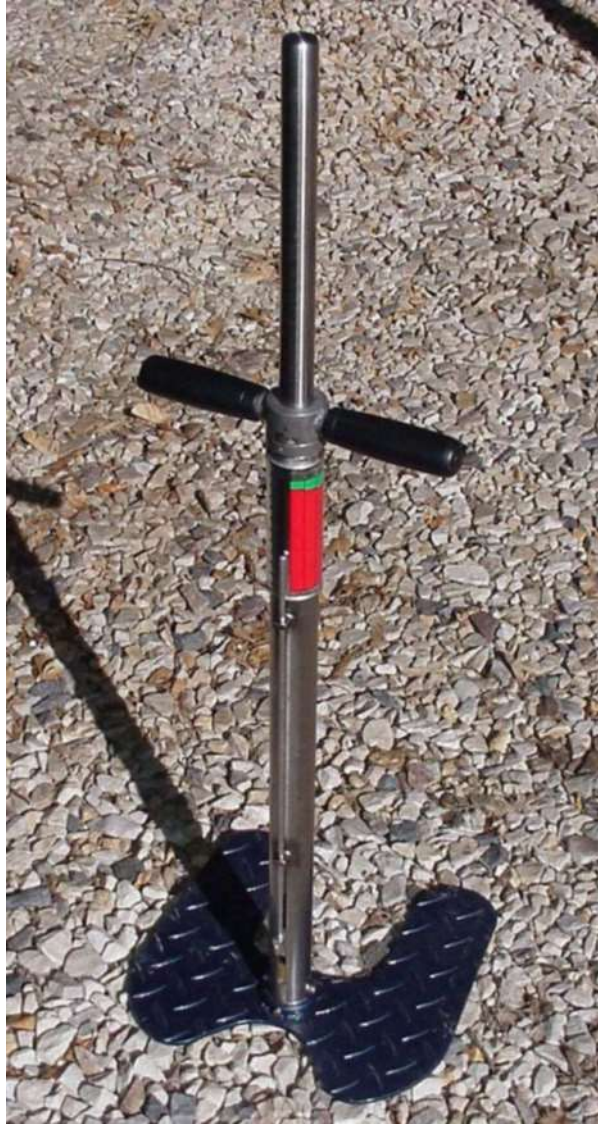
Figure 13: RCCD Device for indicating proper compaction

- The density attained should be measured using a Hydromensometer (Troxler). One measurement should be done every 100 metres. Alternately, use a Rapid Compaction Control Device (RCCD) (Figure 13), to determine that the correct strength for the material has been attained with compaction. A strength value of CBR equal to at least 15% is required. This may also be measured using a Dynamic Cone Penetrometer (DCP), where it is difficult to use the RCCD. However, where a DCP device is used, care must be taken not to damage the cable.
