Zilwa Marina, St Annes, Seychelles

Physical Model Tests of Wave Penetration, Breakwater Stability and Overtopping

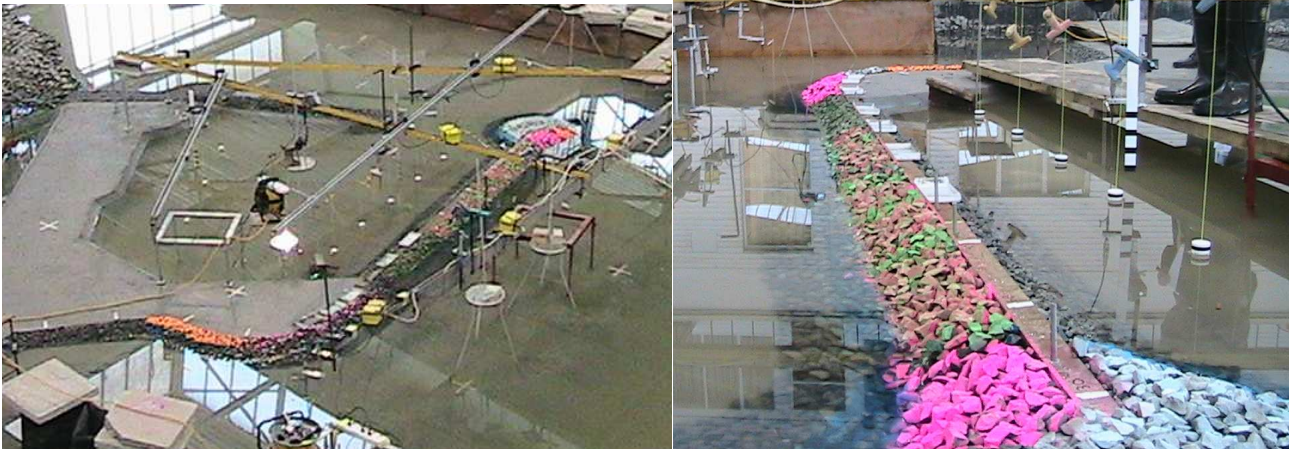
The model was constructed at a 1:60 scale in a 32 m long by 12 m wide 3D basin. The near-shore bathymetry was accurately constructed with a cement layer using masonite templates. A precise replication of the bathymetry is necessary to include the correct wave dynamics on the main breakwater.

A blend of different stone sizes, making up the core of the breakwater, was scaled to reproduce the flow through the core. Accurate scaling of the breakwater core was done to correctly model damage levels and overtopping discharges at the breakwater
