ENVIRONMENTAL MANAGEMENT PROGRAMME

Edison PV 100 MW Photovoltaic Facility
near Dealesville, Free State.

Version 2
December 2018

Prepared by: Council for Scientific and Industrial Research
Prepared for: 29 Solar (Pty) Ltd

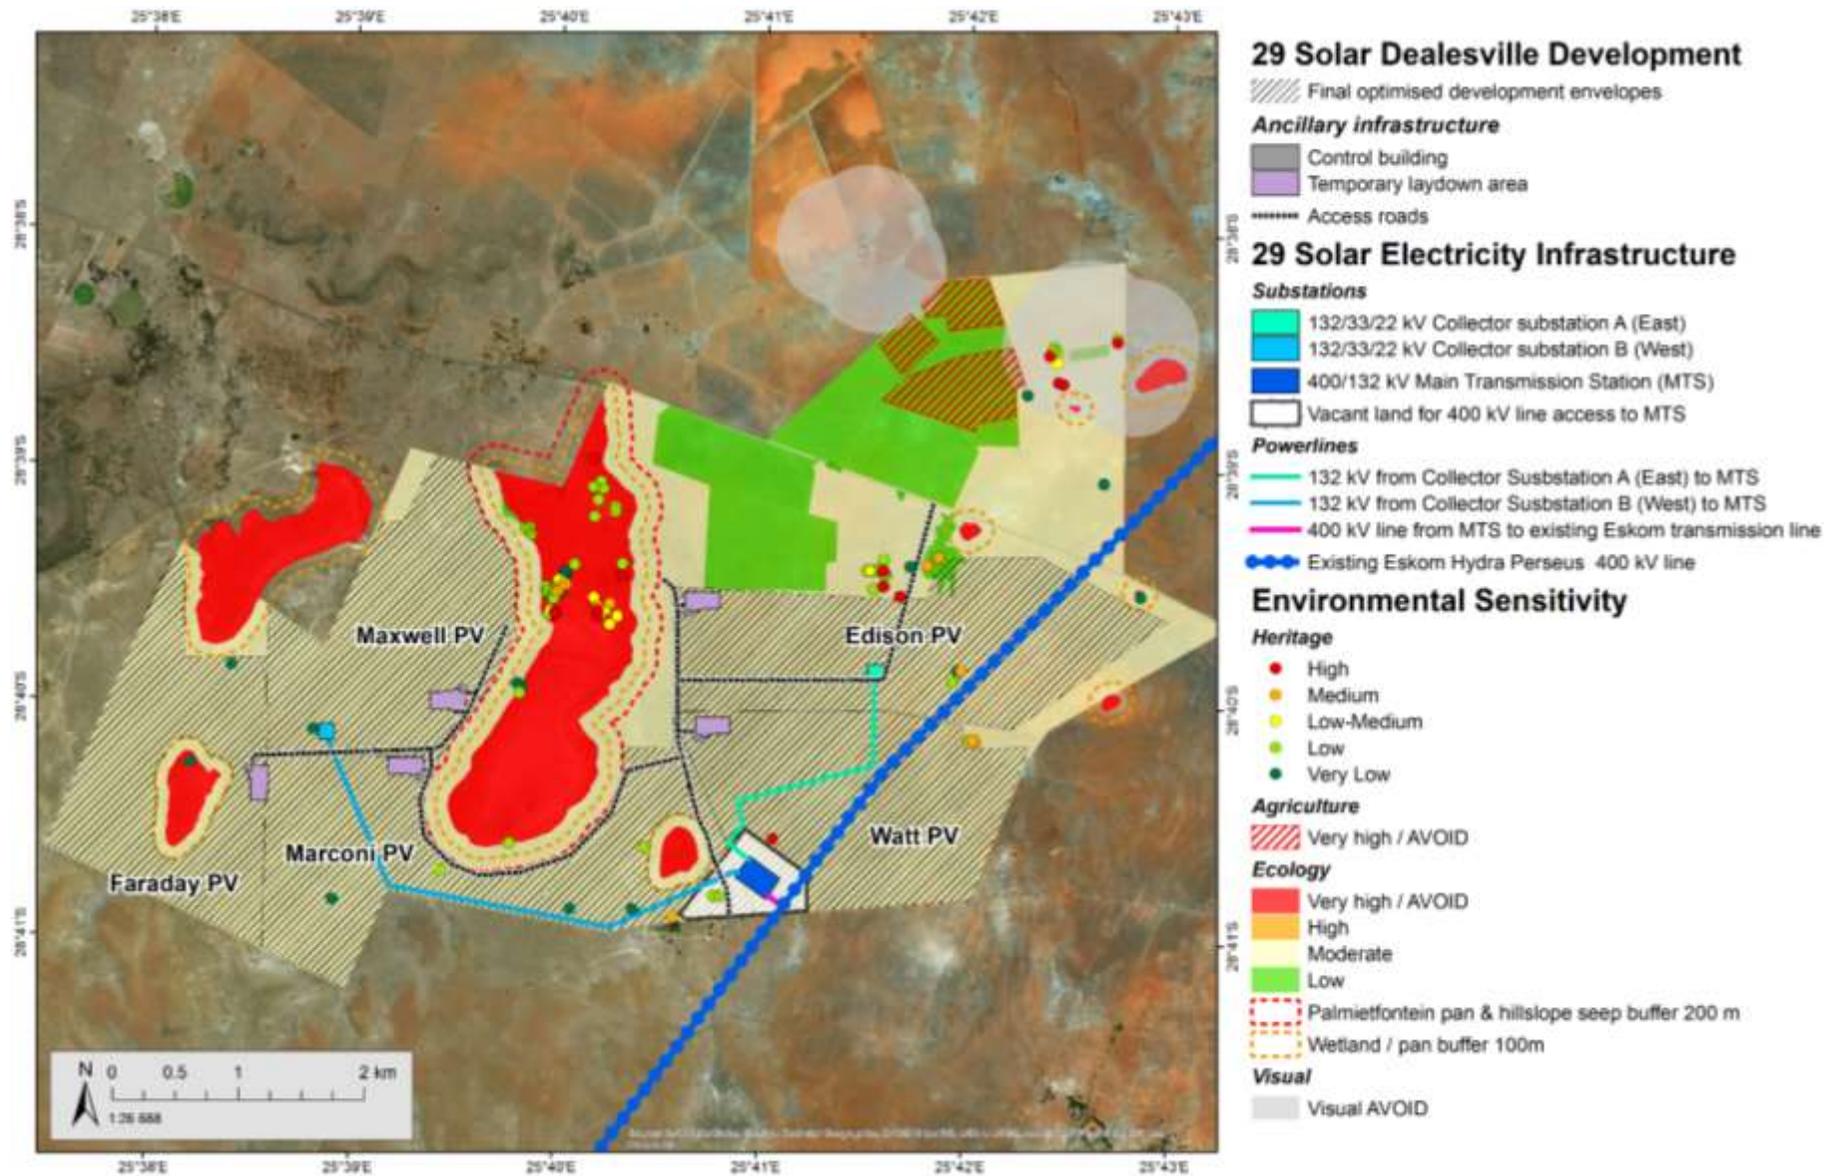
Figure 3: Environmental sensitivity map indicating the optimised 29 Solar PV development envelopes and layouts that avoid identified environmental setbacks and buffers.

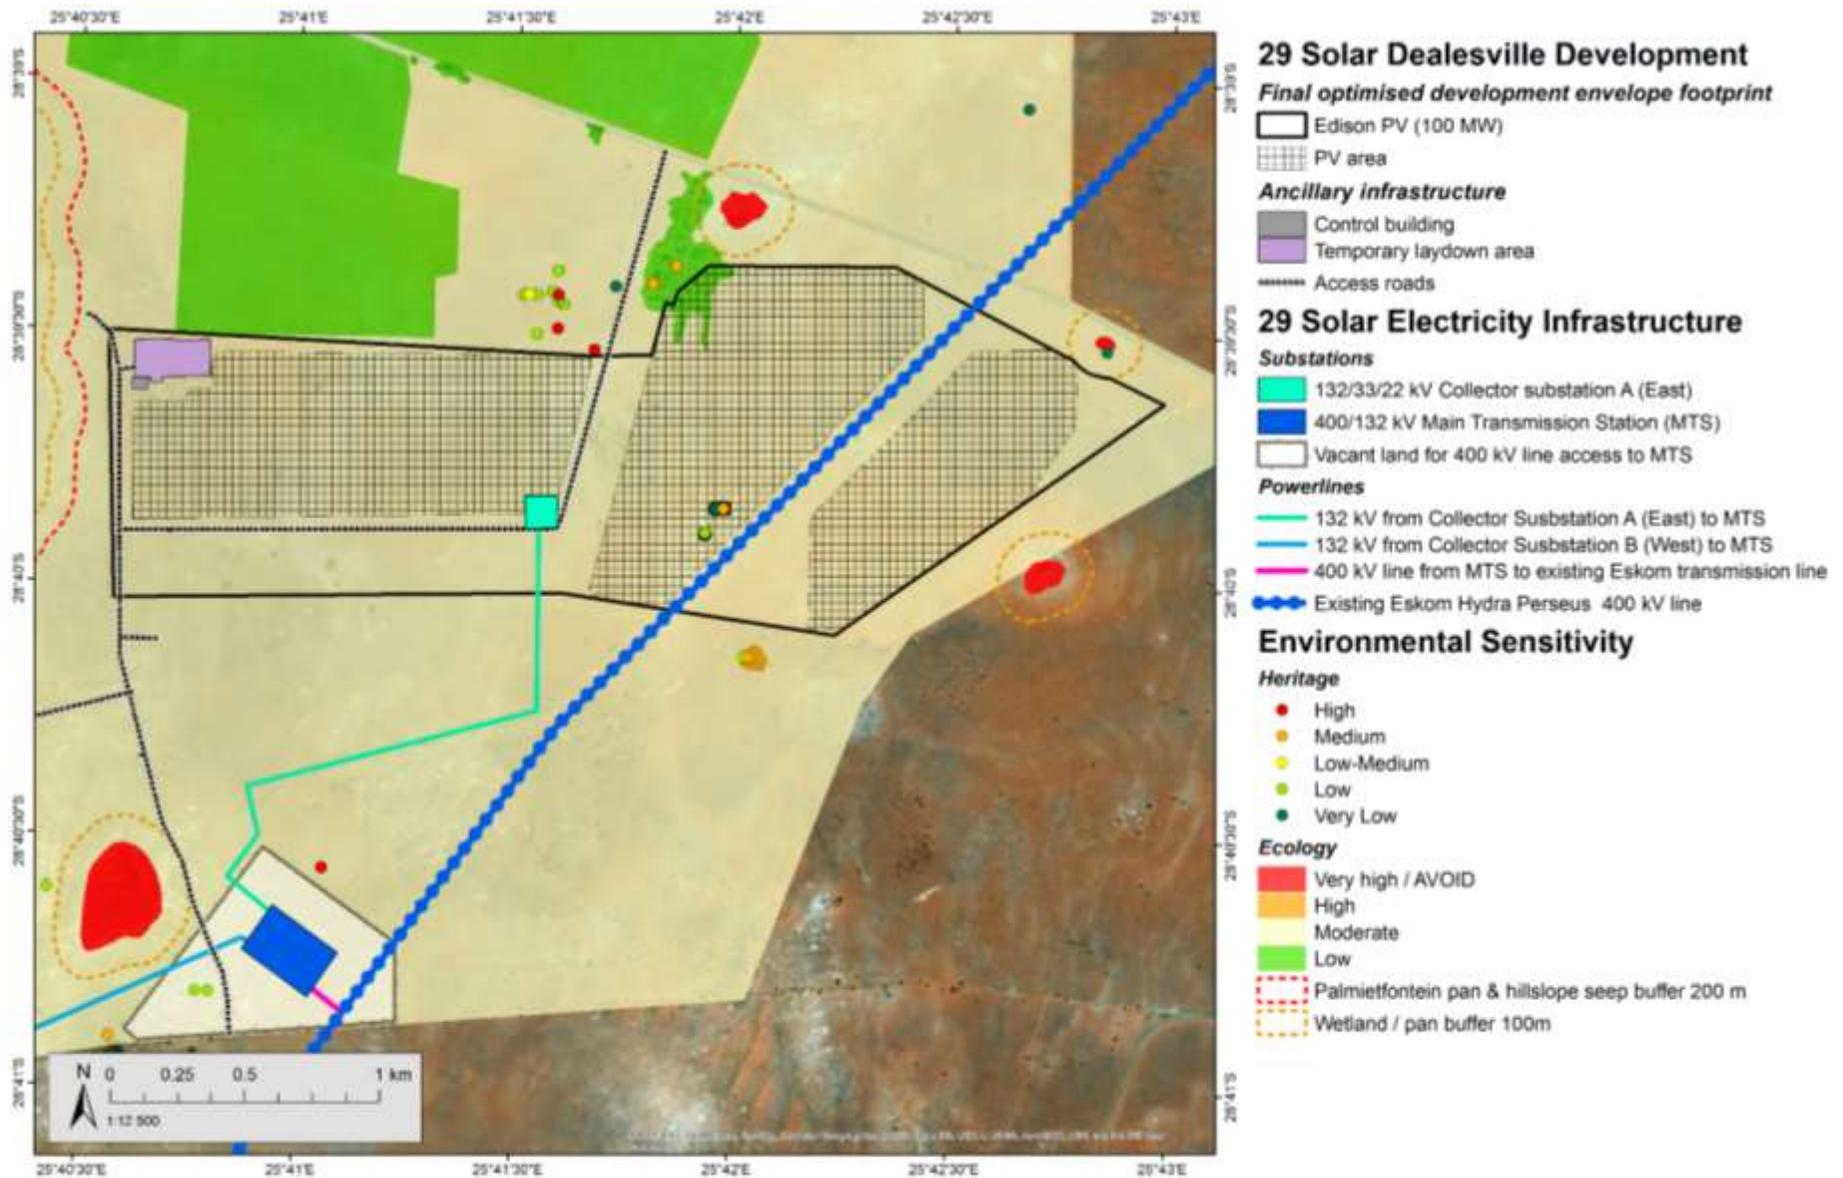
Figure 4: Environmental sensitivity map indicating the Edison PV development envelope with proposed technical layout, which avoids all environmental sensitivities and buffers.
