Basic Assessment for the Proposed Construction and Operation of Electrical Grid Infrastructure to support the Sutherland, Sutherland 2 and Rietrug Wind Energy Facilities (WEFs), Northern and Western Cape Provinces: DRAFT BASIC ASSESSMENT REPORT

APPENDIX D.1: Terrestrial Ecology Impact Assessment

FAUNA & FLORA SPECIALIST STUDY

Basic Assessment Report for the Proposed Grid Connection Infrastructure for the Mainstream Sutherland Wind Energy Facilities

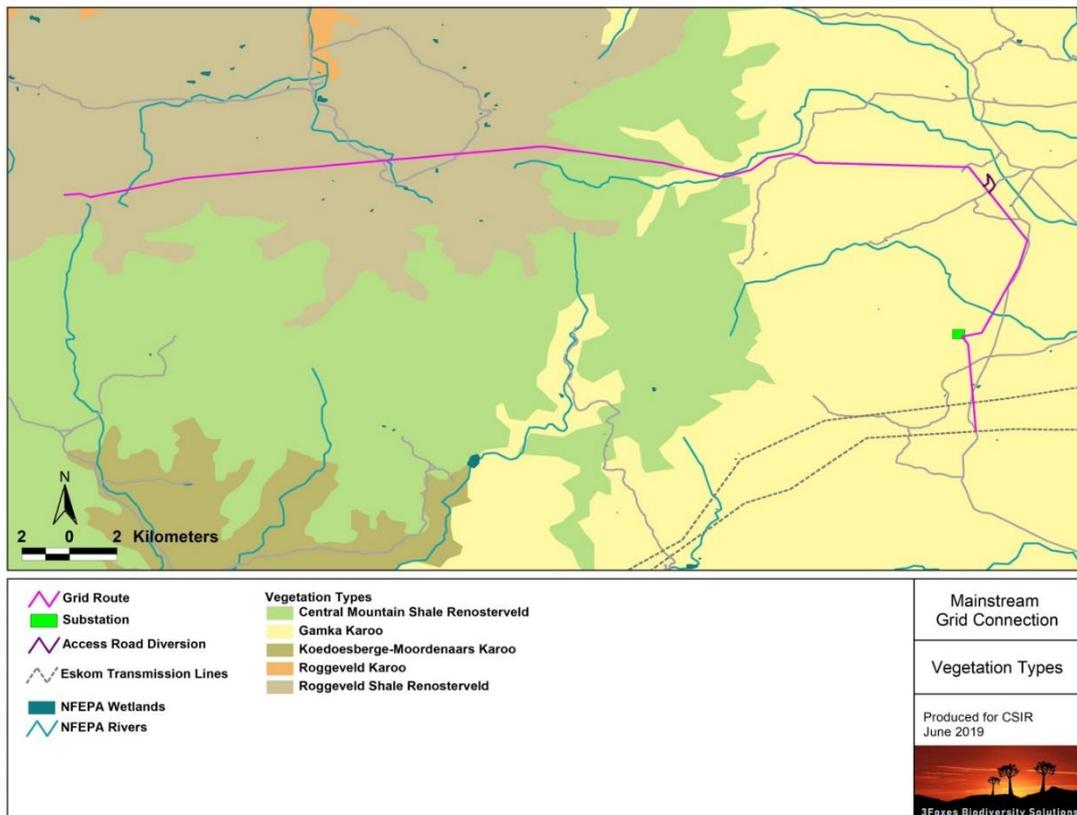
Figure 1. Vegetation map of the grid connection, including the substation site and the 400kV section to the existing Eskom Grid.

According to the national vegetation map, there are three vegetation types along the grid connection (Figure 1). The initial section on the plateau towards the wind farm is classified as Roggeveld Shale Renosterveld, the central section of the 132kV line is Central Mountains Shale Renosterveld and the final section of 132kV line as well as the substation and 400kV line fall within the Gamka Karoo vegetation type.

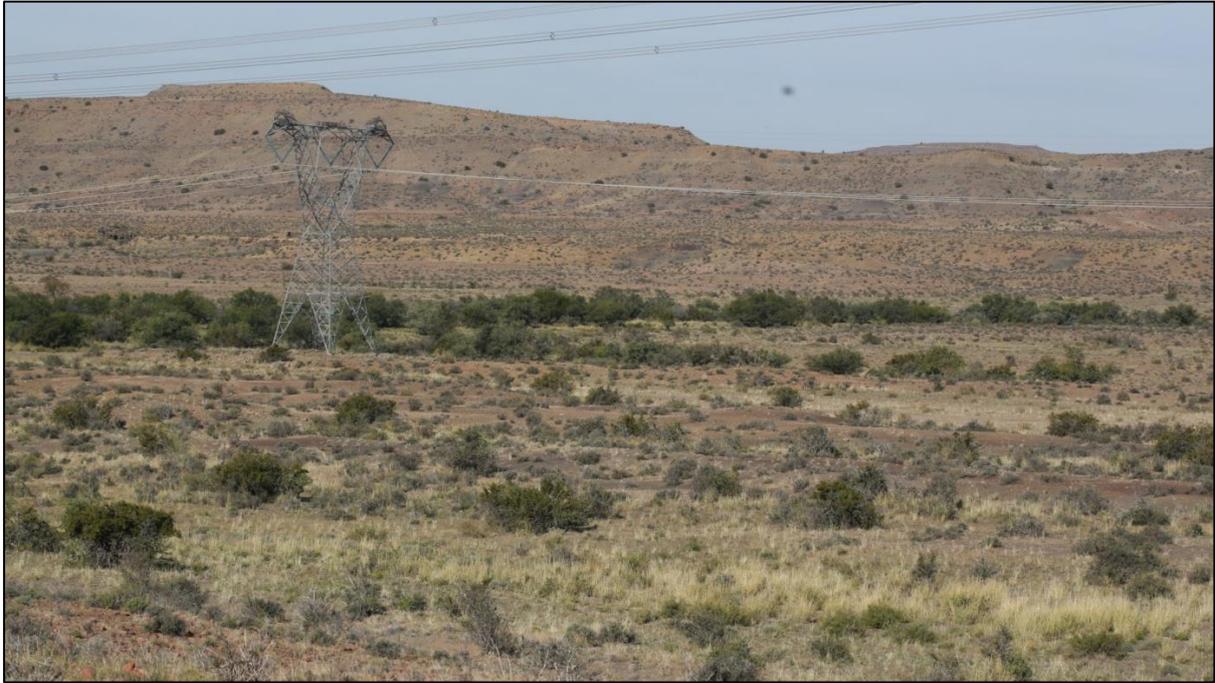
Figure 2. Looking towards the Eskom 400kV power line where the current planned 400kV lines would link into the existing line. Typical and dominant species include *Stipagrostis ciliata*, *Eriocephalus ericoides*, *Eriocephalus eximus*, *Lycium prunus-spinosa*, *Gazania lichtensteinii*, *Searsia burchellii*, *Pentzia incana*, *Cenchrus ciliaris*, *Garuleum bipinatum*, *Zygophyllum retrofractum*, *Acanthopsis disperma*.

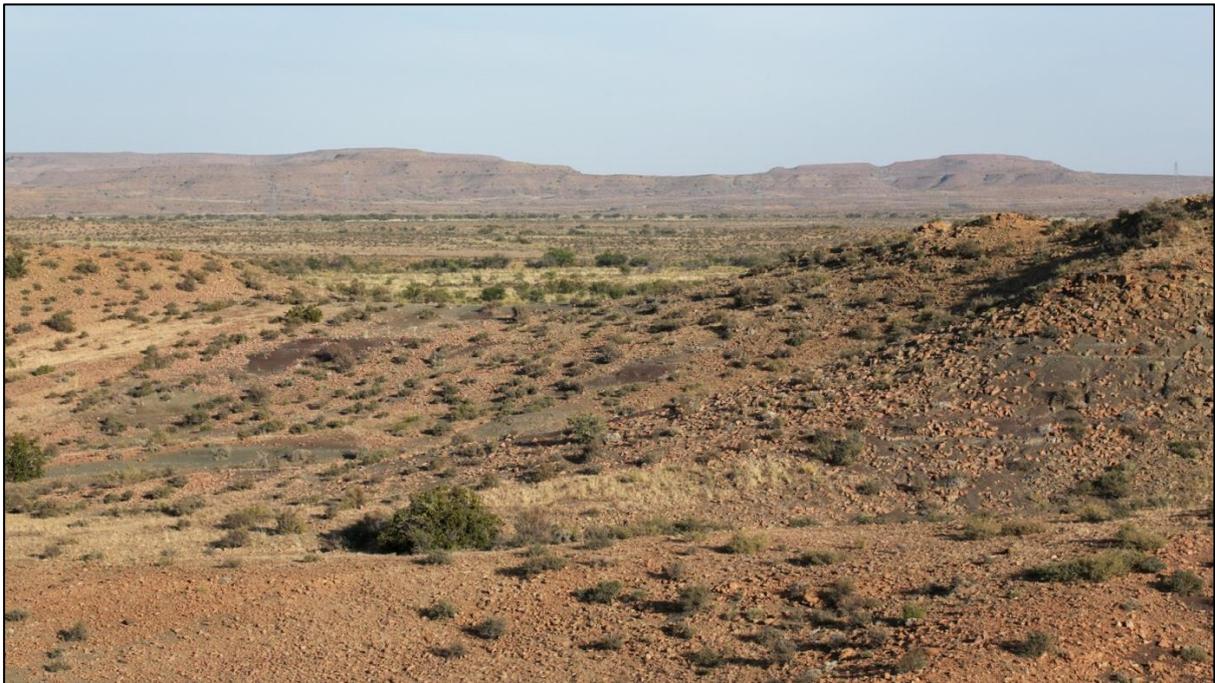
Figure 3. Looking south from the substation site along the alignment of the 400kV line, showing the extensive gravel plains of the Gamka Karoo.

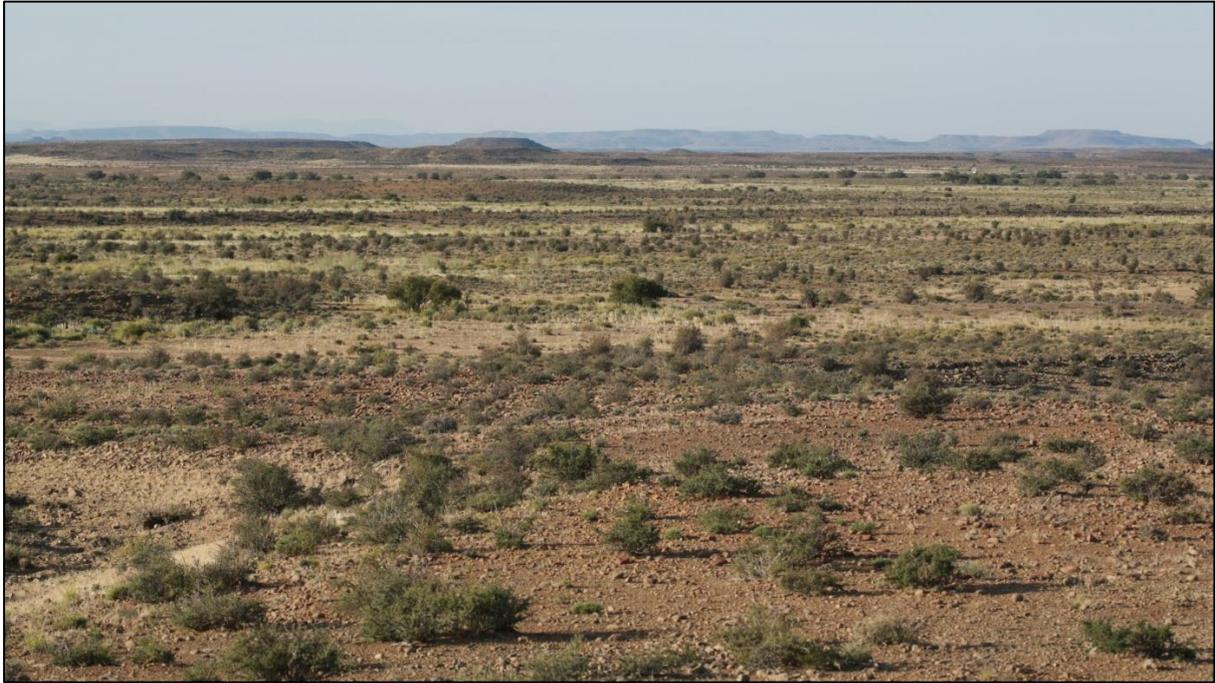
Figure 4. Looking north from the substation site along the approach of the 132kV line, showing the extensive open plains of the Gamka Karoo vegetation type which characterises this area.

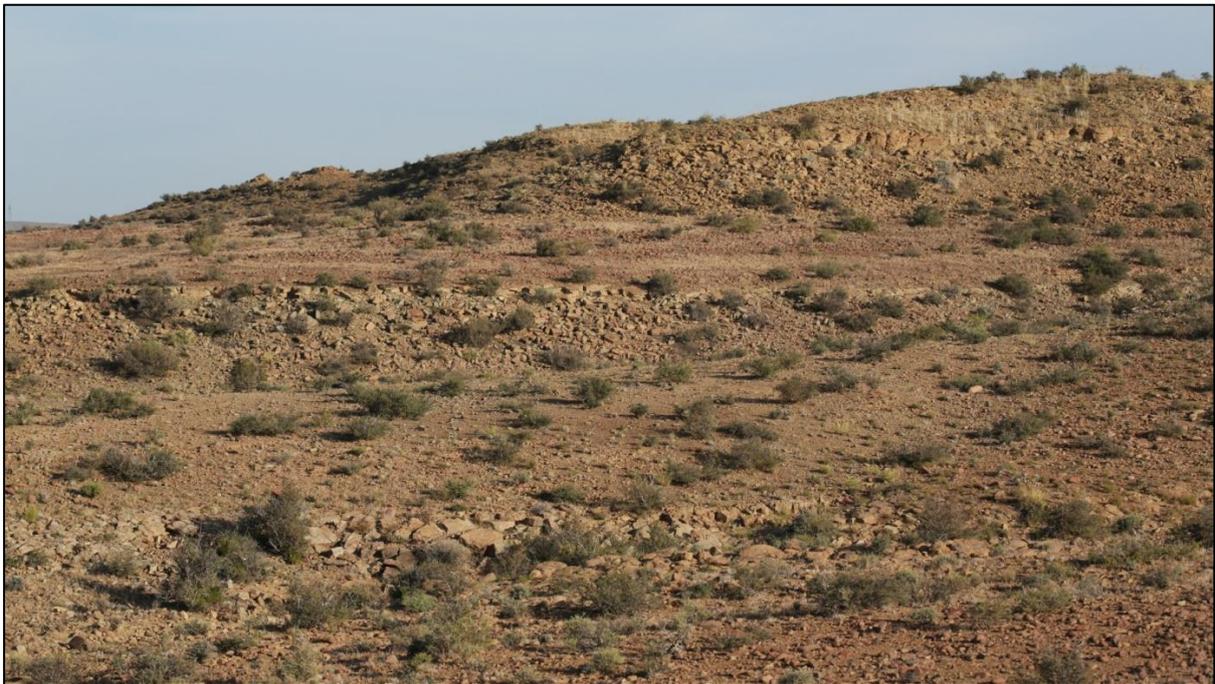
Figure 5. Looking south over the substation site from near the northern boundary of the site.

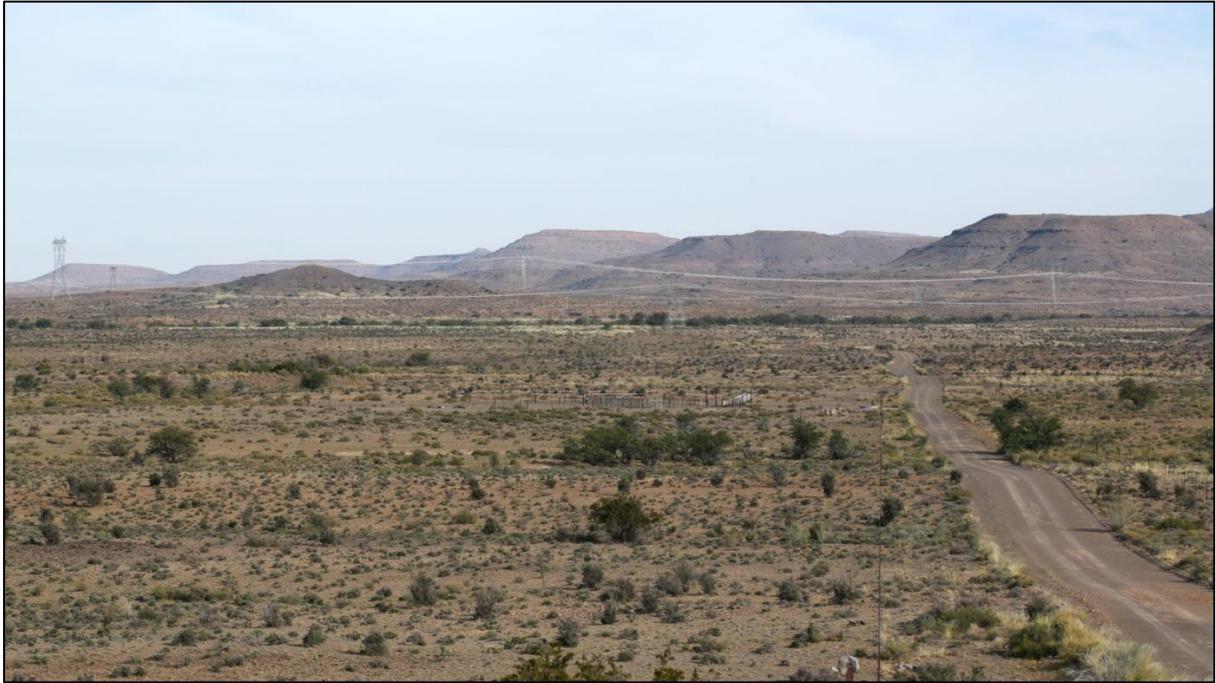
Figure 6. Looking south along the final section of the 132kV line, with the Eskom 400kV lines in the distance.

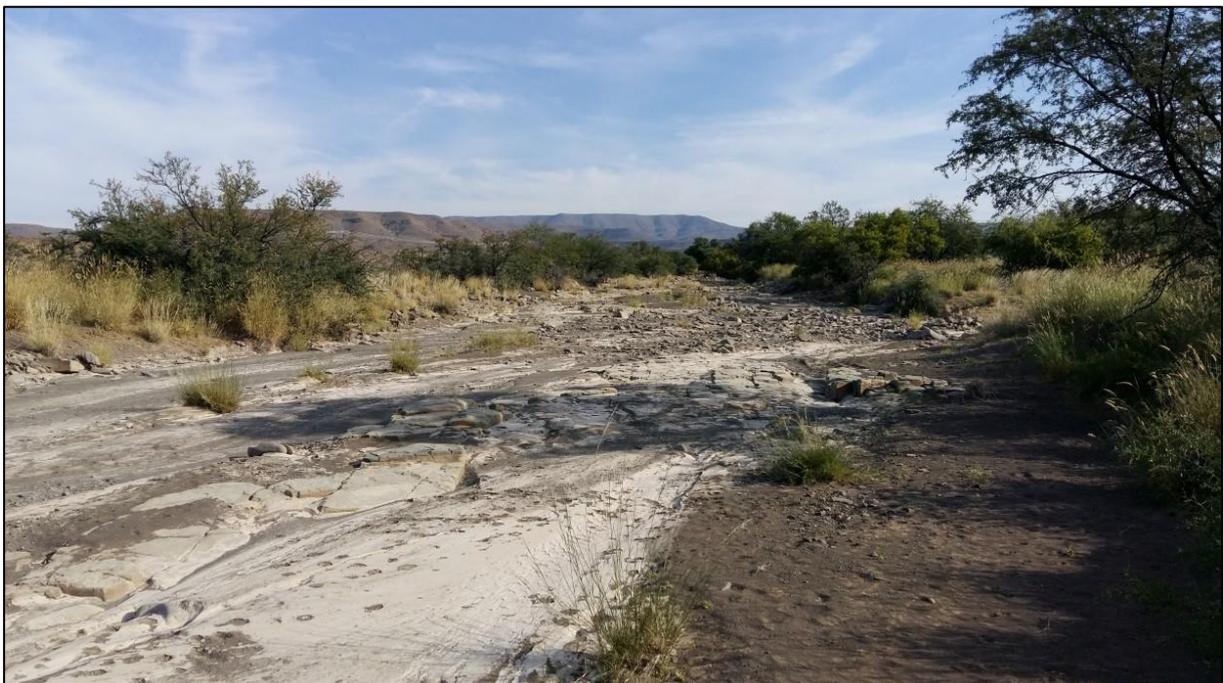
Figure 7. The larger drainage lines of the site are typically fringed by trees such as *Acacia karoo* and *Searsia lancea*, fringed with grasses and tall shrubs such as *Stipagrostis namaquensis*, *Diospyros lycioides*, *Cenchrus ciliaris*, *Salsola aphylla* and *Lycium prunus-spinosa*.

| Figure 7. The larger drainage lines of the site are typically fringed by trees such as <i>Acacia karoo</i> and <i>Searsia lancea</i> , fringed with grasses and tall shrubs such as <i>Stipagrostis namaquensis</i> , <i>Diospyros lycioides</i> , <i>Cenchrus ciliaris</i> , <i>Salsola aphylla</i> and <i>Lycium prunus-spinosa</i> . | 21 |

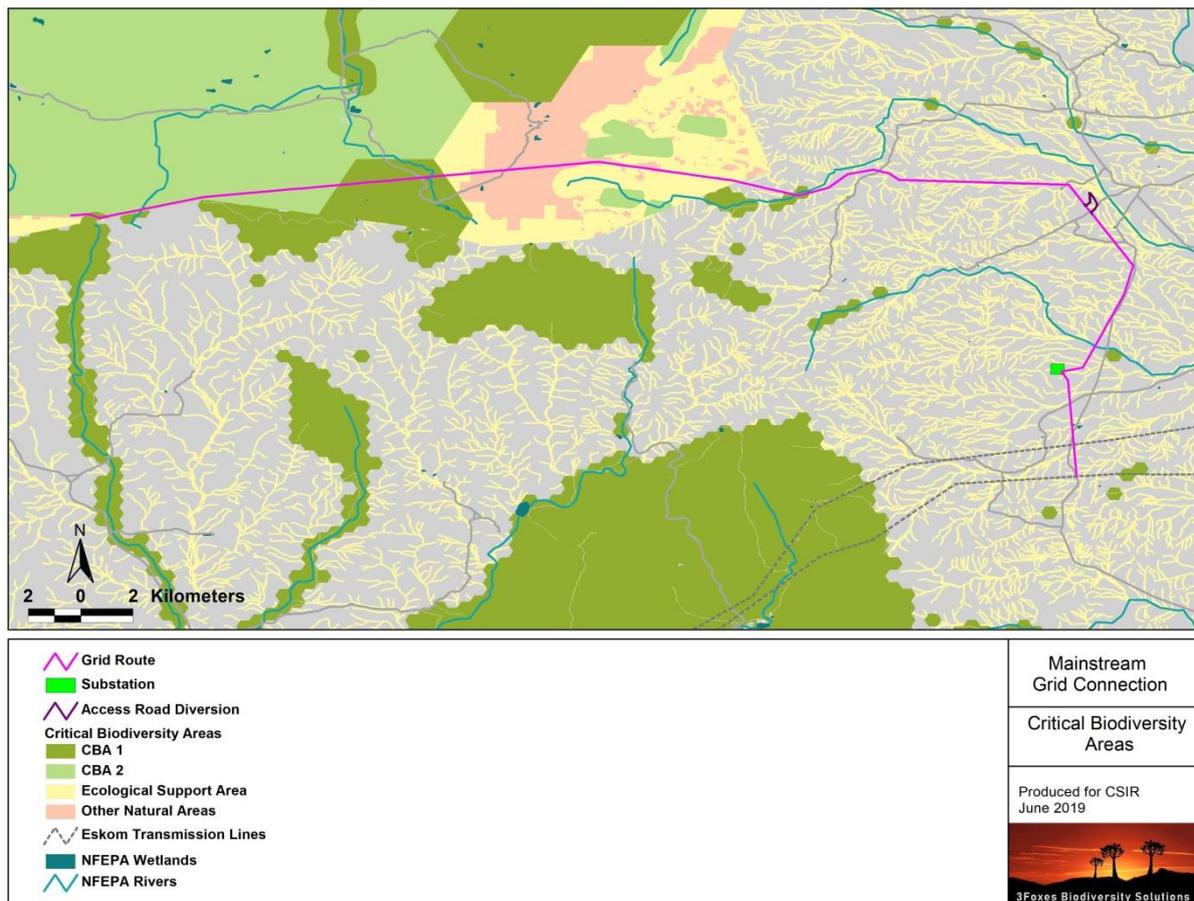
Figure 8. Critical Biodiversity Areas for the study area, which is based on the CBA map for the Northern Cape and the Western Cape BSP for the Laingsburg District.

The Critical Biodiversity Areas map for the study area is depicted below in Figure 8 and is composed of the 2017 Northern Cape CBA map and the 2017 Western Cape BSP for the Laingsburg municipality. There are some short sections of the power line route within the Western Cape that are CBA 1 associated with water courses. Within the Northern Cape, a large part of the route is either CBA 1 or CBA 2. Development within CBAs can have negative impacts on biodiversity pattern and process and is generally considered undesirable. The footprint within the CBAs would however be low and the ecological functioning of the CBAs would not be compromised by the development. Overall the impact of the development on CBAs and broad-scale ecological processes would be low and no major impacts on ecological processes would occur.

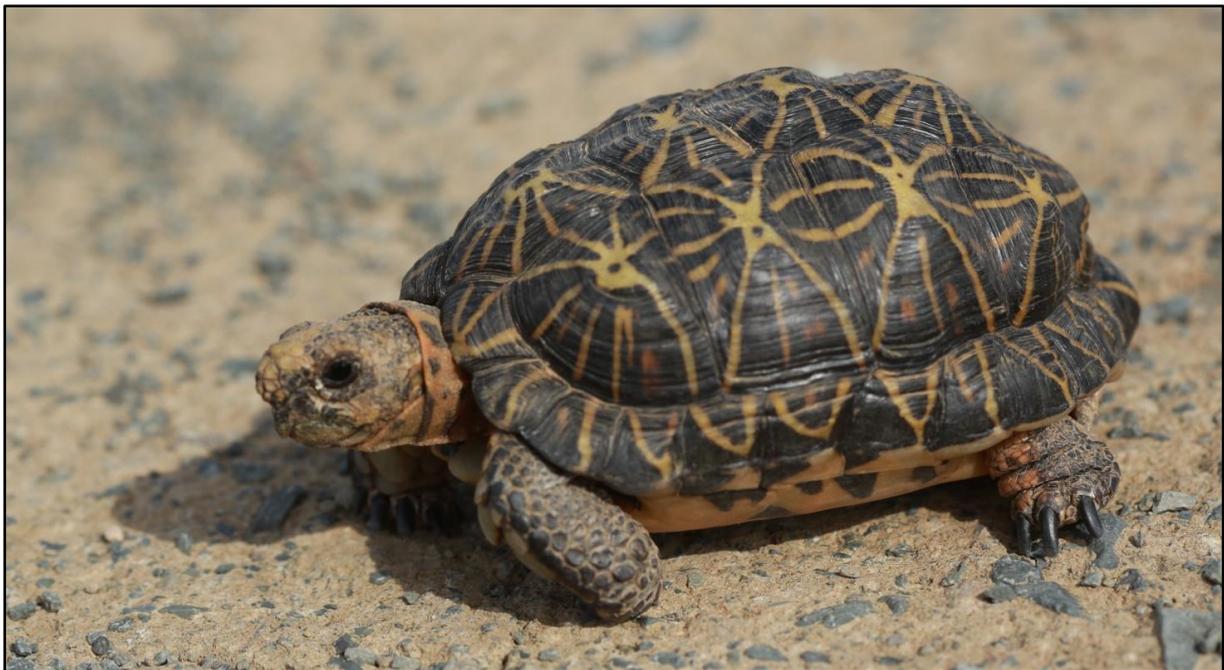
Figure 9. The Karoo Tent Tortoise *Psammobates tentorius tentorius* is common in the areas of Gamka Karoo near to the substation.

| Figure 9. The Karoo Tent Tortoise <i>Psammobates tentorius tentorius</i> is common in the areas of Gamka Karoo near to the substation. | 24 |

Species observed in the area during the site visit or on other visits to the area include Karoo Tent Tortoise *Psammobates tentorius tentorius*, Angulate Tortoise *Chersina angulata*, Puff Adder *Bitis arietans*, Karoo Girdled Lizard *Cordylus polyzonus*, Southern Rock Agama *Agama atra*, Cape Skink *Mabuya capensis*, Variegated Skink *Trachylepis variegata*, Common Sand Lizard *Pedioplanis lineocellata pulchella* and Cape Cobra *Naja nivea*. Although there are a variety of different habitats present, the generally intact nature of the area means that most habitats have associated reptiles. Habitats of higher potential sensitivity include drainage lines and vleis and the rocky bluffs and cliffs of the site. In terms of impacts of the development on reptiles, the major impact is likely to come from disturbance during the construction phase which would be transient and localised and consequently of low long-term consequence.

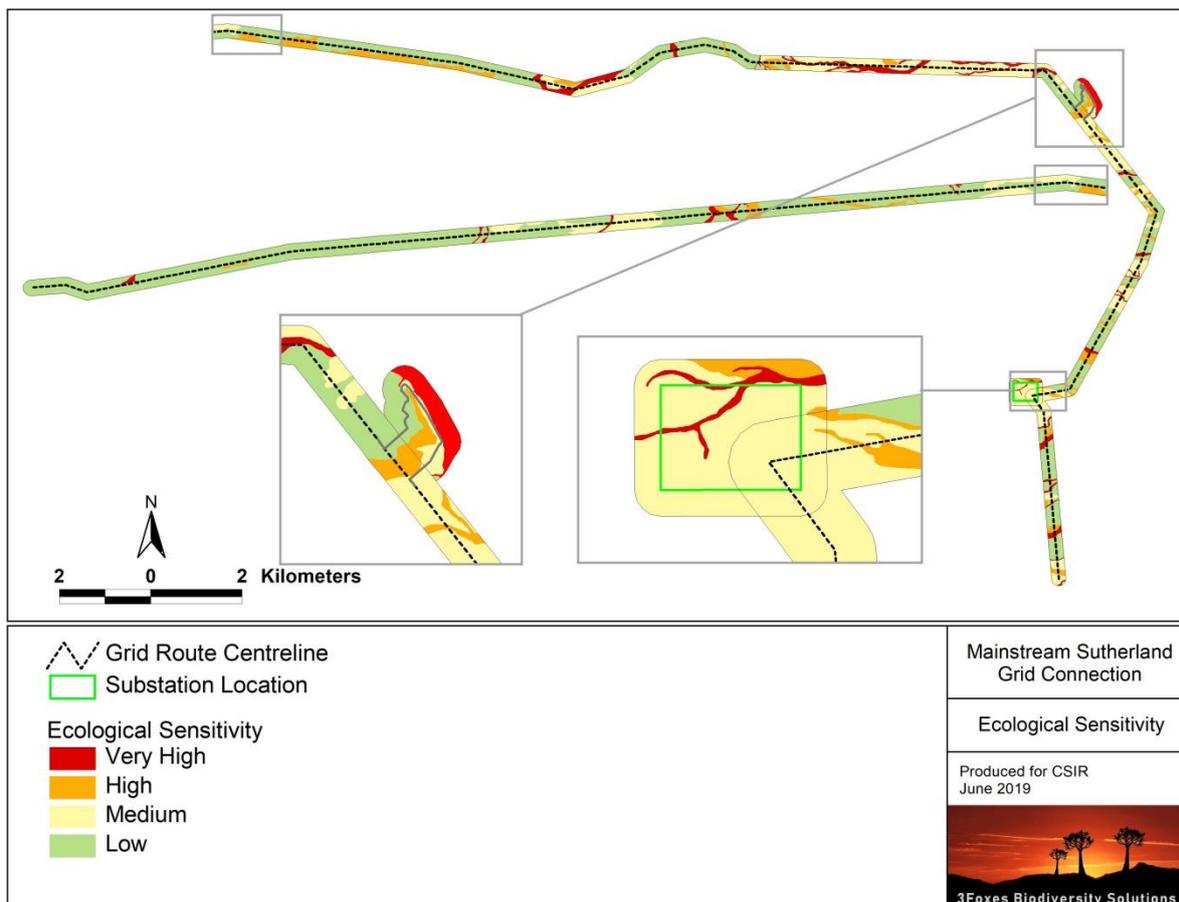
Figure 10. Ecological sensitivity map for the grid connection route and substation site.

The ecological sensitivity map for the grid connection route and substation site is illustrated below. The majority of the route traverses open plains on the escarpment or on the lower elevation plains of the Gamka Karoo below. The plains are generally considered to represent low sensitivity areas with a relatively low abundance of species of conservation concern. The main areas of sensitivity along the power line route would be the numerous drainage lines that the power line and access road must traverse as well as several areas of steep slopes that the line and road must negotiate. In some cases, such as the section where the road deviates from the line, such minor deviations between the road and the line are required as the line can span steep sections of rugged terrain, whereas the access road should preferably take less steep routes and avoid areas where the risk of erosion would be very high. The deviation is considered acceptable and runs between the higher sensitivity drainage line and the steeper parts of the adjacent slope. In terms of the power line itself, the span between pylons can usually be extended quite far in

rugged terrain, with the result that the overall footprint within these more sensitive areas can be reduced to a low level. Provided that measures to reduce secondary impact such as erosion are implemented, then risk through these areas can be reduced to an acceptable level. The impact on the line on fauna would largely be restricted to the construction phase and associated with disturbance during construction. During the operational phase, impacts on fauna would be very low. The substation site is not particularly flat and would require a large amount of earth-moving to level the site. As such, it is not considered to represent an ideal site for the substation, but as the area is considered largely moderate sensitivity and no particularly high value species or ecosystems are present within the footprint, it is considered acceptable and of moderate local impact.

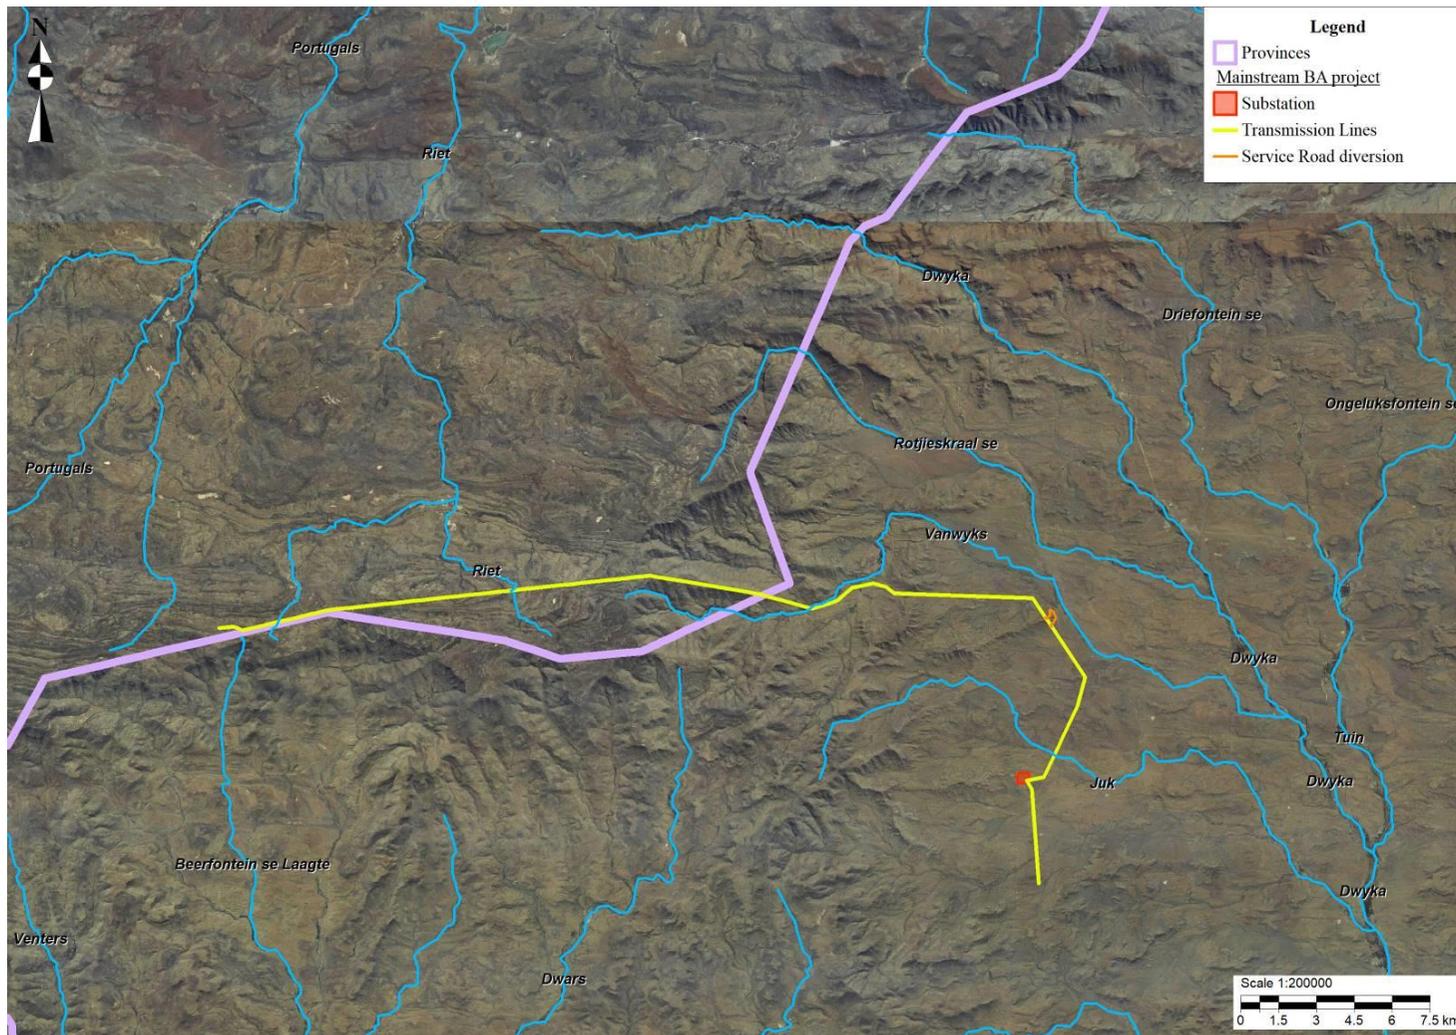
Figure 1. Locality map of the proposed substation and transmission lines relative to freshwater features present

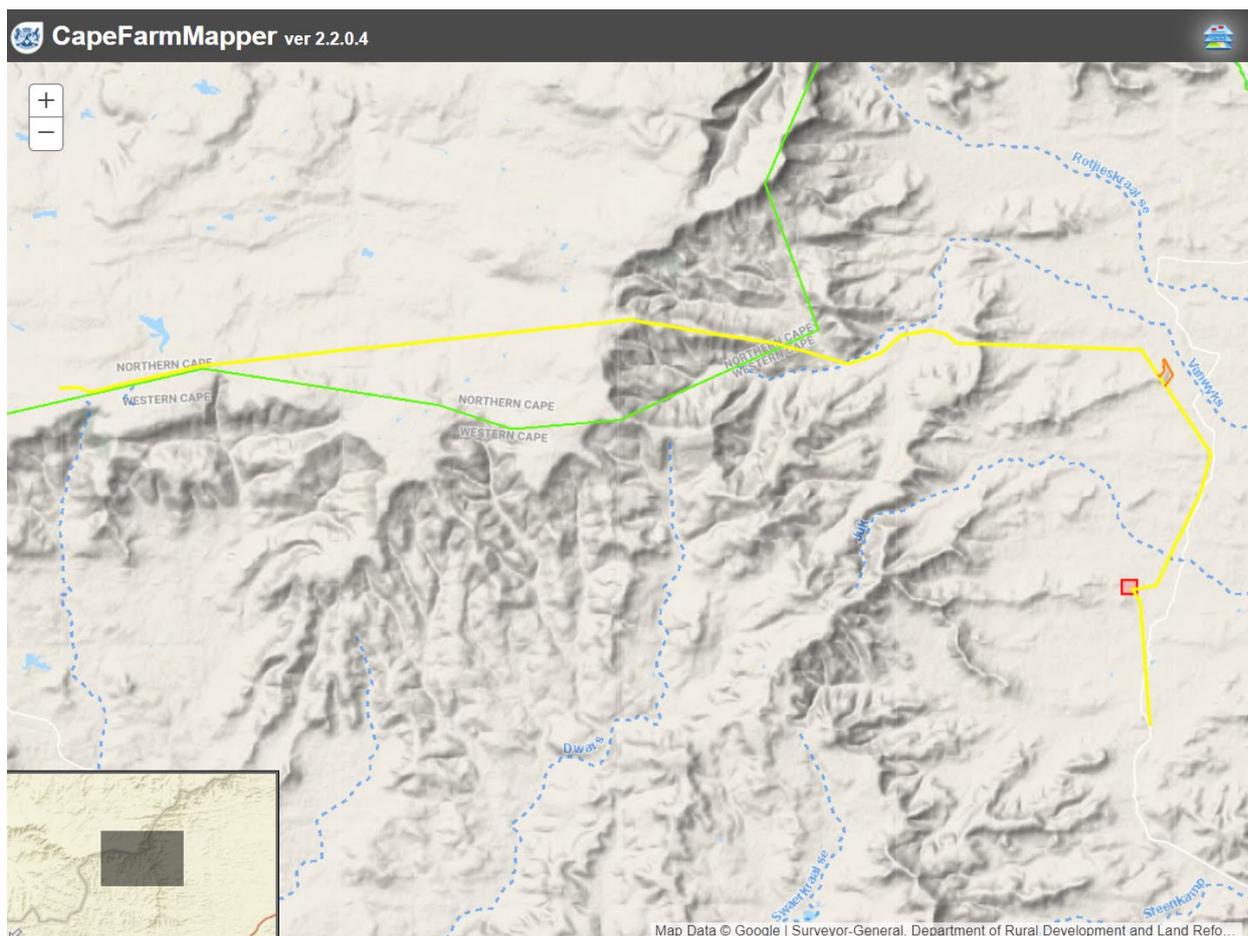
Figure 2. Relief map for the area, showing the main watercourses and the location of the proposed project activities (CapeFarmMapper, 2019)

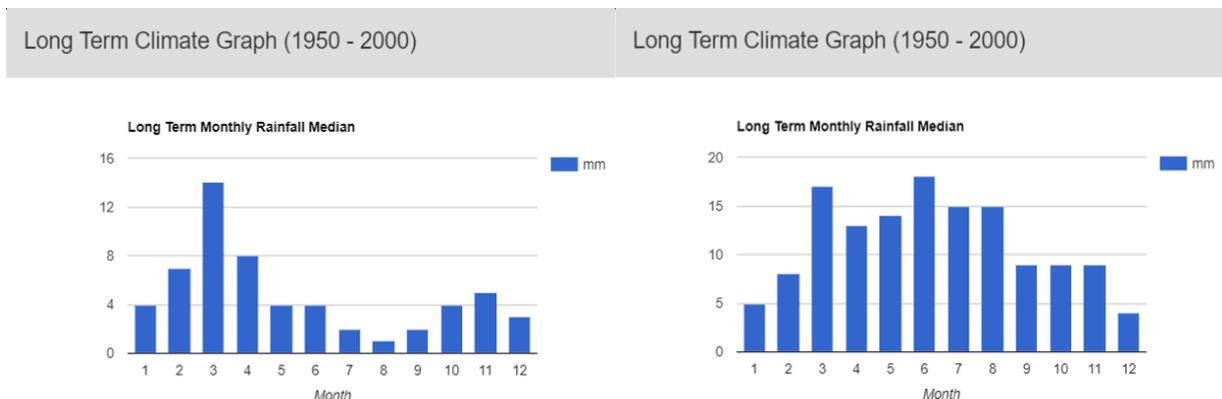
Figure 3. Average monthly rainfall in the eastern (left) and the western (right) extents for the study area, collected between 1950 and 2000 (Schulze, 2009)

The study area experiences a low rainfall of only 126mm per annum in the eastern extent to 206 mm in the west. Rainfall varies somewhat between the two extents with rainfall in the east falling mostly in summer (February) while in the west rain falls throughout the year with slightly higher rainfall in winter with June being the highest rainfall month on average (Figure 3).

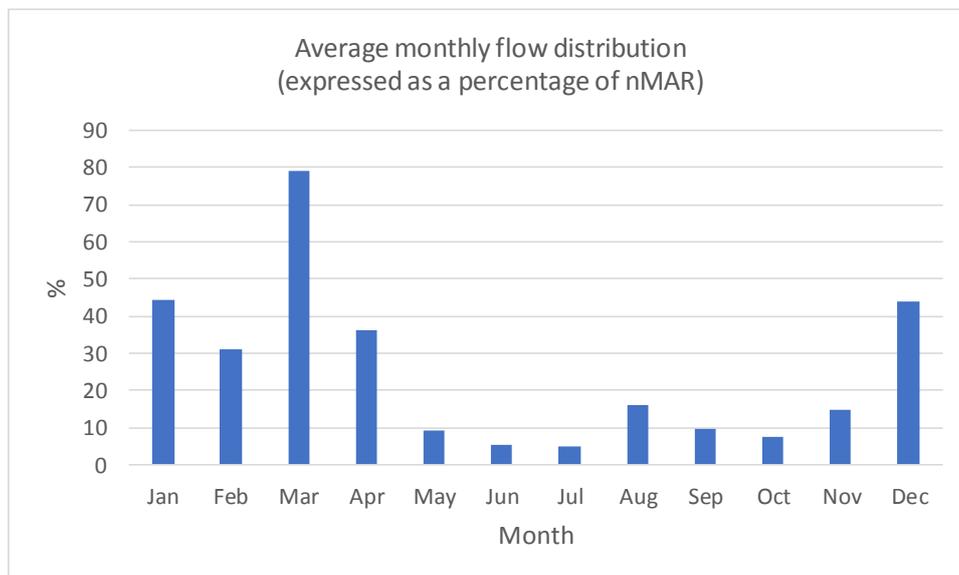
Figure 4. Monthly flow distribution within the Dwyka River Catchment as the catchment where infrastructure would be placed within the valley and floodplain. The monthly flow is shown as a percentage of the natural mean annual runoff (nMAR) for the catchment.

The flow pattern (Figure 4) is similar to the rainfall pattern. Flow in the rivers however tends to be episodic (Figure 4) with very little to no flow in the rivers for much of the river. Water flow typically only occurs for a short period of time following localised rainfall. When flow occurs in the

watercourses it occurs as a high flow event. The flow nature does however make erosion control measures in the watercourses, particularly on the slopes, an essential mitigation.

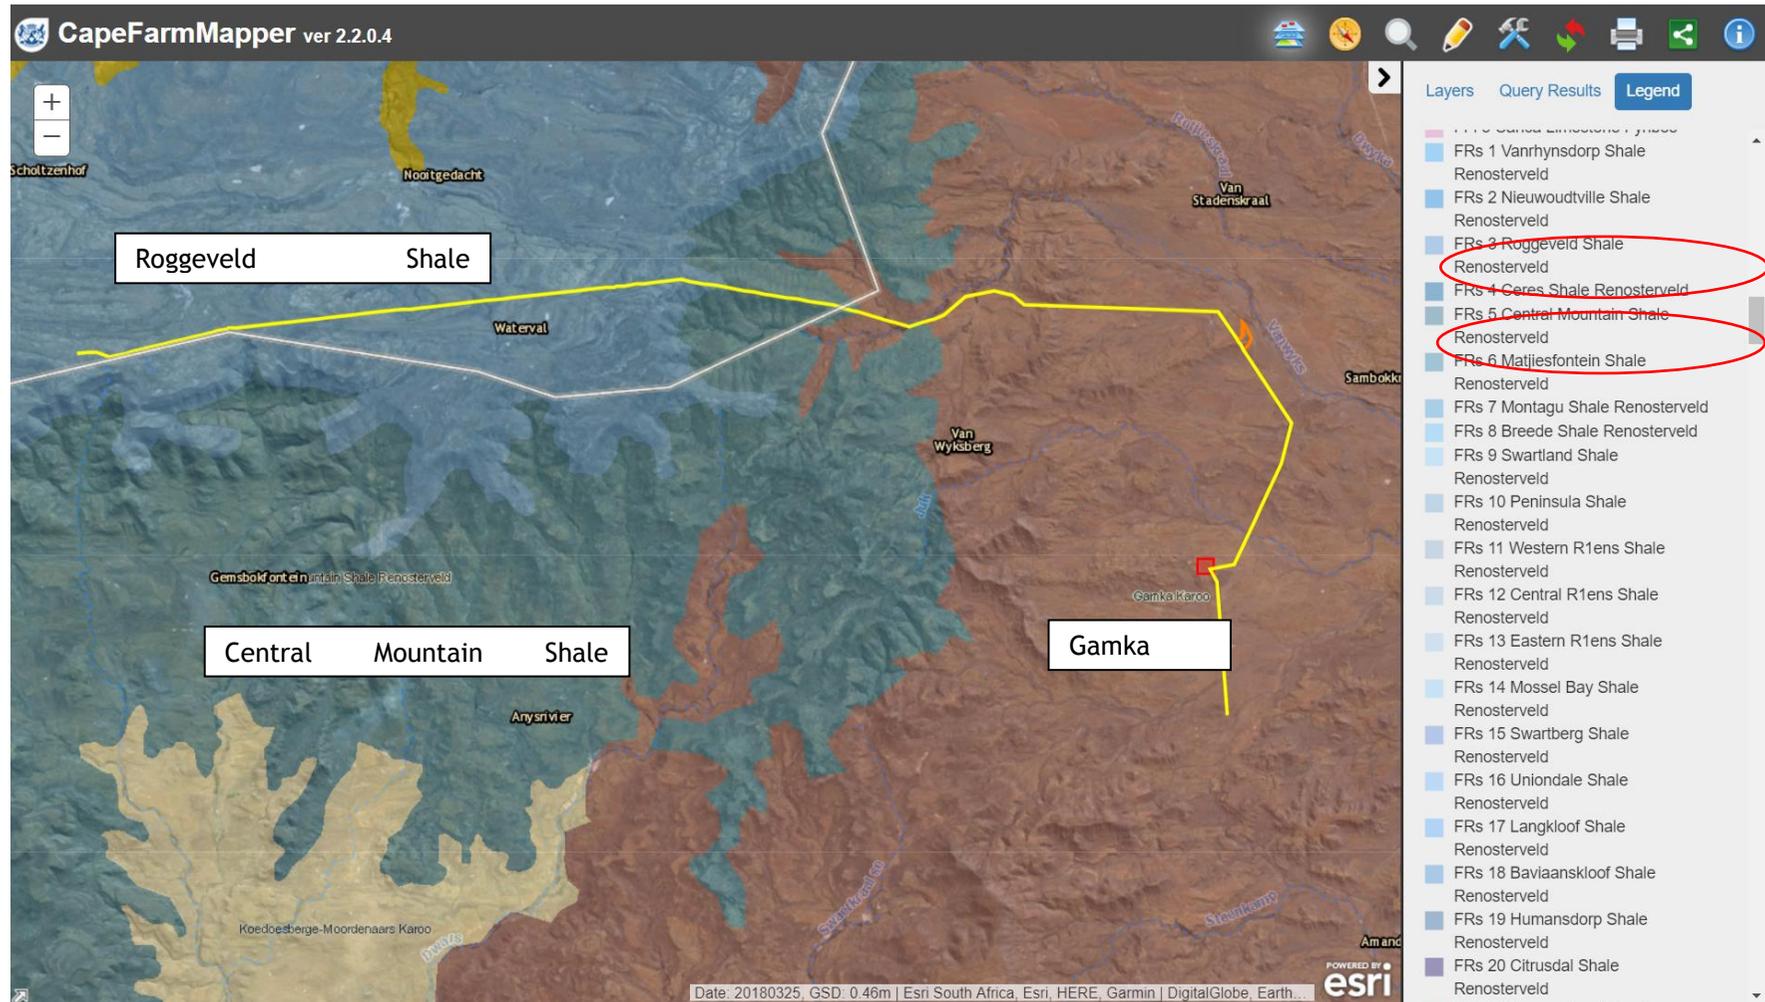
Figure 5. National Vegetation Map (SANBI, 2012) for the study area (yellow line) (CapeFarmMapper, 2019)

| Figure 5. | National Vegetation Map (SANBI, 2012) for the study area (yellow line) (CapeFarmMapper, 2019) | 24 |

Under unmodified conditions, the vegetation type comprises of Roggeveld Shale Renosterveld for the western extent of the study area, Central Mountain Shale Renosterveld in the central area and Gamka Karoo in the eastern extent (Figure 5). The vegetation reflects the varied topography and associated geology of the area with Central Mountain Shale Renosterveld occurring predominantly on the ridges, Roggeveld Shale Renosterveld on the low hills and broad shallow valleys, while Gamka Karoo dominates the lowlands.

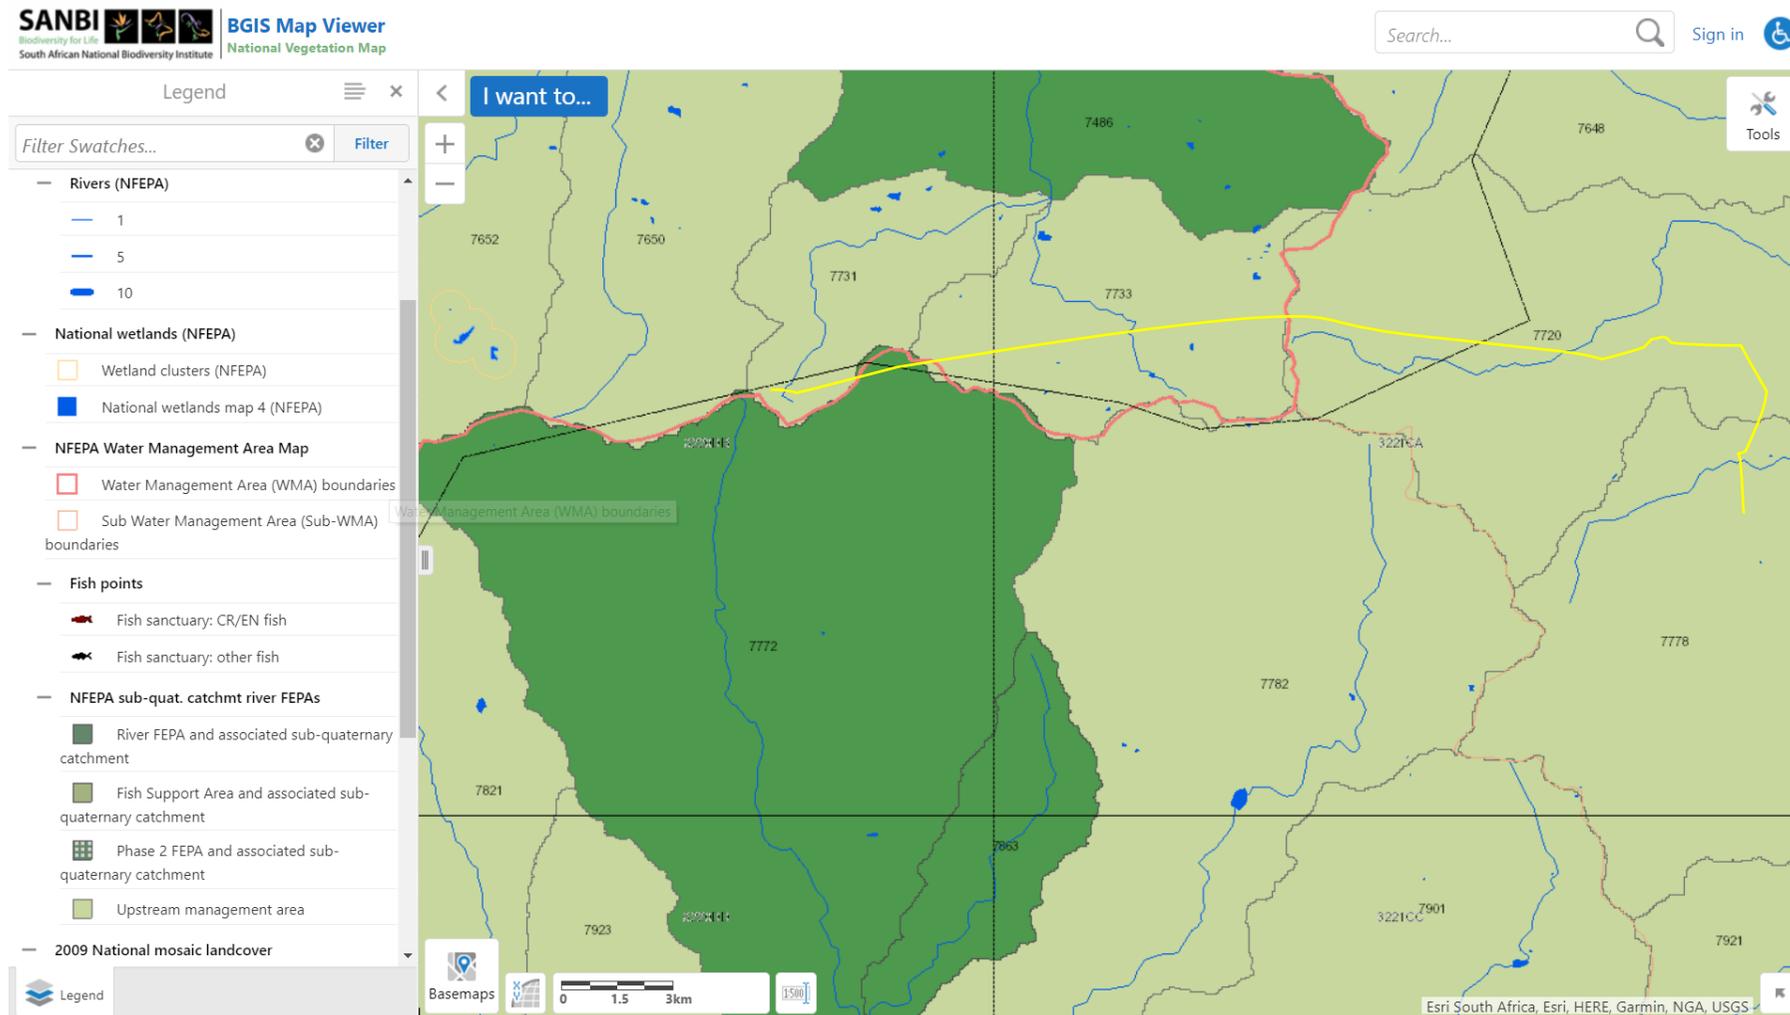
Figure 6. National Freshwater Ecosystem Priority Areas for the study area (yellow line) (SANBI Biodiversity GIS, 2019)

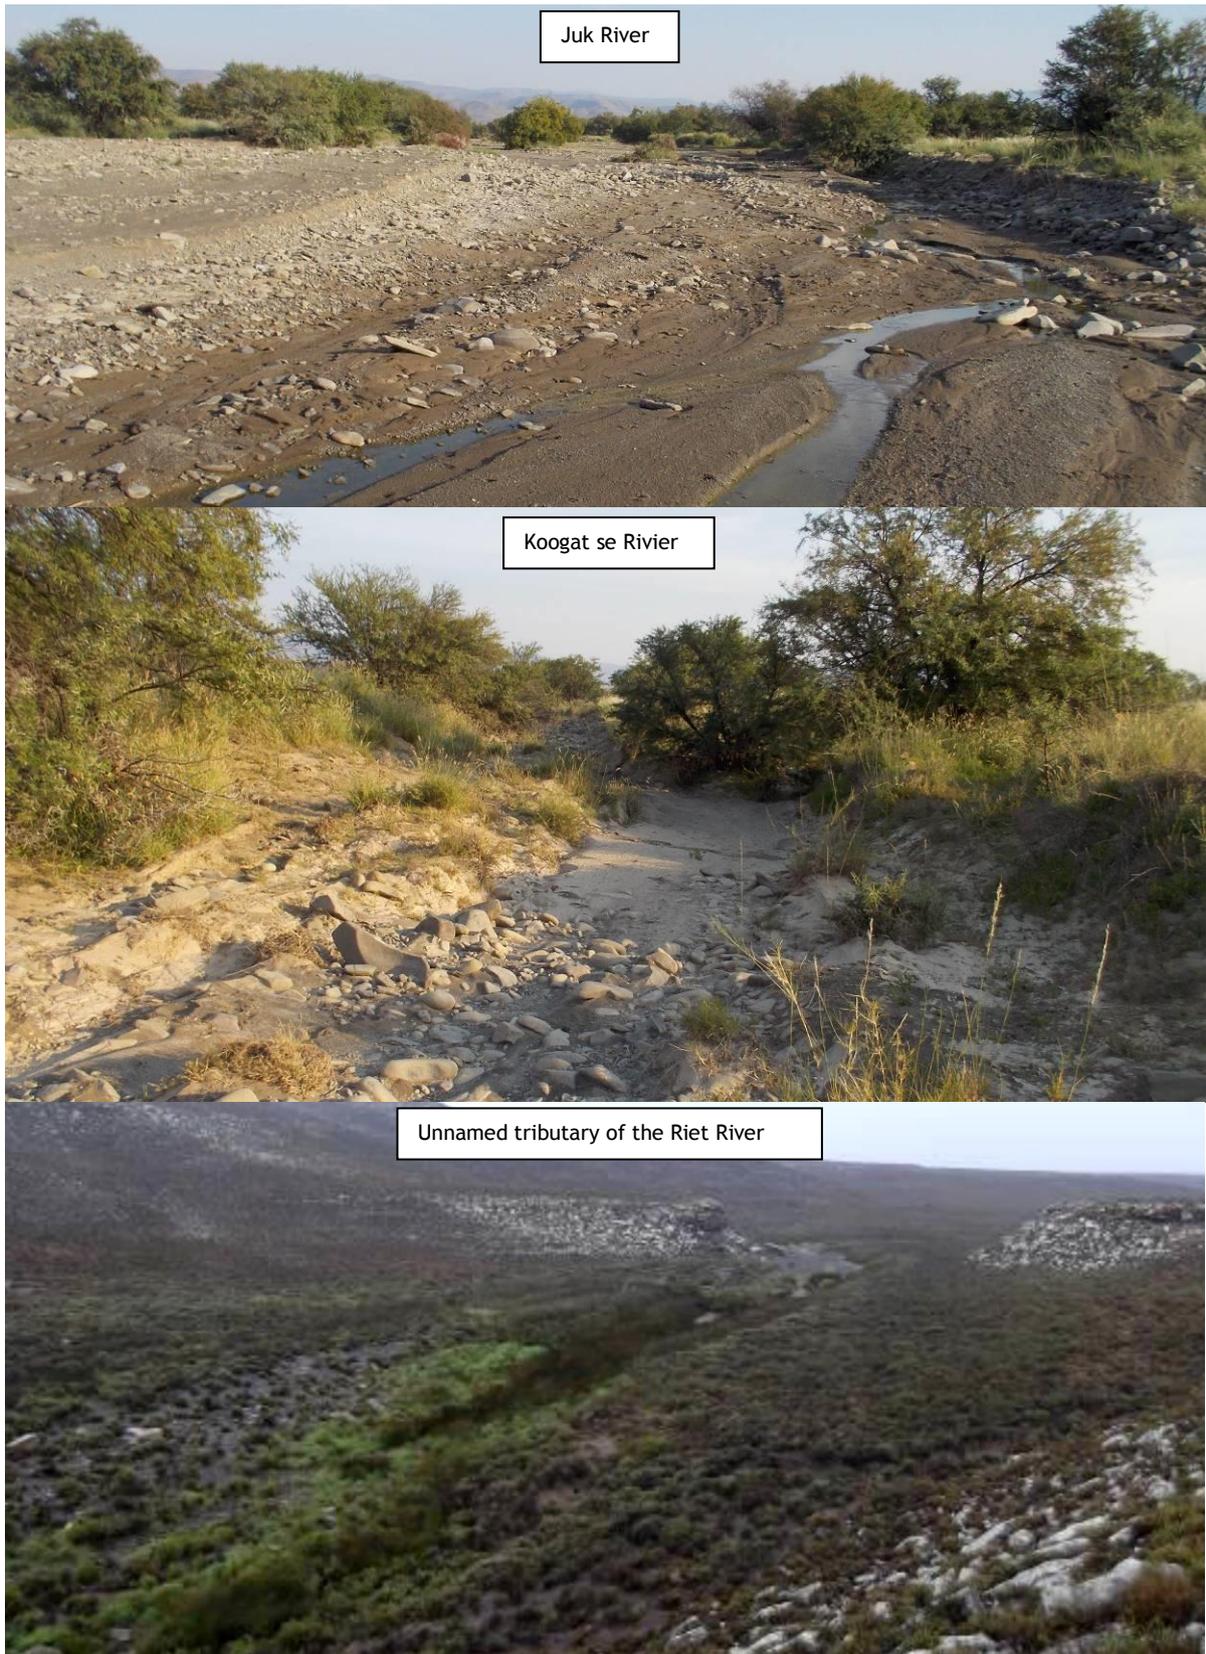
Figure 10. View of the larger rivers and smaller tributaries within the study area

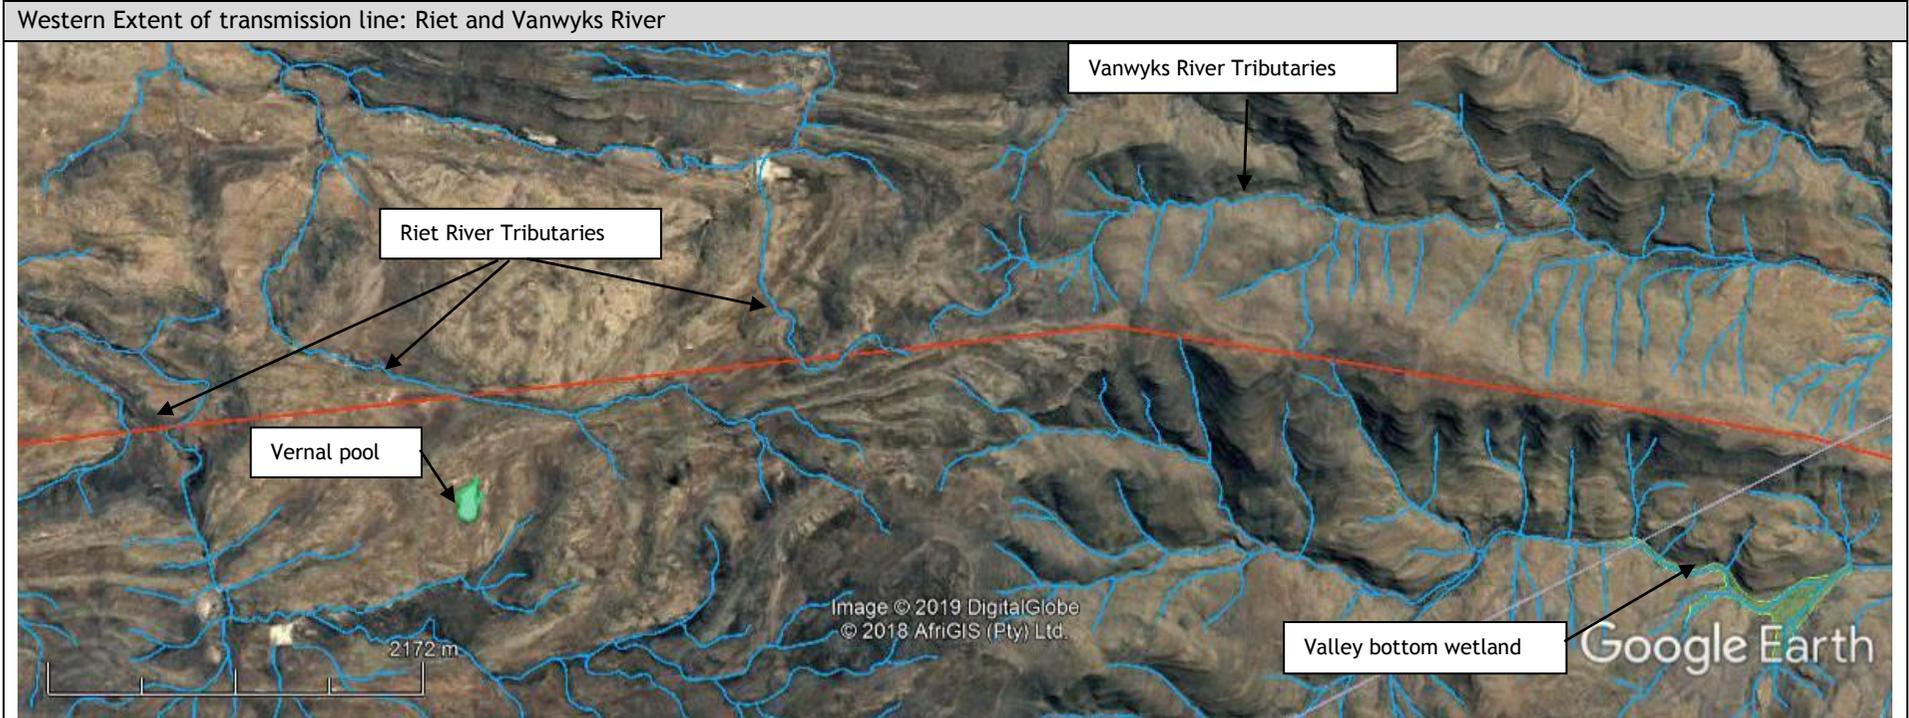
Within this section, the line crosses the upper Riet River and its tributaries and then passes eastwards along a ridge between two tributaries of the Vanwyks River. The Riet River at the line is mapped as an aquatic CBA in the west and then ESAs further east. As stated for the previous section, the watercourses are within an Upstream FEPA sub-catchment. The middle reaches of the Vanwyks River, where valley bottom wetland areas occur, the river is mapped as an aquatic CBA, while the remainder of the watercourses are aquatic ESAs. Within this section, the PES of the rivers becomes slightly more modified, becoming largely natural to moderately modified and the EIS of the watercourses remains high. The rivers should remain at least in a largely natural to moderately modified ecological condition.
