Basic Assessment for the Proposed Construction and Operation of Electrical Grid Infrastructure to support the Sutherland, Sutherland 2 and Rietrug Wind Energy Facilities (WEFs), Northern and Western Cape Provinces: DRAFT BASIC ASSESSMENT REPORT

APPENDIX D.1: Terrestrial Ecology Impact Assessment

FAUNA & FLORA SPECIALIST STUDY

Basic Assessment Report for the Proposed Grid Connection Infrastructure for the Mainstream Sutherland Wind Energy Facilities

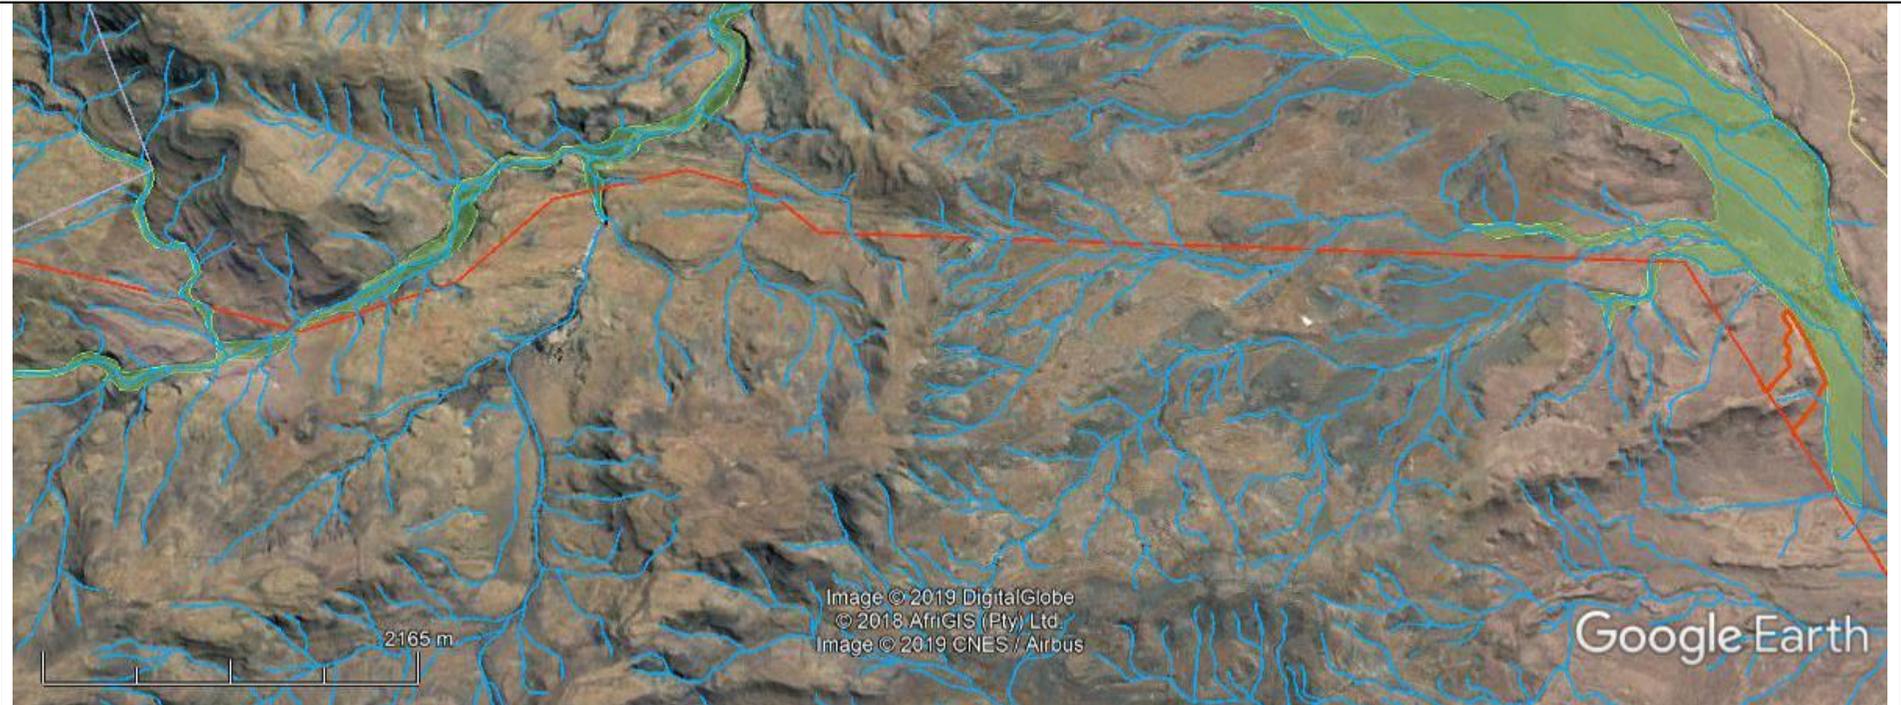
Western Extent of transmission line: Vanwyks River

Within this section, the line crosses the middle reaches of the Vanwyks River, its tributaries and the associated valley bottom and floodplain wetlands. The alternative service road is also located within this section, directly adjacent to the floodplain of the Vanwyks River. As stated for the previous section, the middle reaches of the Vanwyks River, where valley bottom wetland areas occur, the river is mapped as an aquatic CBA, while the remainder of the watercourses are aquatic ESAs. Within this section, the PES of the watercourses is largely natural to moderately modified and the EIS of the watercourses remains high. The rivers should remain at least in a largely natural to moderately modified ecological condition.

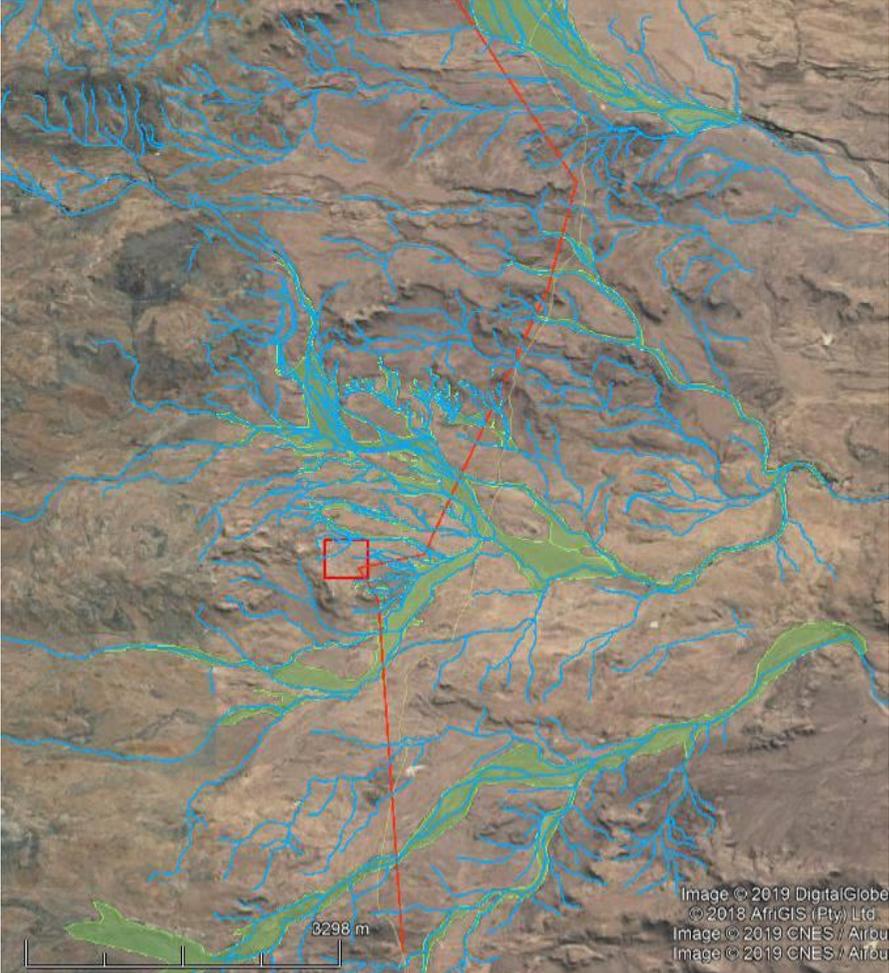
| Western Extent of transmission line: Juk and Ouberg Rivers | Comments and Recommendations |

| Western Extent of transmission line: Juk and Ouberg Rivers | Comments and Recommendations |
|---|---|
| | <p>Within this section, the line crosses the middle reaches of the Vanwyks, Juks and Oubergs Rivers, its tributaries and the associated valley bottom and floodplain wetlands. The middle reaches of these rivers are mapped as aquatic ESAs and they are within an Upstream FEPA sub-catchment. The PES of the watercourses is largely natural to moderately modified and the EIS of the watercourses is high. The rivers should remain at least in a largely natural to moderately modified ecological condition.</p> <p>The recommended buffer to protect the smaller tributaries is 50m while there should be at least a 100m buffer, measured from the top of bank of the river channels or the delineated wetland edge (whichever is the furthest), for the larger rivers. It is still possible to place the pylons of the proposed transmission line outside of the aquatic features and the recommended buffers however the access roads will need to pass through these areas. Where possible existing access roads should be used, the routing should try to minimise the number of watercourses crossed or placing the road directly along the watercourses. Any potential erosion along the constructed road should be mitigated.</p> |

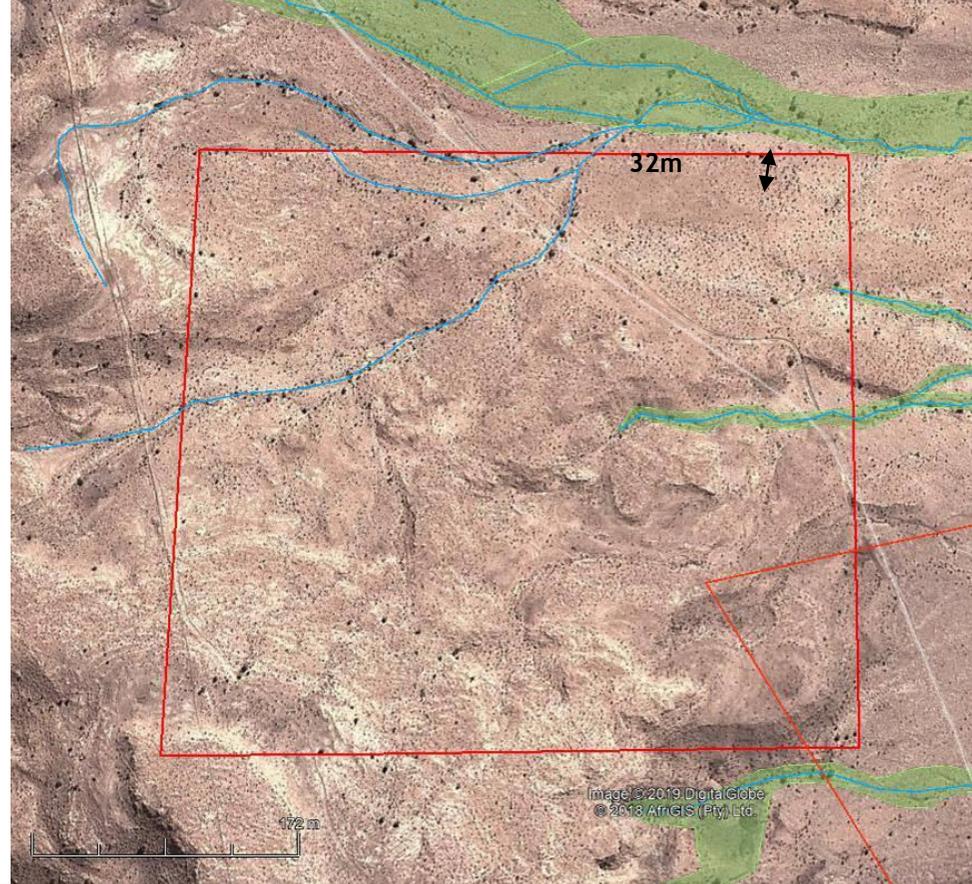
| Proposed substation | Comments and Recommendations |

| Proposed substation | Comments and Recommendations |
|---|--|
| | <p>The proposed location of the substation is within the upper to middle reaches of Juks River. It has been located to try and avoid the watercourses as far as possible and only a few minor watercourses occur within the footprint. The loss of the watercourses within the footprint is not seen as a significant impact and if properly mitigated, particularly in terms of stormwater runoff from the developed area, will not result in any degradation of the watercourses downstream of the site. The footprint should be located within this footprint such that it avoids loss of the watercourses as far as possible. Allowance for a buffer of at least 32m should be sought from the watercourse to the north of the site. The existing access road to the site should preferably be utilised.</p> |

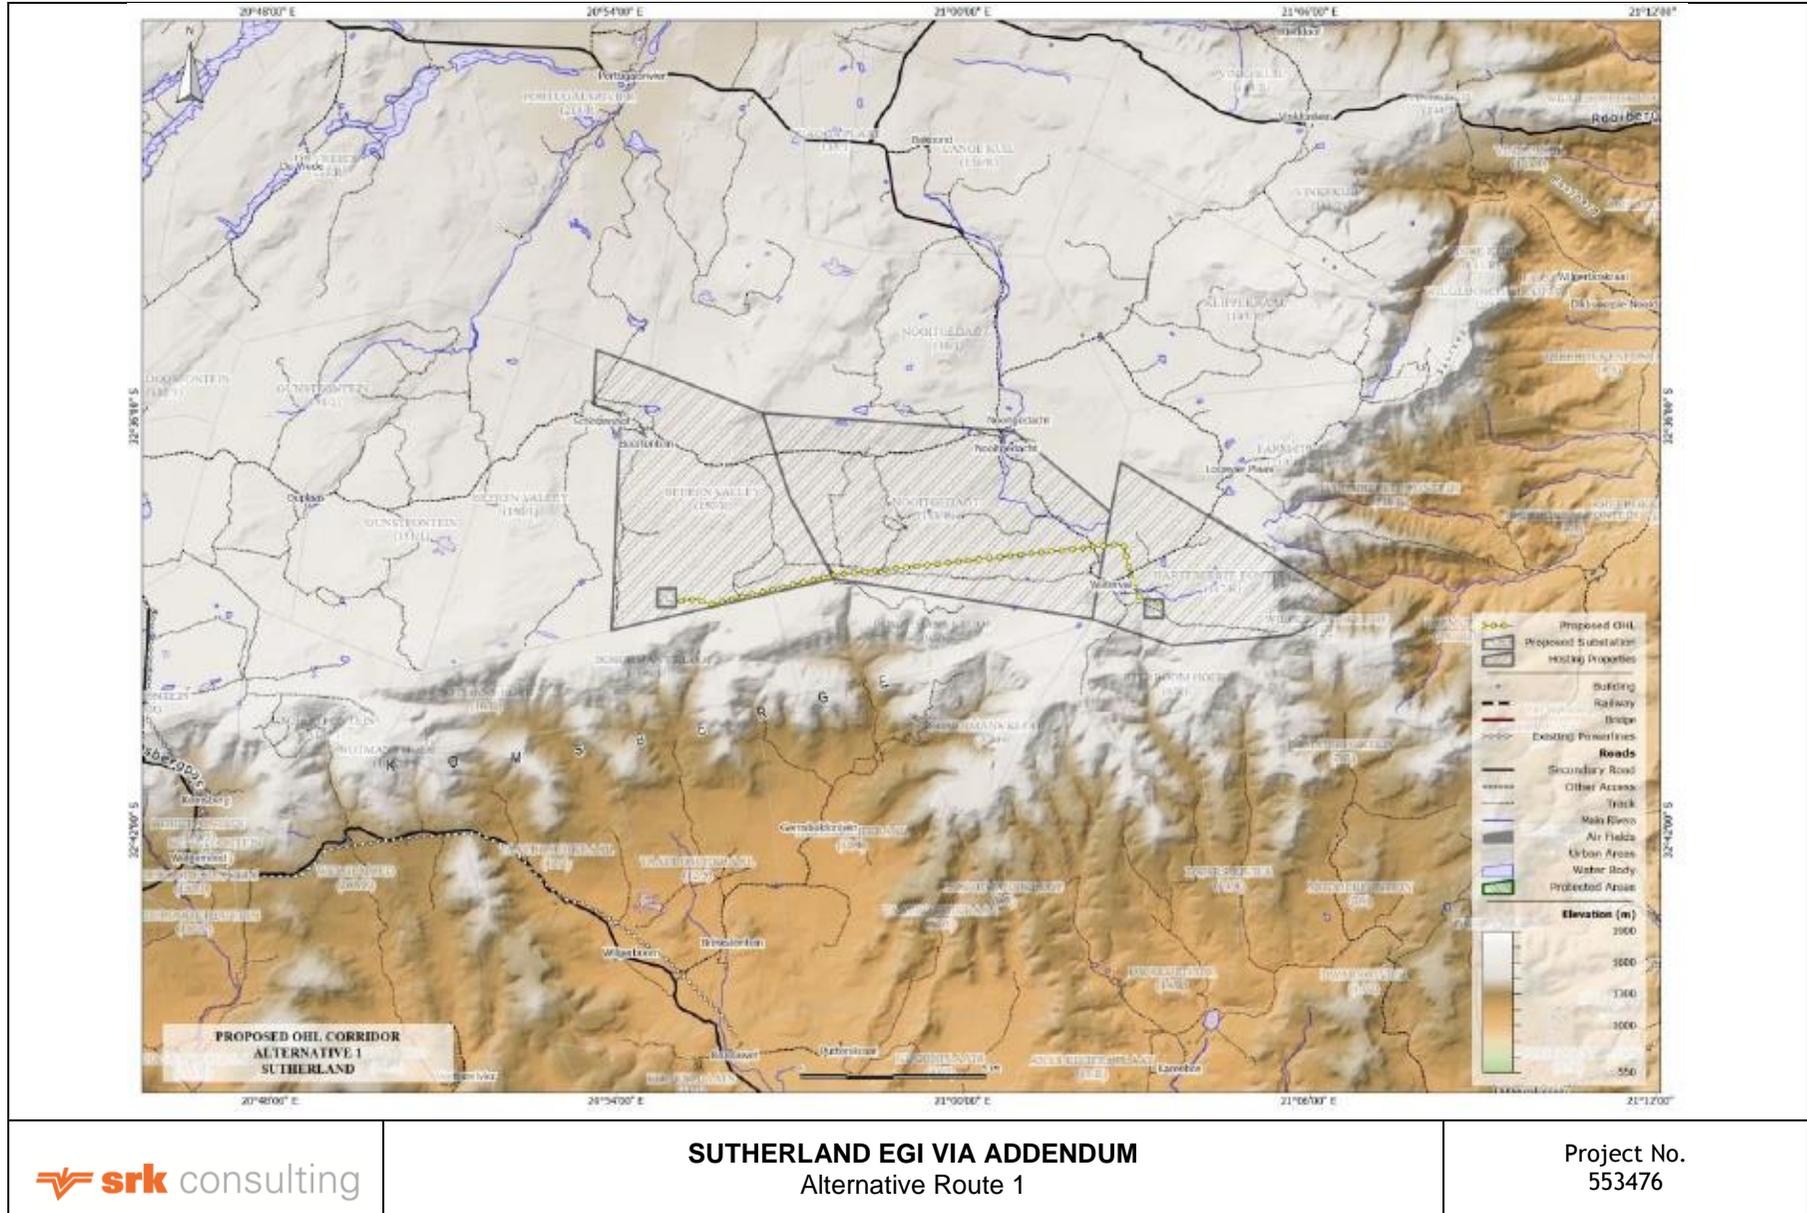
Figure 3-1: Alternative Route 1
Source: Holland, 2017

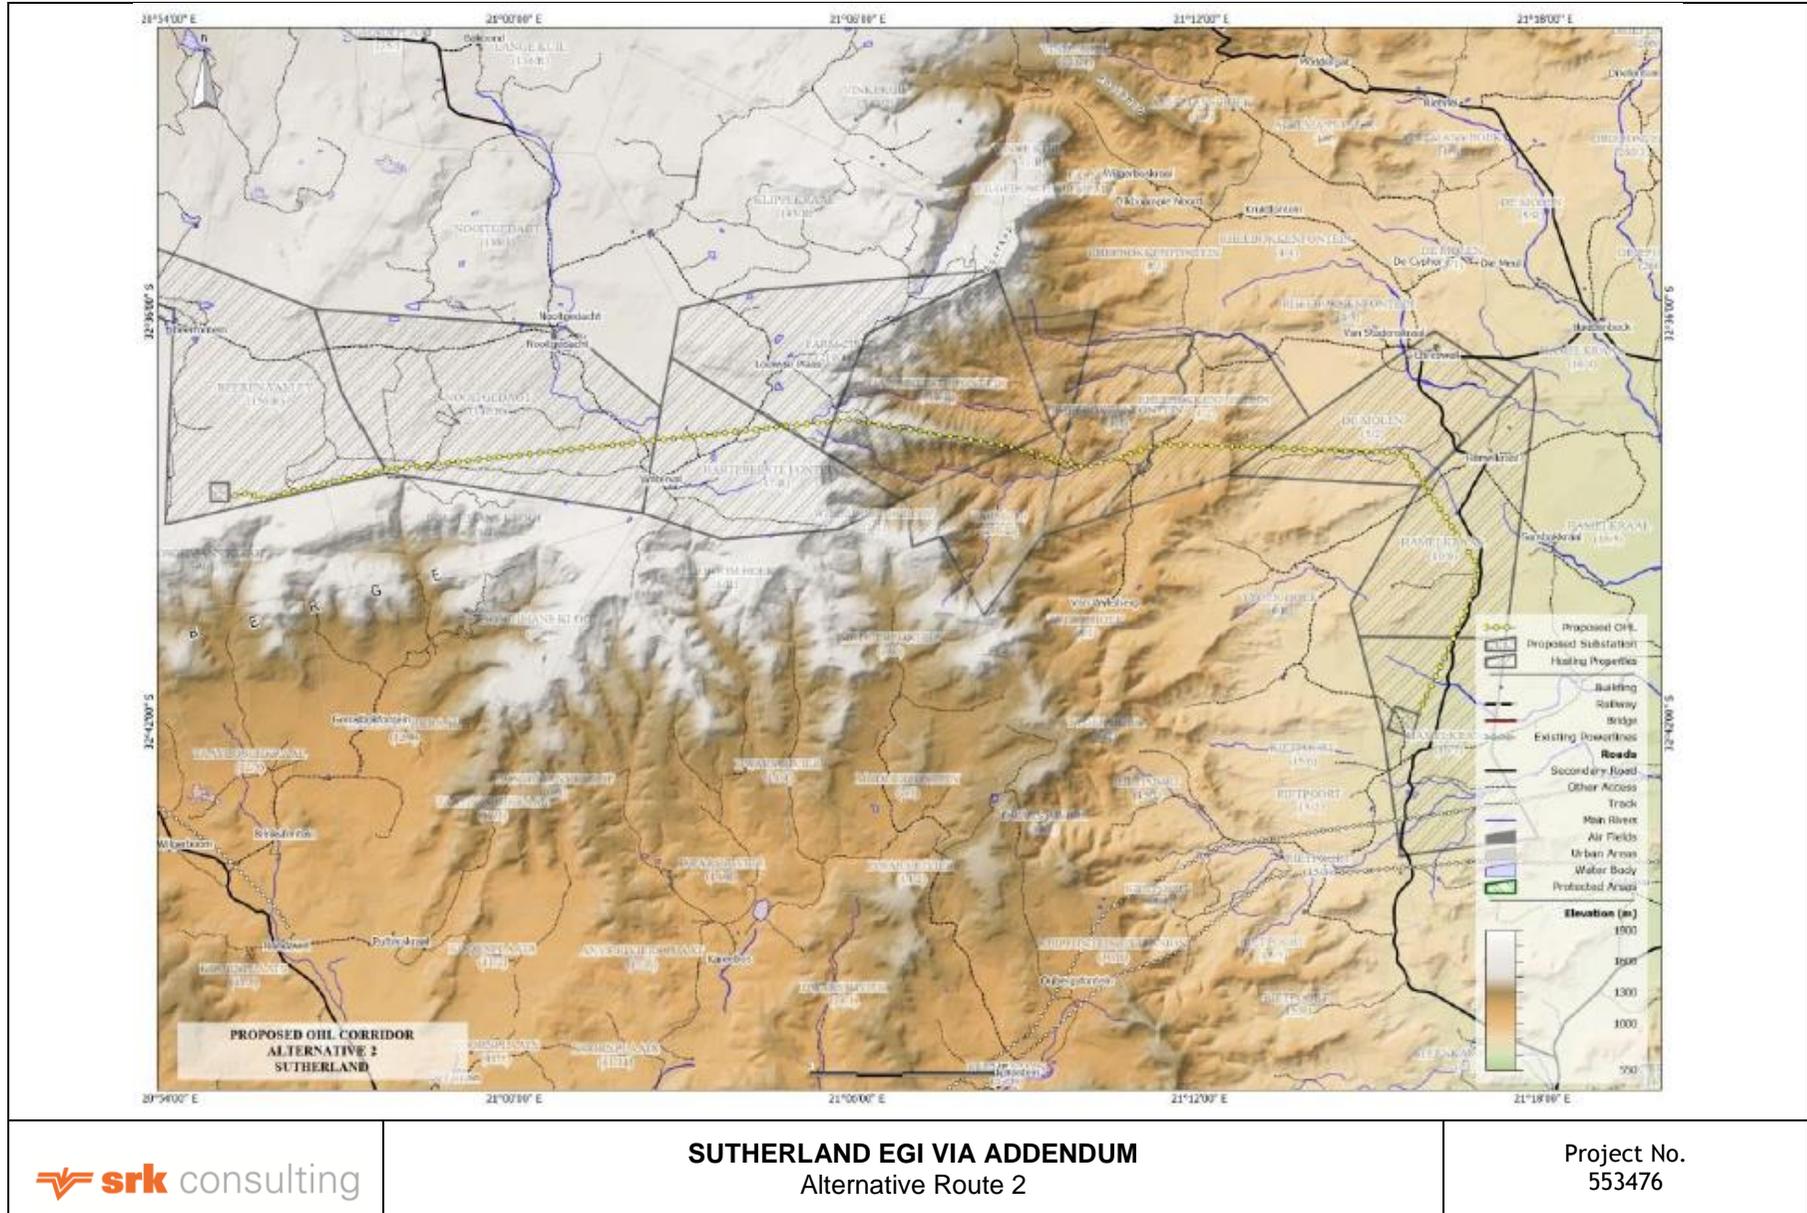
Figure 3-2: Alternative Route 2

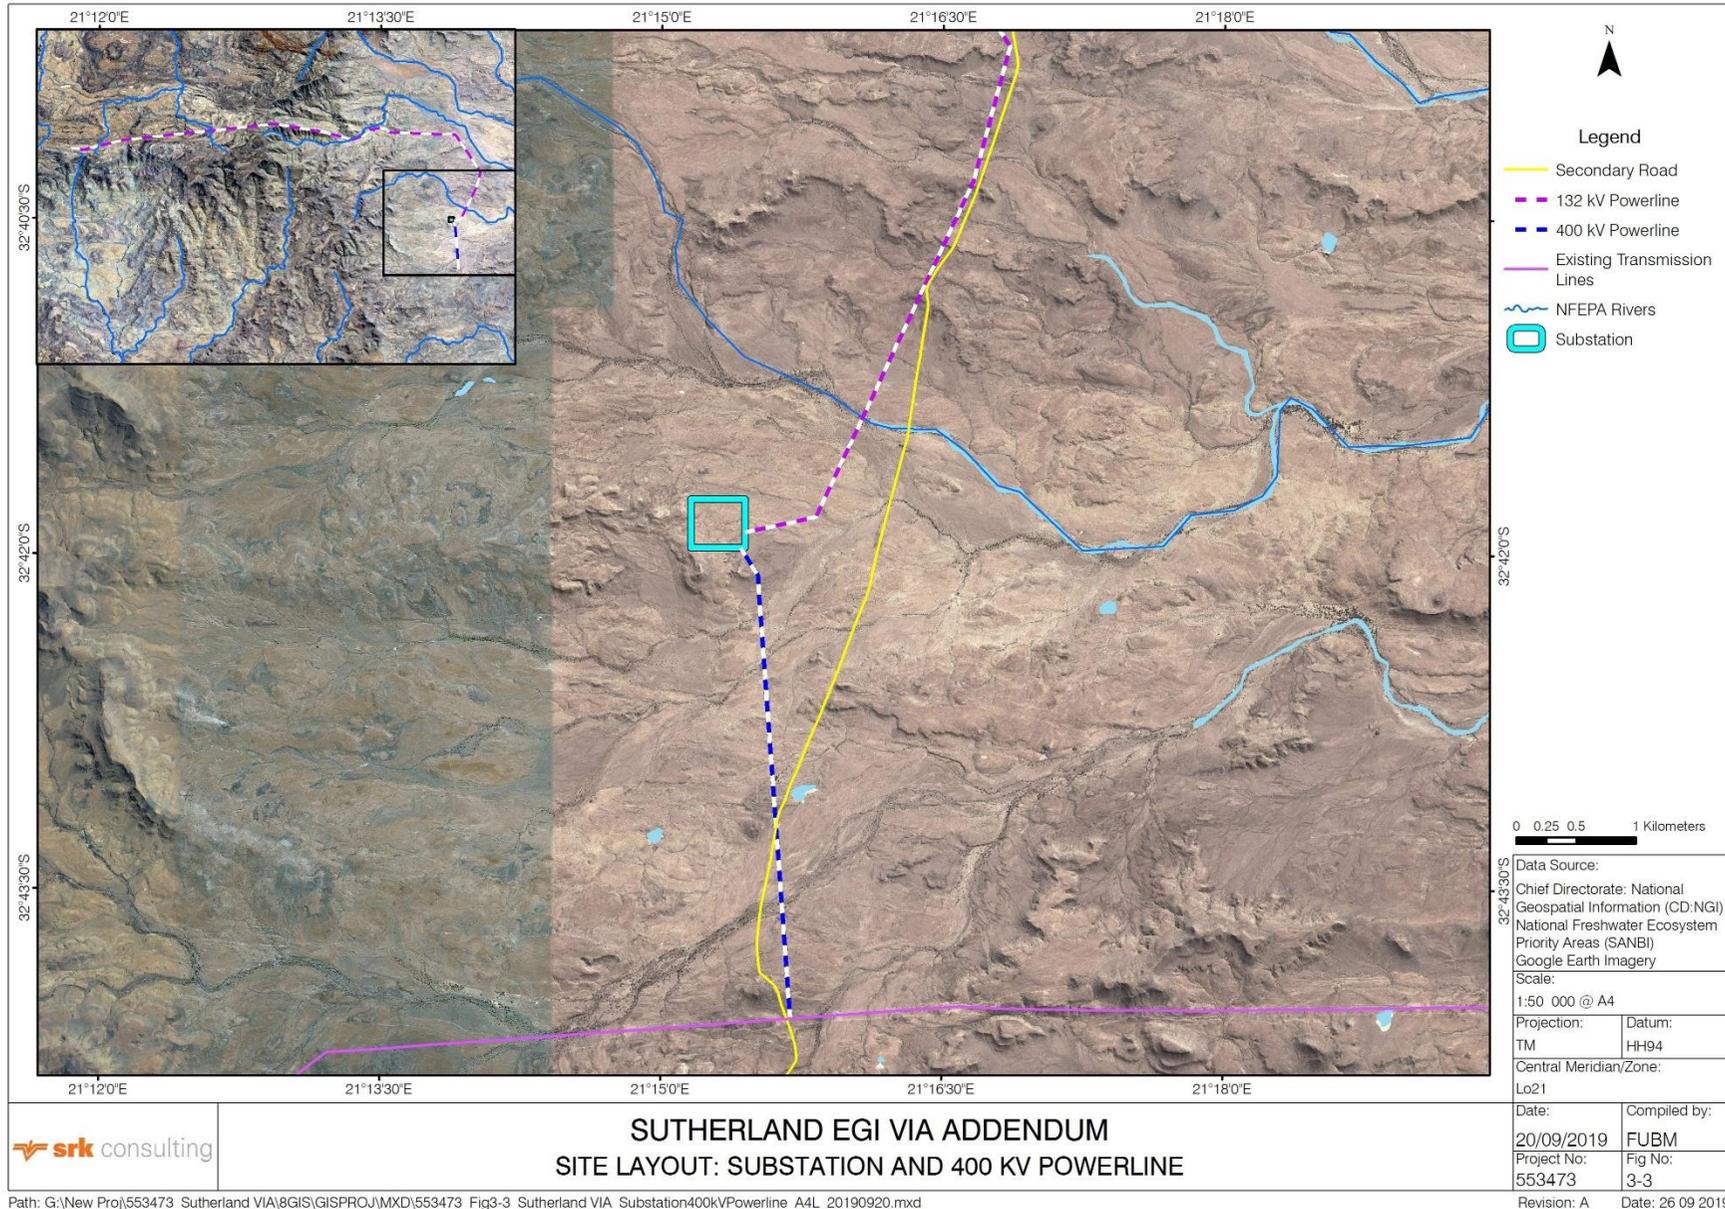
Figure 3-3: Proposed substation location and 400 kV powerline route

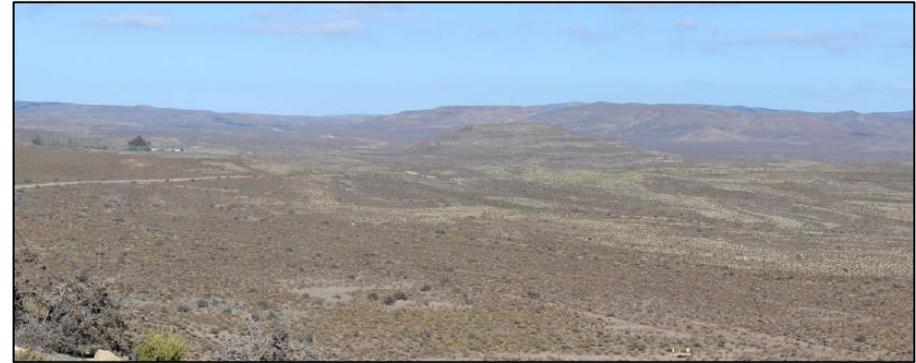
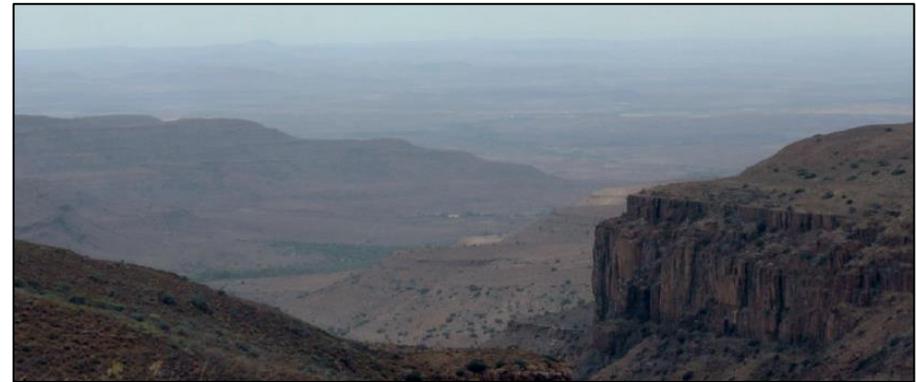
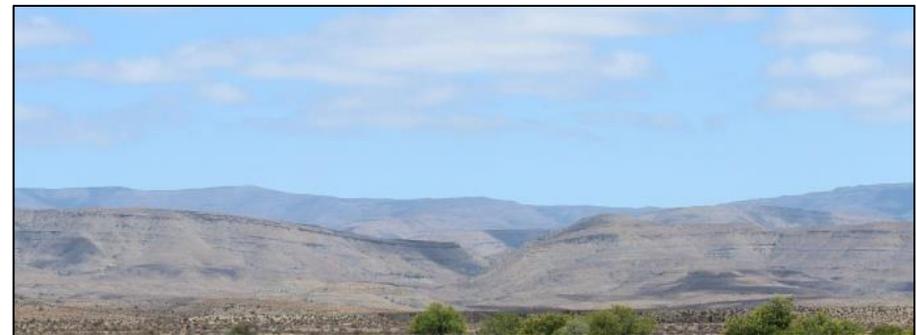
Figure 4-1: Visual character on the plateau (top), plain below the escarpment (middle) and view of the escarpment (bottom)

The vast 400 000 km² Karoo cultural landscape has a defined sense of place in terms of its open setting and sense of wilderness invoked when visiting, partly due to the predominantly natural landscape and relatively limited human influence throughout the region. The study area is not particularly distinct from the Karoo landscape with possible exception of the dramatic escarpment.

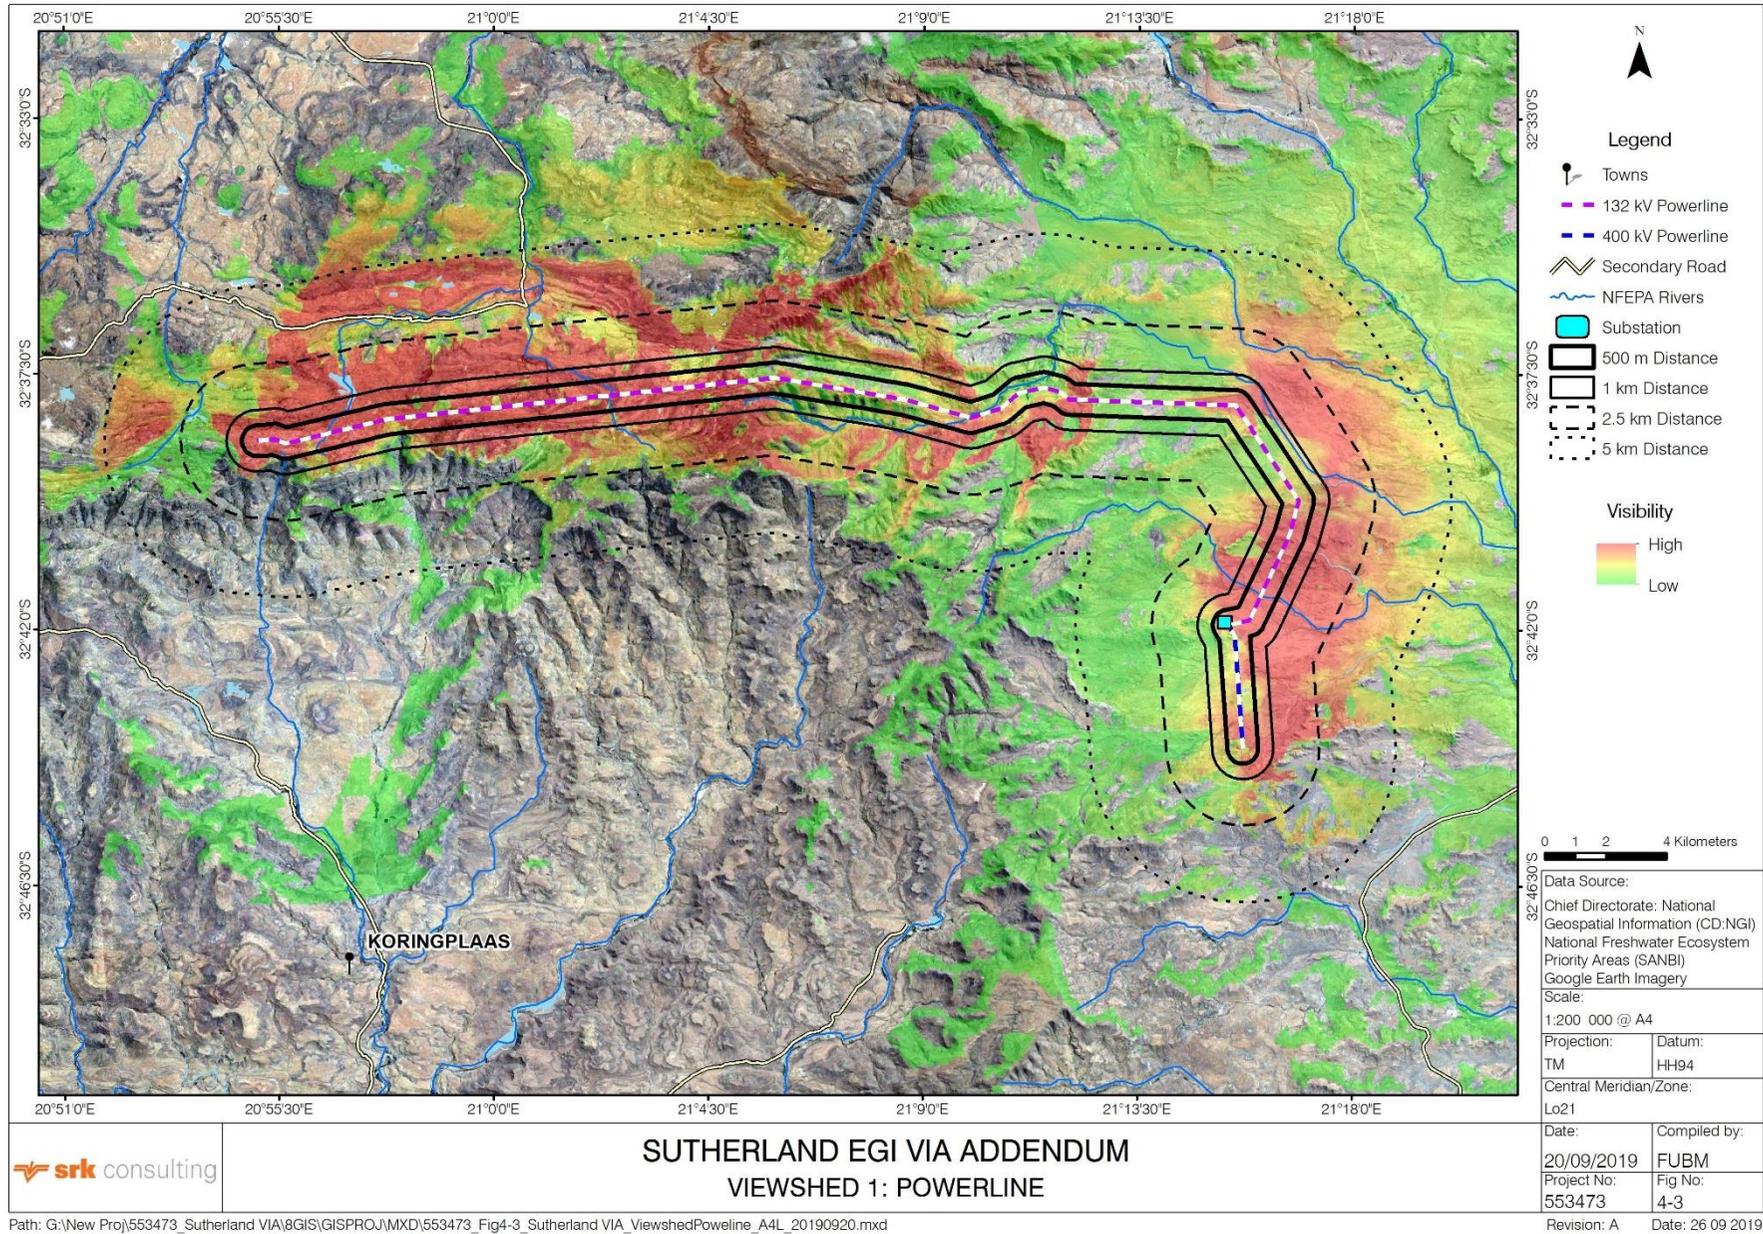
Figure 4-3: Viewshed 1: Powerline Alternative Route 2

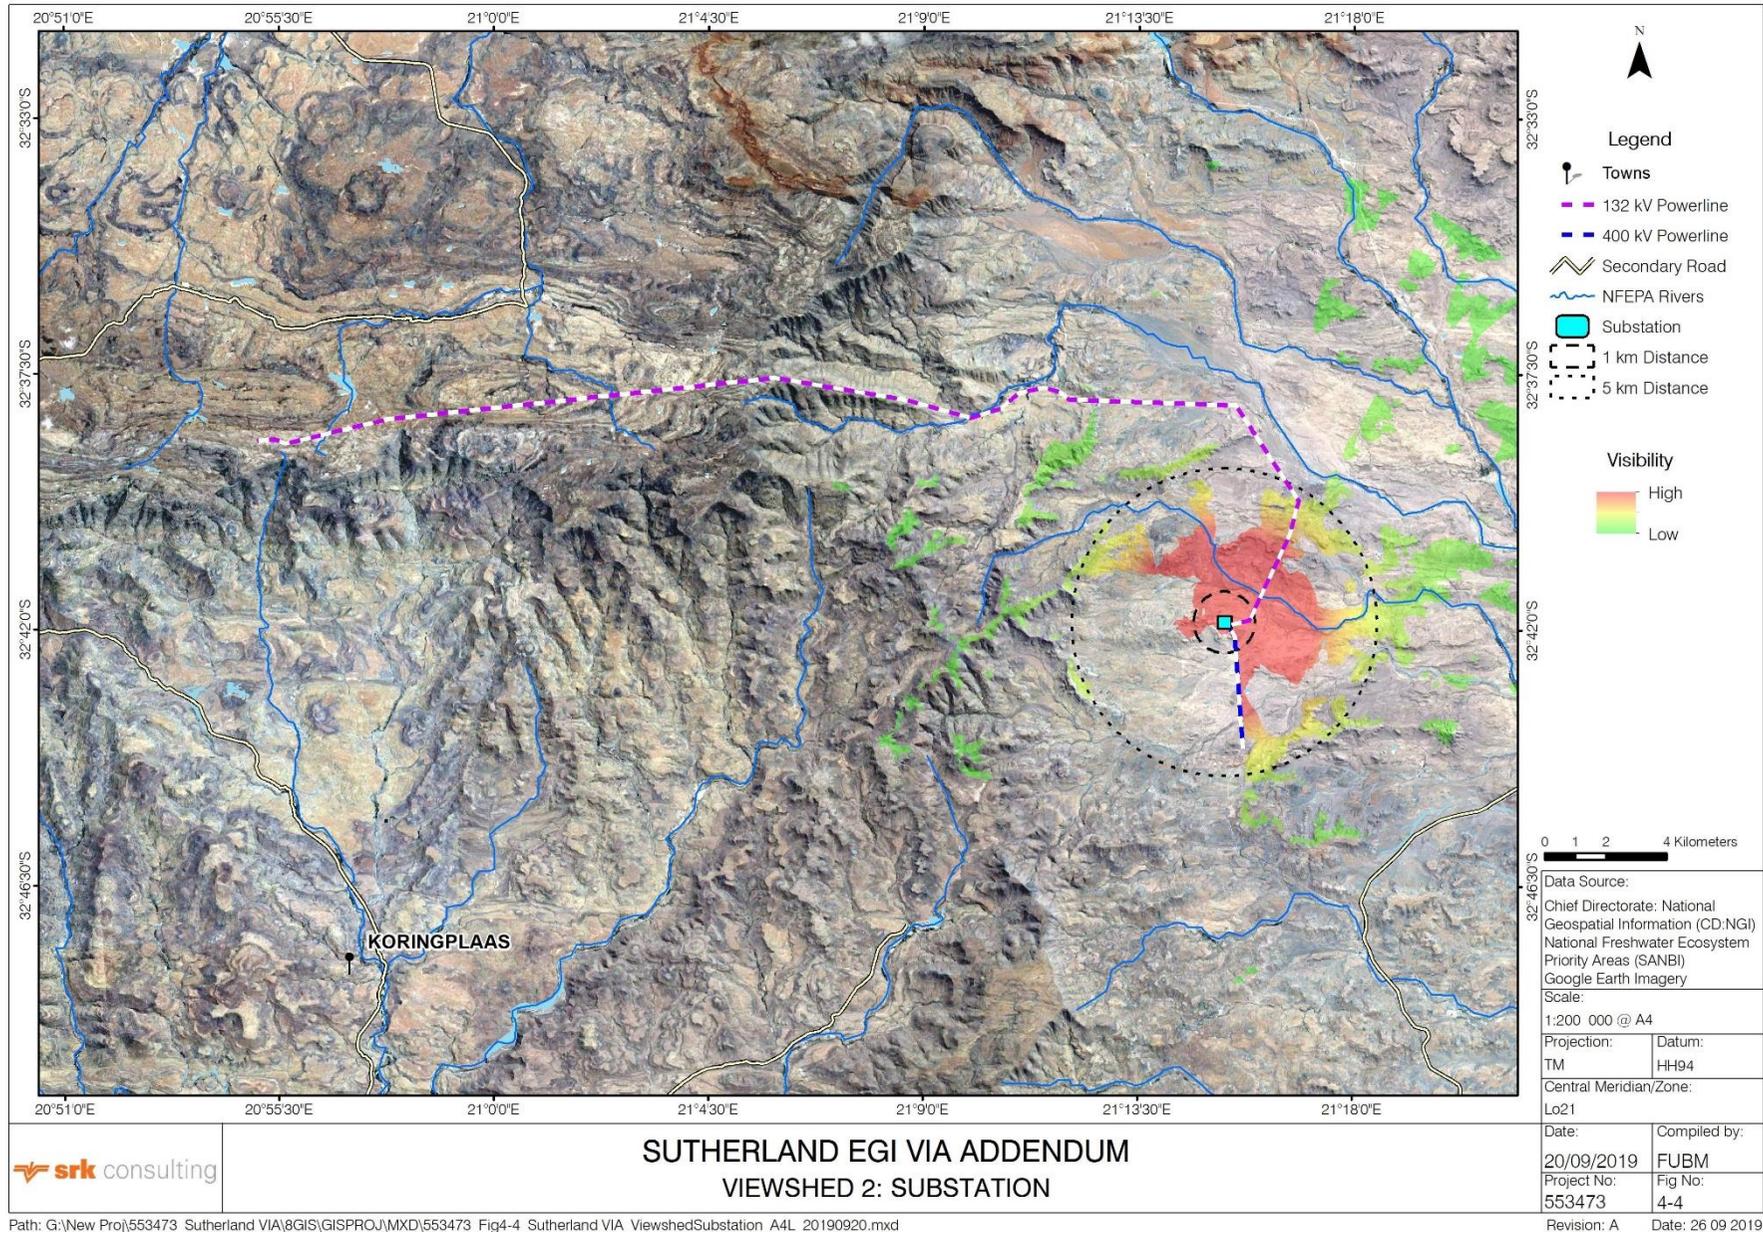
Figure 4-4: Viewshed 2: Substation
