4.2 Ecological Status of Sub-quaternary Catchments [DWS Resource Quality Services (RQS) PES/EIS database, 2014.]

APPENDIX D.3: Visual Impact Assessment

VISUAL IMPACT ASSESSMENT:

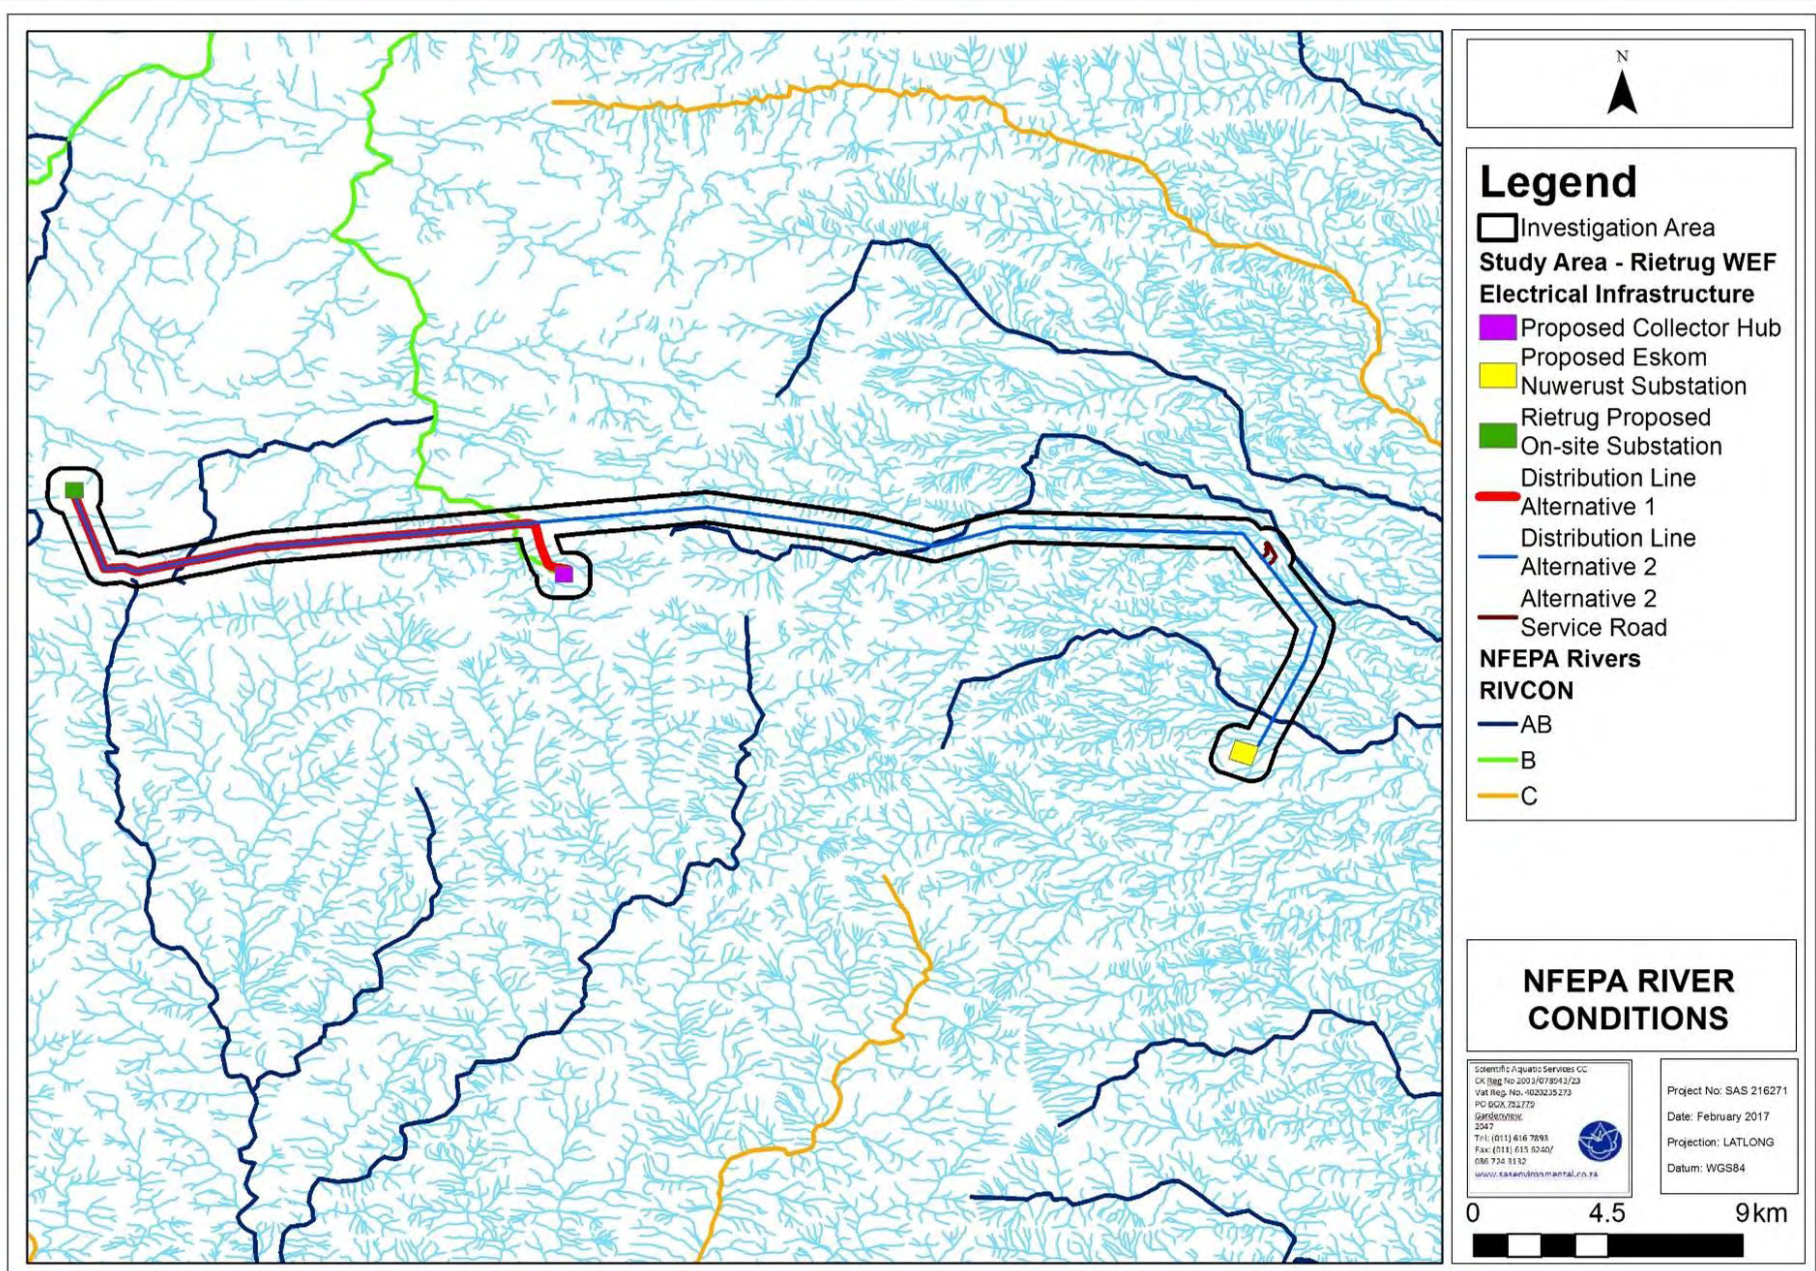
Figure 9: Ecological condition of the rivers associated with the study area according to the NFEPA database (2011).

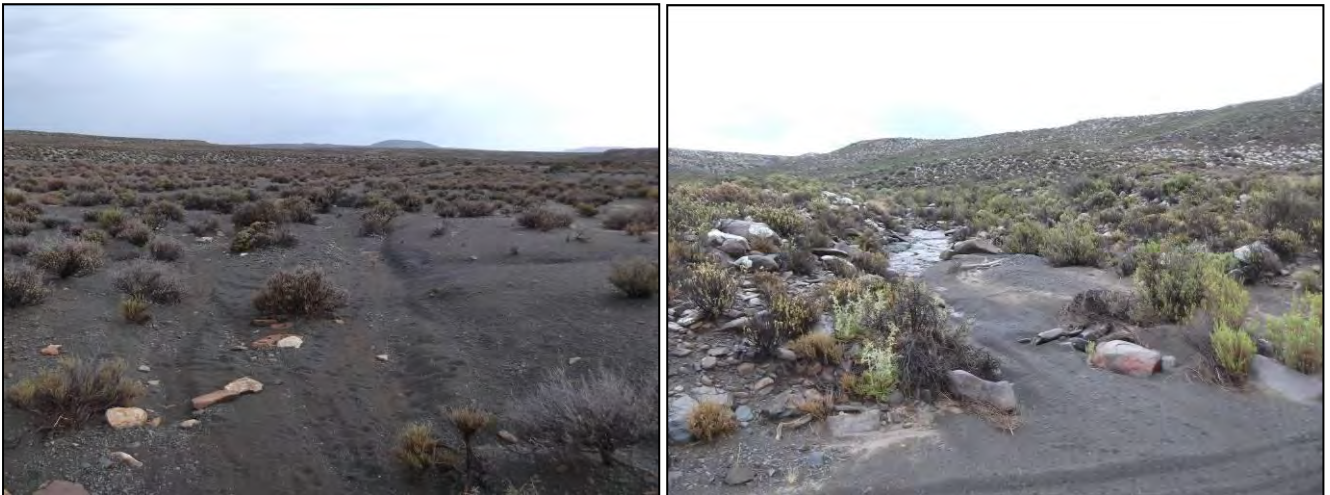
Figure 16: Representative photographs of evidence of alluvial soils present within smaller tributaries and ephemeral drainage lines.

- Terrain units were used to determine in which parts of the landscape freshwater resources would most likely occur in;
- The presence of alluvial soils was used as an indication of where and how water would flow across a landscape (Figure 16). The deposition of alluvial soils within channels/gullies was used to identify possible watercourses; and
- The vegetation indicator was used where possible in the identification of the riparian boundary through the identification of the distribution of both facultative and obligate wetland vegetation associated with soils that are frequently saturated. Key species utilised included *Scirpoides dioecus* and *Schoenoplectus sp* (Figure 17). Changes in vegetation density and levels of greening were also considered during the delineation process, particularly in instances where ephemeral drainage lines were identified.

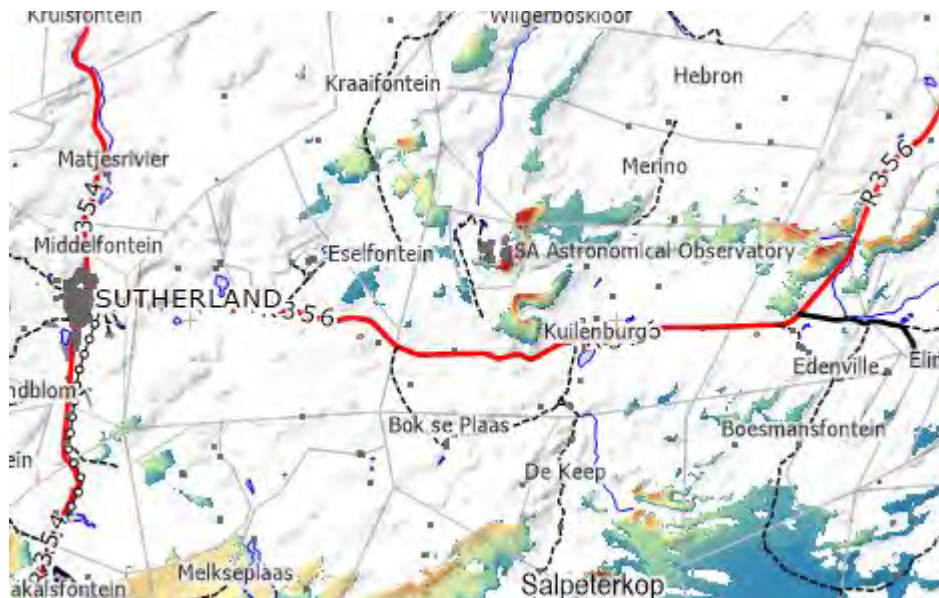
Figure 1-8 Inset map showing the viewshed for Alternative 1 near Sutherland and the SA Astronomical Observatory. The Observatory is more than 30 km from Alternative 1 and 2, and it is very unlikely that the proposed power line will be noticed from here.

It should further be noted that Sutherland is not located in viewsheds for either route, and although the South African Astronomical Observatory is located in both viewsheds (Figure 1-8) it is approximately 30 km from the proposed routes and viewers are highly unlikely to notice a 132 kV power line over this distance.

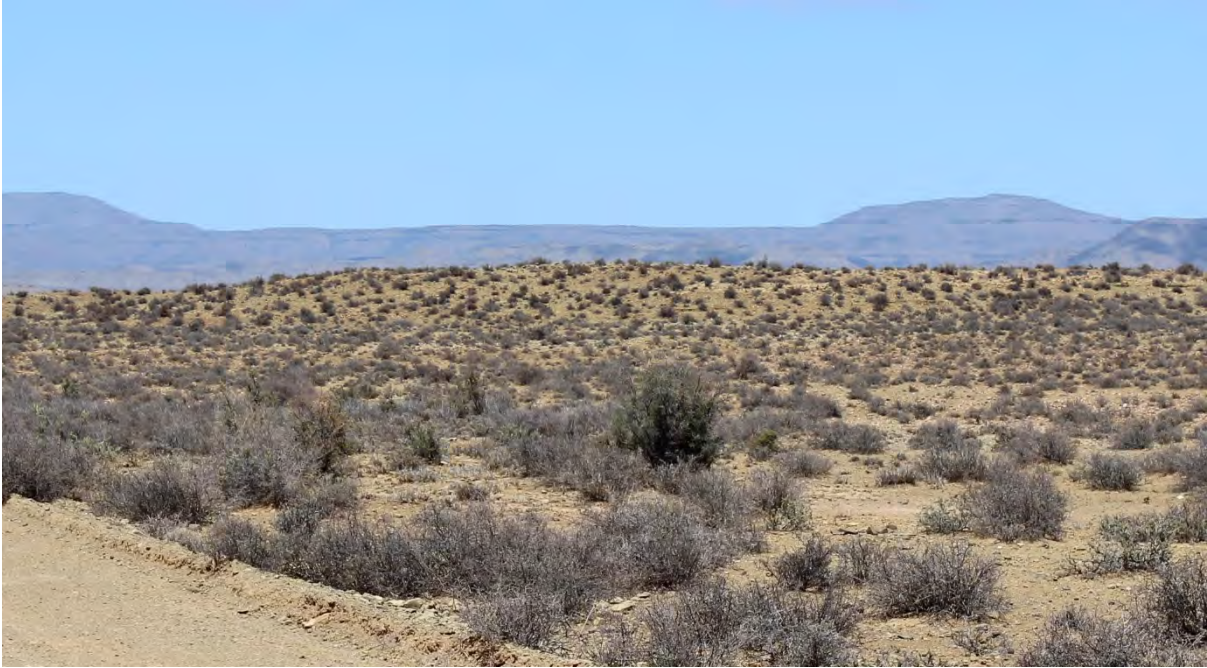
Figure 1-17 View south-west from SVP021 near the Hamelkraal farmstead. Existing high voltage transmission line towers are visible on the distant hills. This site (SVP021) is on the plains below the escarpment.

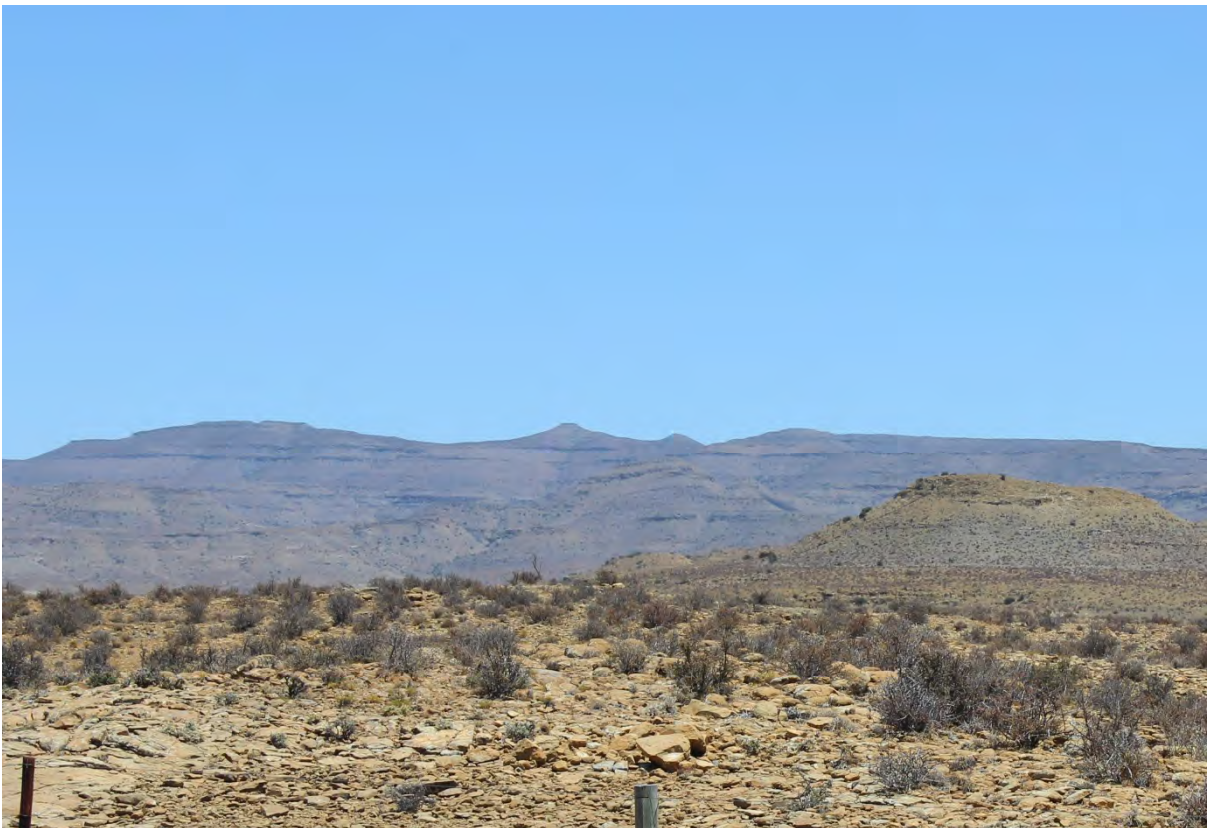
Figure 1-20 View west from SVP024 towards the proposed site for the proposed Eskom substation at the eastern end of Alternative 2. Due to the high ridges (escarpment) in the background the substation is unlikely to be exposed above the skyline for motorists.

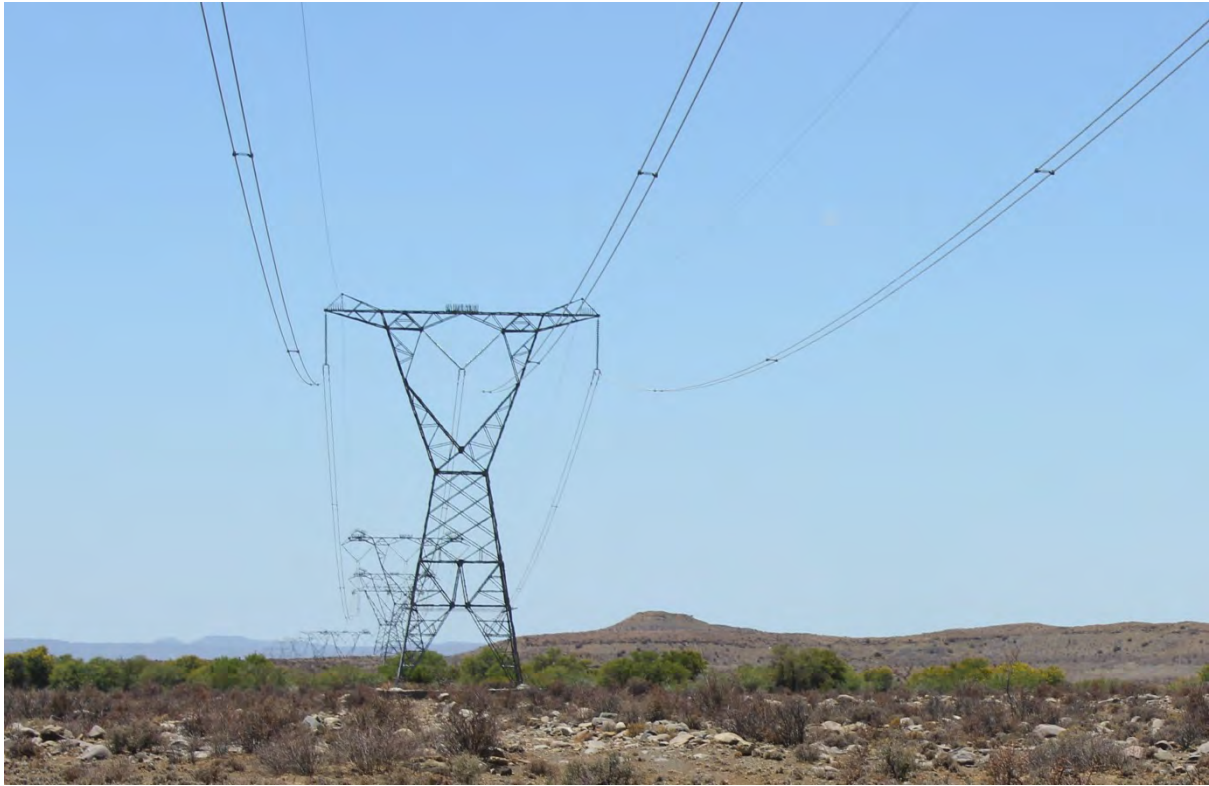
Figure 1-21 High voltage power lines crossing the road at SVP025 (looking east).

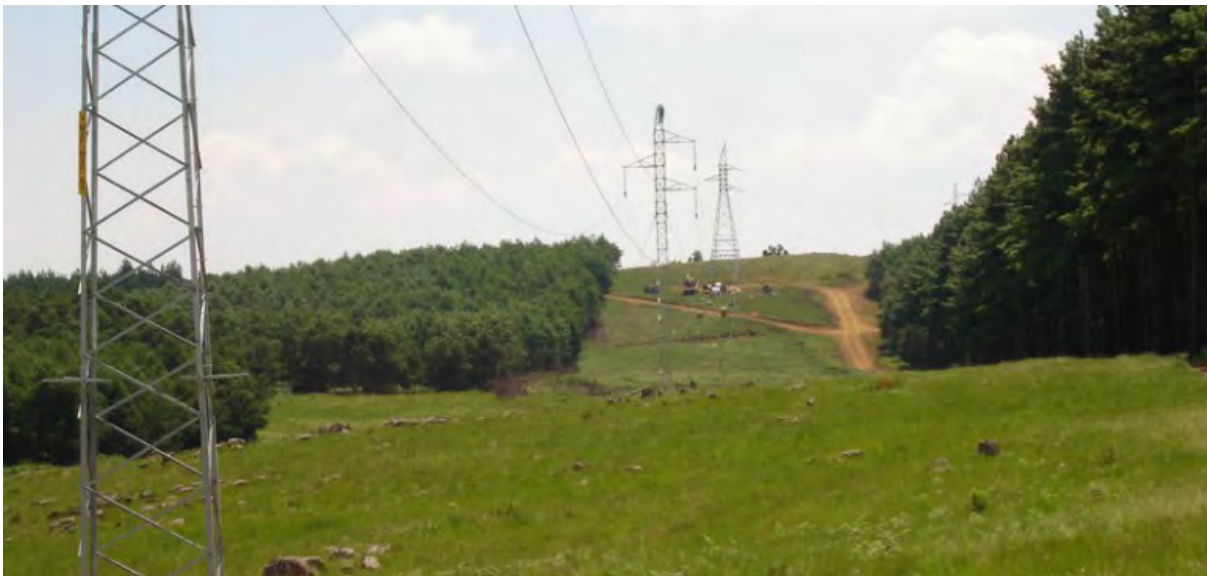
Figure 1-22 An example of lattice towers used for 132 kV power lines. (Source: <https://optipower.co.za/mizpah-msingqa/>)

It is recommended that the type of towers used for the proposed power line should be lattice towers rather than monopole. Lattice type towers are framework towers made up of thin "[*metal strips arranged to form a diagonal pattern of open spaces between the strips*](#)" (Figure 1-22) which allows for the background to be visible through the spaces. The towers proposed for this project are monopole structures (Figure 1-23) which are solid. Although monopole structures can be seen as aesthetically more pleasing than lattice type structures, either is likely to cause negative visual impacts on views. The mitigation measure proposed here is therefore intended to reduce the visibility of the structures rather than to improve its aesthetics. It is believed by the author that a lattice tower will be less visible against the mottled landscape background of the region than a monopole tower (Figure 1-24). This is not an essential mitigation measure but its implementation will potentially lower the significance of the impact for Alternative 1 to very low

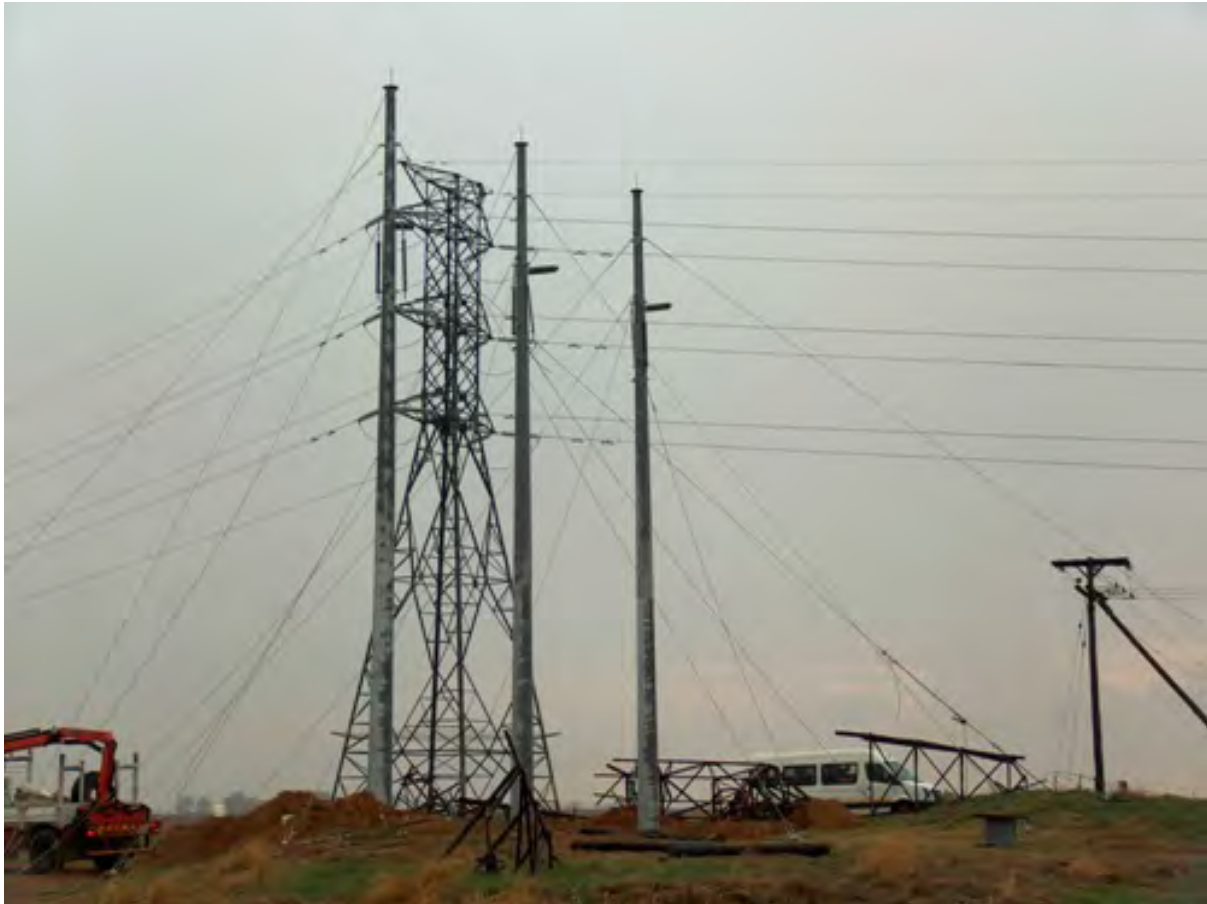
Figure 1-23 An example of monopole towers next to a lattice type tower for 132 kV power lines. (Source: <http://www.rame.co.za/flagship-projects/132kv-lattice-to-mono-pole-replacement/nggallery/image/578>)

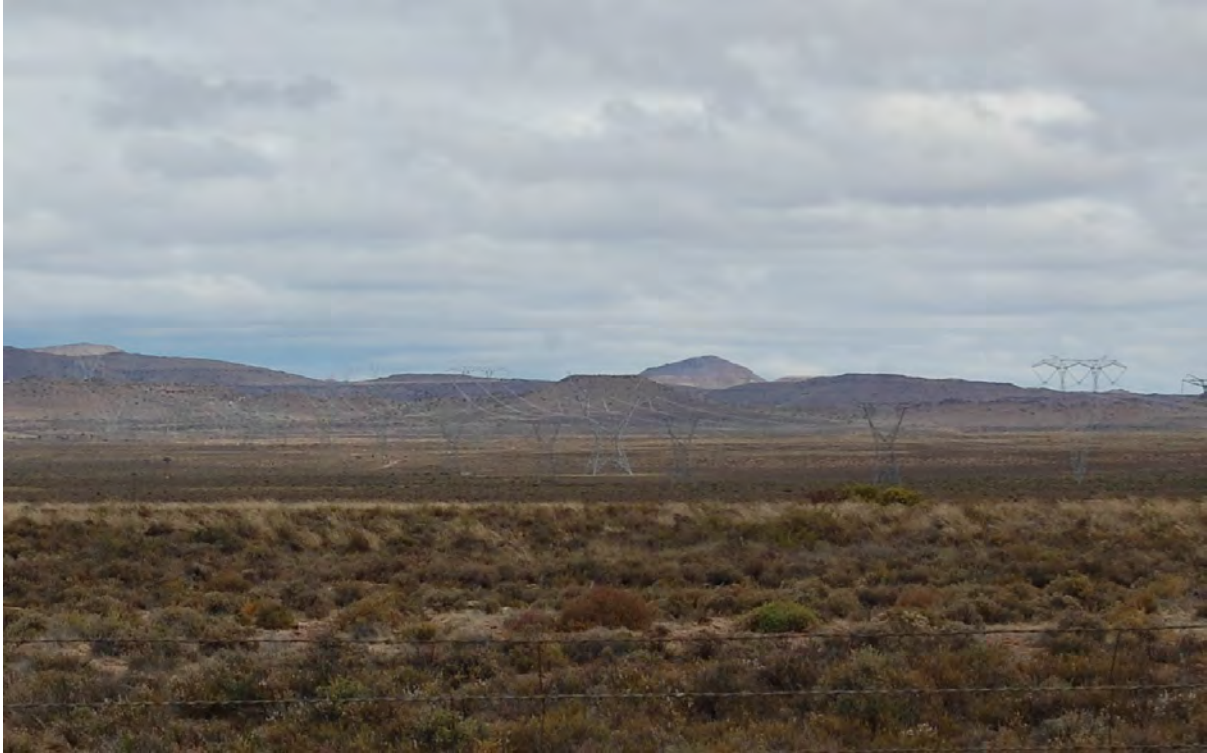
Figure 1-24 High voltage transmission lines with lattice towers against a mottled landscape similar to that of the Sutherland region (photo taken by author).

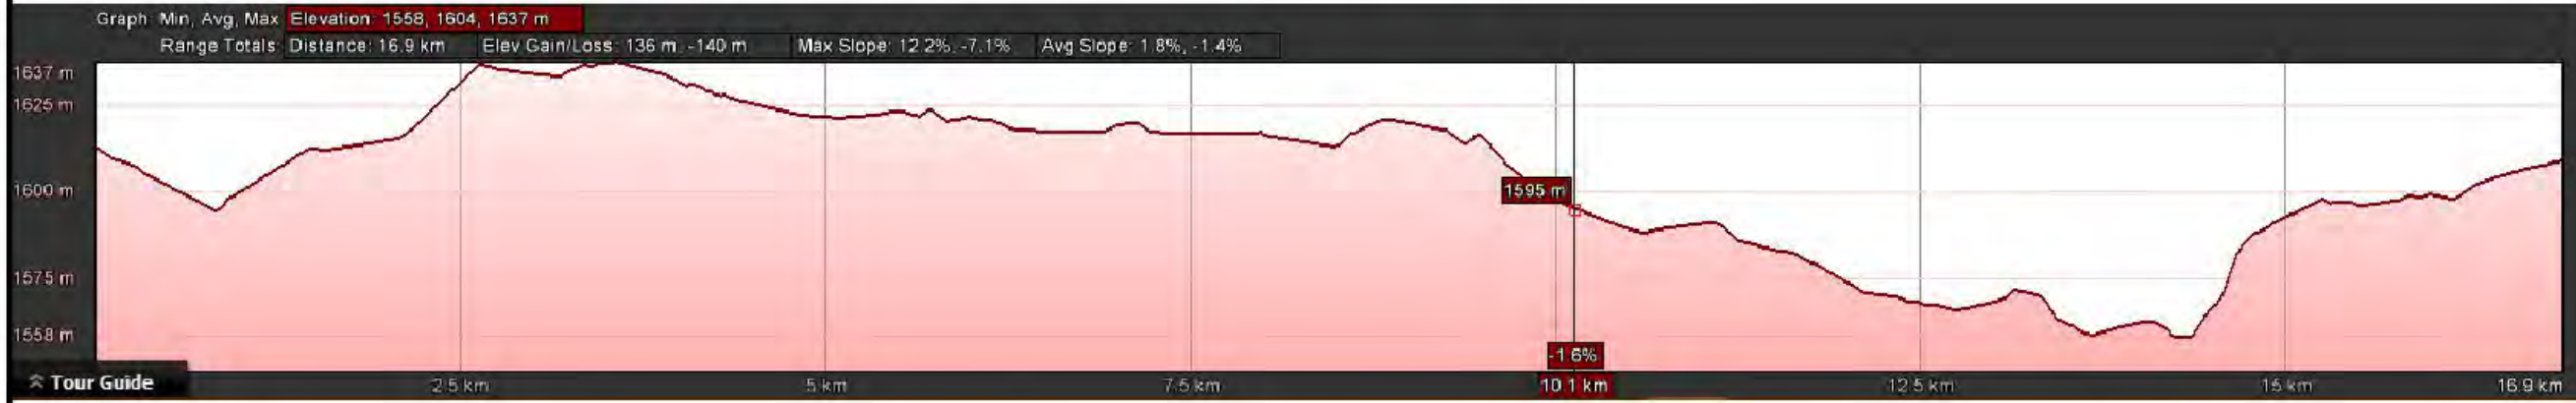
a) Alternative 1 topographic profile.

Map 5 Topographic profiles of proposed alternative routes for the overhead lines.
