VISUAL IMPACT ASSESSMENT:

Basic Assessment for the proposed Construction of Electrical
Grid Infrastructure to support the proposed Sutherland
Wind Energy Facility, near Sutherland, in the
Northern and Western Cape Provinces

Basic Assessment for the Proposed Construction of Electrical Grid Infrastructure to support the Sutherland Wind Energy Facility (WEF), Northern and Western Cape Provinces (Sutherland WEF - Electrical Grid Infrastructure)

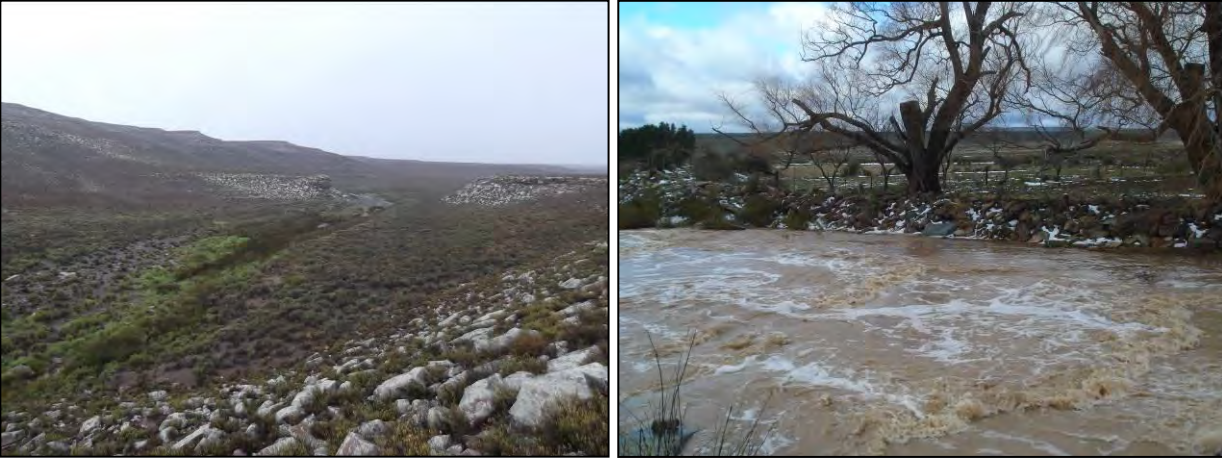
<p>Vegetation Ecostatus (VEGRAI) and PES discussion</p>	<p>Category B/C (Largely natural to moderately modified) There has been minimal change to the natural habitats present within the site, and therefore few changes to the natural biota from its reference state. Some invasion by alien species was evident and hence this accounts for the vast majority of modification. Basic ecosystem function will be marginally altered (e.g. nutrient cycling). Given this characterisation, the system is likely fairly resilient to minor modification of vegetation communities.</p> <p>This portion of the Riet River was found to be largely natural, with few modifications to the ecosystem from its reference state. Minor modifications to the river include the impoundment of water for agricultural purposes, localised bank erosion which will marginally alter channel competency, as well as a negligible degree of exotic invasion. Minor loss of vegetation as a result of browsing by sheep and other ruminants, a common farming practice in the region, is considered possible. These impacts have caused a slight, albeit discernible change to ecosystem processes.</p>	<p>Photograph notes</p> <p><u>Watercourse characteristics:</u> a) Hydraulic regime Culverts and the artificial impoundment of the river along particular portions of its channel will have influenced the flow pattern/hydraulic regime of the system, albeit only moderately. Abstraction and redirection of water for agricultural purposes is evident and has resulted in a minor to moderate reduction in flow, especially given the limited surface water and high evaporative potential in the region. Furthermore, inundation of sections of the river course have resulted in permanent submersion, in order to facilitate the abstraction of this water for irrigation, thereby altering downstream sites by reducing flow, and upstream sites by increasing saturation potential. Given that Sutherland experiences an average of six snow days per year (Van der Merwe 2010), there is an increased likelihood of the development of preferential flow paths as a result of snow melt and subsequent water flow, especially from higher lying regions. Ultimately, this water will then feed into the river system. These flow paths may also be of substantial importance for diverting all forms of precipitation to groundwater systems (as well as the river channel) and as such these are considered sensitive areas, vital to the effective functioning of the catchment as a whole. Channel competency is high, with only minor modifications to the existing bank (e.g., erosion due to trampling by livestock) following flood events.</p> <p>b) Water quality Detailed assessment of water quality was not within the scope of this study, however water quality is anticipated to be high, and is likely, especially given the limited input of pollutants and lack of industry or urban development in the region. However, runoff from cultivated areas,</p>	<p>Representative photograph of a section of the Riet River, illustrating the surrounding high lying regions in the distance and the associated river channel traversing it. Note the typical Roggeveld Karroo shrubland as well as the evidence of an altered growth habit (height/colour) of vegetation within and alongside the main stream channel. Snow melt contributes significantly to the hydraulic regime of the river, as depicted in the photograph on the right³.</p>

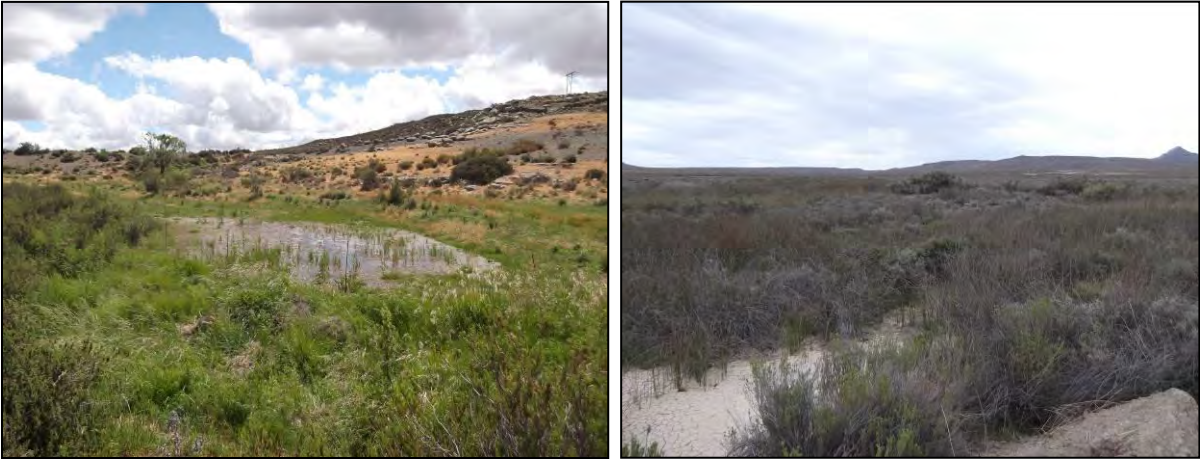
<p>Vegetation Ecostatus (VEGRA) and PES discussion</p>	<p>REC Category: B/C (Largely natural to moderately modified) There has been minimal change to the natural habitats present within the site, and therefore few changes to the natural biota from its reference state. Some basic ecosystem functions may be marginally altered (e.g., nutrient cycling) but these features are important to ecosystem functioning of the greater riparian system within the study area.</p> <p>Tributaries of the Portugal's River traversing the study site were found to have undergone relatively minor modifications and hence are considered to be in largely natural condition. Minor impacts in the form of erosion, catchment hardening (culverts and roads), artificial impoundment and the building of swales will have influenced flow patterns but are not expected to have significantly altered the ecological integrity of the system.</p>	<p>Photograph notes</p>	<p>Representative photographs of a tributary of the Portugals River located within the Sutherland 2 study area. The freshwater feature is composed predominantly of hydrophilic herbaceous vegetation, including a number of species of grass and sedges (such as <i>Scirpoides dioecus</i> - an obligate wetland plant). Whilst the upstream area (left) contained some surface water, the downstream portion of the tributary was dry (right).</p>

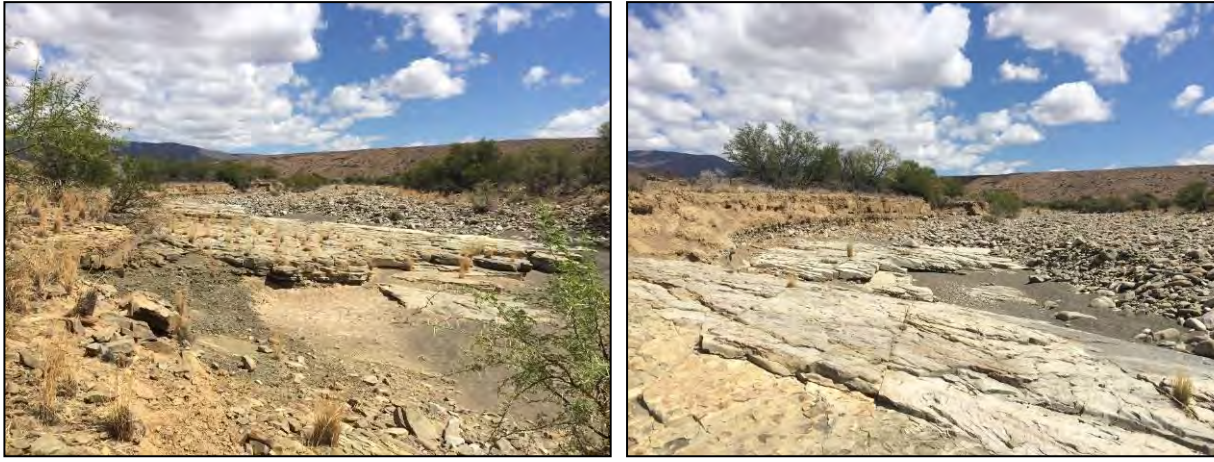
<p>Vegetation Ecostatus (VEGRAI) and PES discussion</p>	<p>Category: C (Moderately modified) The Van Wyks River is an ephemeral system, with a large portion of the system falling within the valley of the surrounding mountains, where there are likely to be minimal anthropogenic impacts. The system was observed to have little surrounding vegetation, due to the nature of the semi-arid environment, although some clearing has occurred to allow for the construction of informal farm roads through the river. Overgrazing by domestic livestock was also observed and is likely to have contributed to altered vegetation communities. Embankments of the system were visibly eroded and informal farm roads and fences were identified crossing the system, which may have impacted the hydrological regime marginally when surface water is present, in terms of hardened surfaces (causing increased water velocity and thus exacerbating bank incision) and potentially causing blockages, particularly if debris is caught up in the fences.</p>	<p>Photograph notes</p>	<p>The Van Wyks River is an ephemeral system, and no surface water was present at the time of the assessment. No obligate or facultative wetland vegetation present, however <i>Acacia</i> species as well as other smaller terrestrial vegetation were observed surrounding the watercourse. Informal farm roads and fences were identified crossing the Van Wyks River. Note the severity and extent of bank incision in the photograph on the right.</p>

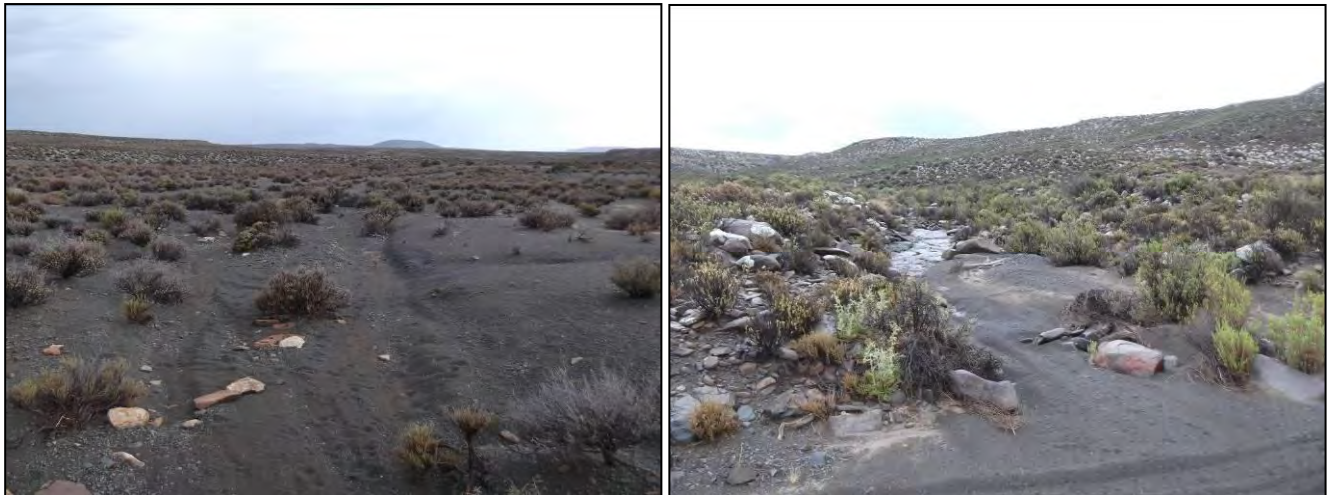
Figure 16: Representative photographs of evidence of alluvial soils present within smaller tributaries and ephemeral drainage lines.

- Terrain units were used to determine in which parts of the landscape freshwater resources would most likely occur in;
- The presence of alluvial soils was used as an indication of where and how water would flow across a landscape (Figure 16). The deposition of alluvial soils within channels/gullies was used to identify possible watercourses; and
- The vegetation indicator was used where possible in the identification of the riparian boundary through the identification of the distribution of both facultative and obligate wetland vegetation associated with soils that are frequently saturated. Key species utilised included *Scirpoides dioecus* and *Schoenoplectus sp* (Figure 17). Changes in vegetation density and levels of greening were also considered during the delineation process, particularly in instances where ephemeral drainage lines were identified.

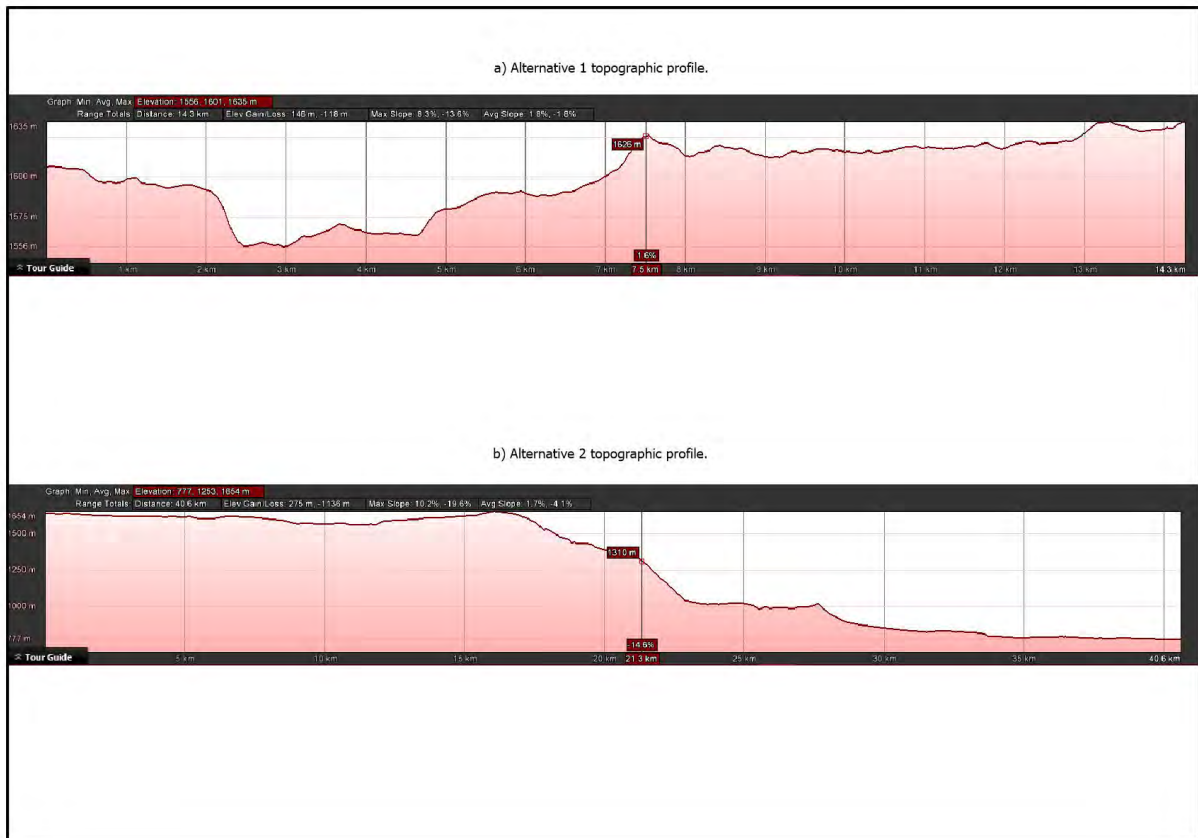
Figure 1-5 Topographic profiles of proposed alternative routes for the overhead lines.

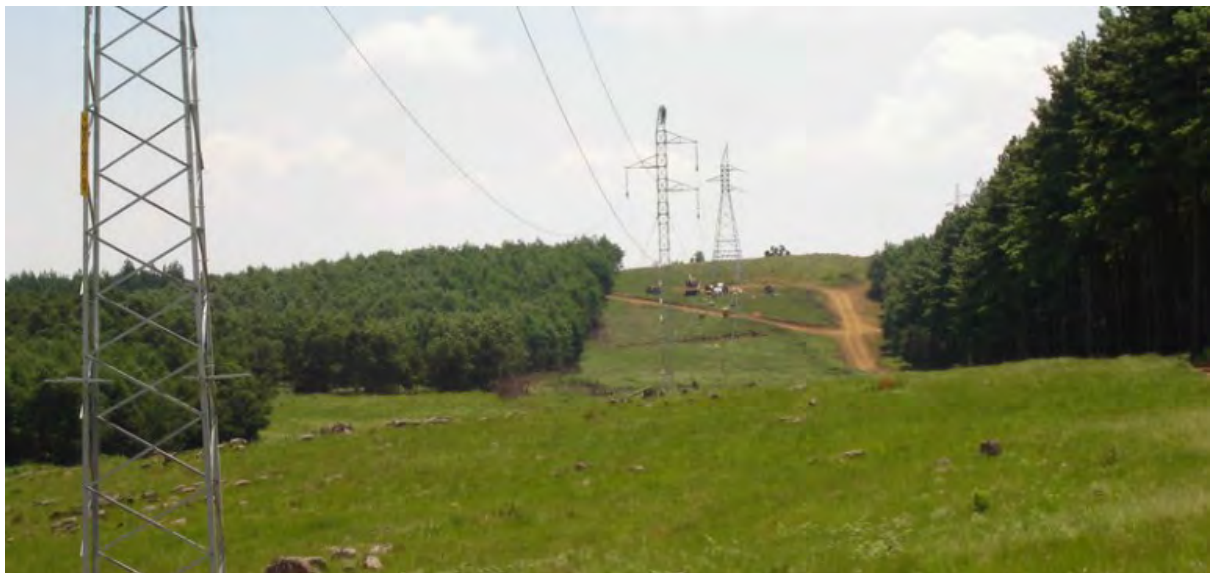
Figure 1-22 An example of lattice towers used for 132 kV power lines. (Source: <https://optipower.co.za/mizpah-msingqa/>)

It is recommended that the type of towers used for the proposed power line should be lattice towers rather than monopole. Lattice type towers are framework towers made up of thin "metal strips arranged to form a diagonal pattern of open spaces between the strips" (Figure 1-22) which allows for the background to be visible through the spaces. The towers proposed for this project are monopole structures (Figure 1-23) which are solid. Although monopole structures can be seen as aesthetically more pleasing than lattice type structures, either is likely to cause negative visual impacts on views. The mitigation measure proposed here is therefore intended to reduce the visibility of the structures rather than to improve its aesthetics. It is believed by the author that a lattice tower will be less visible against the mottled landscape background of the region than a monopole tower (Figure 1-24). This is not an essential mitigation measure but its implementation will potentially lower the significance of the impact for Alternative 1 to very low.

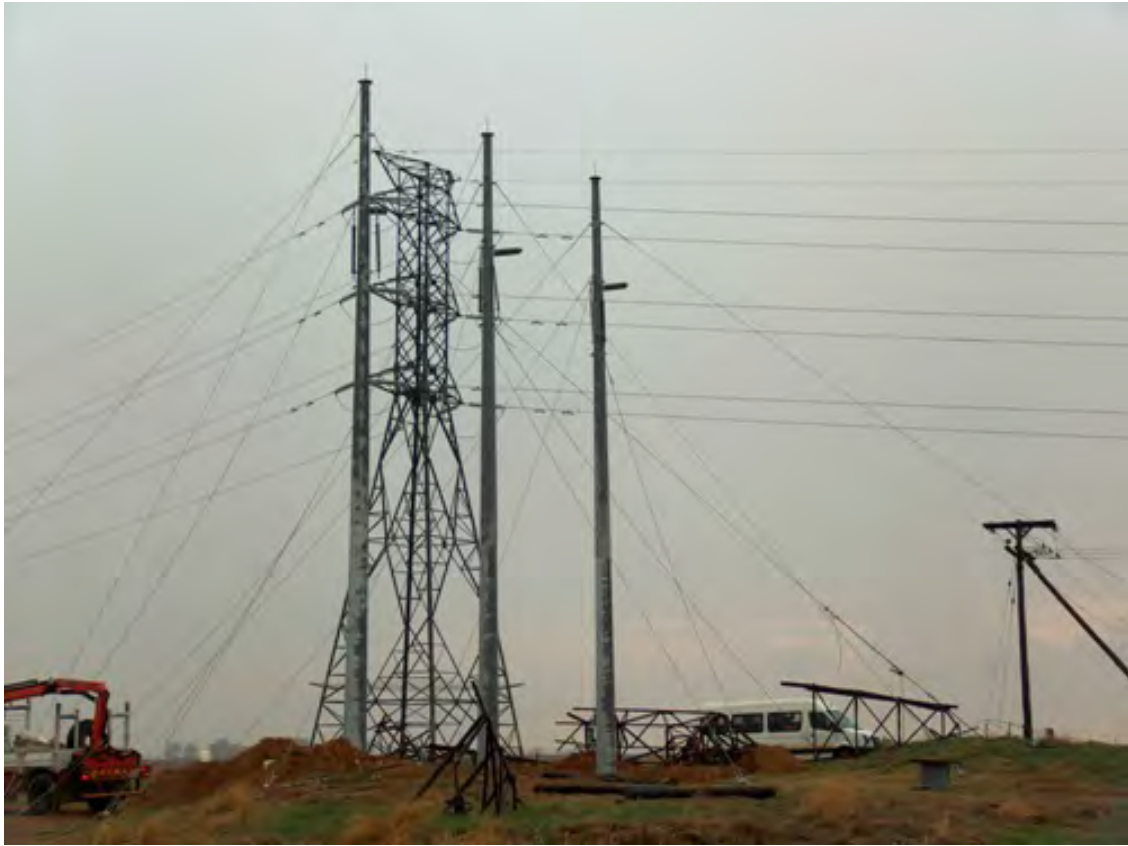
Figure 1-23 An example of monopole towers next to a lattice type tower for 132 kV power lines. (Source: <http://www.rame.co.za/flagship-projects/132kv-lattice-to-mono-pole-replacement/nggallery/image/578>)

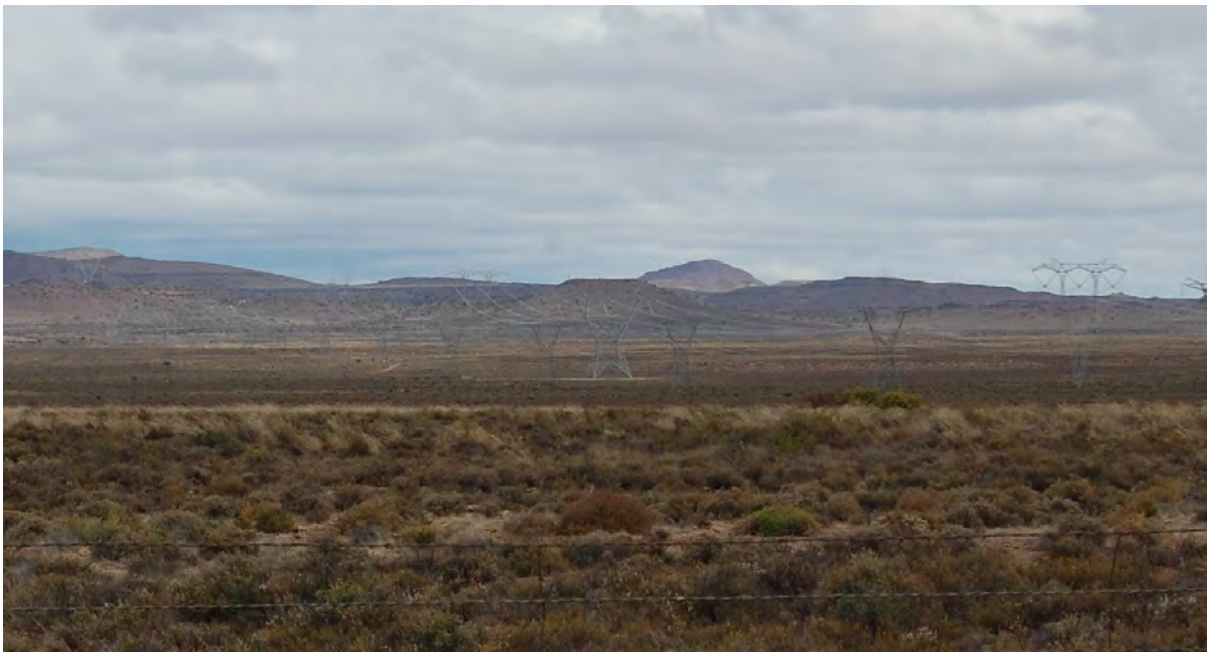
Figure 1-24 High voltage transmission lines with lattice towers against a mottled landscape similar to that of the Sutherland region (photo taken by author).

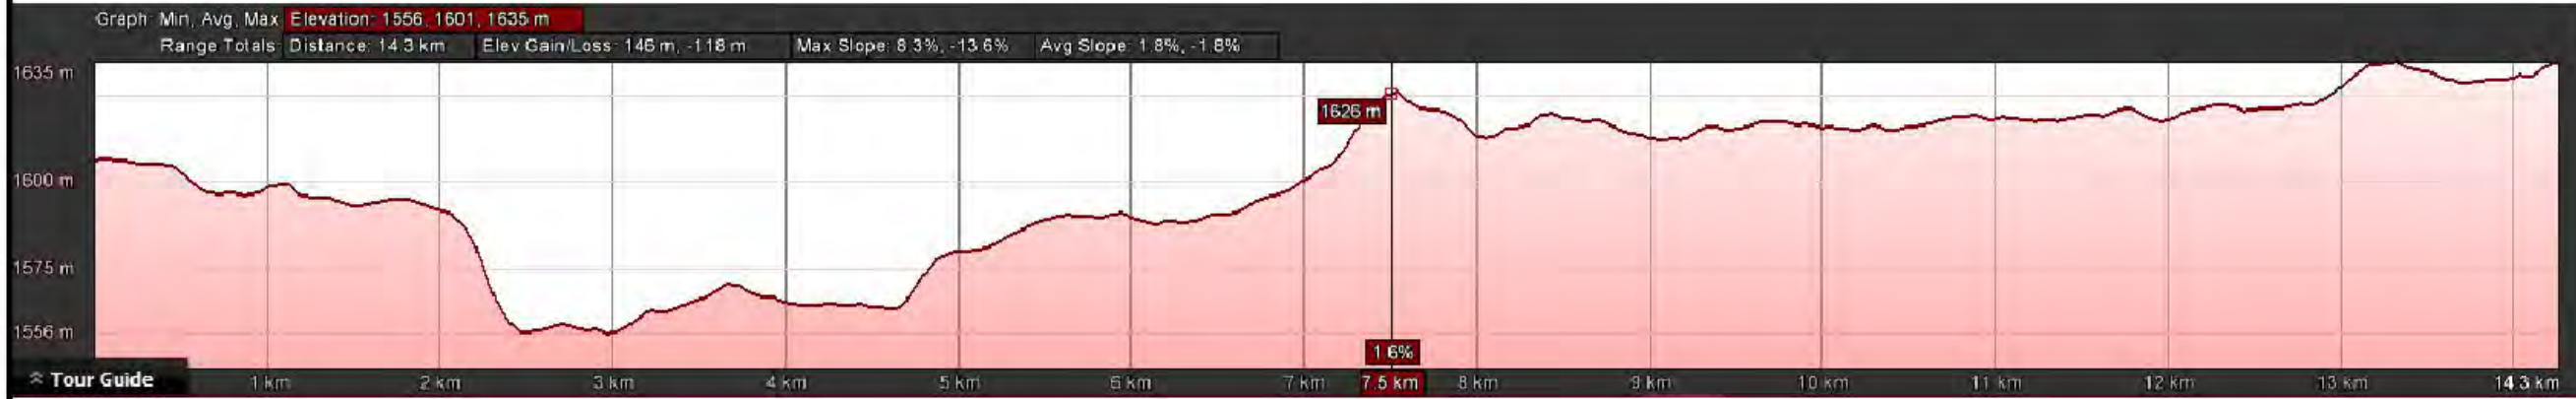
a) Alternative 1 topographic profile.

Map 5 Topographic profiles of proposed alternative routes for the overhead lines.
